STAR ONLINE PUBLICATION

Case Number: S2202000012

Symptom/Vehicle Issue: Click Noise From Front End Or Front Wheel Area While Driving After Recent Service.

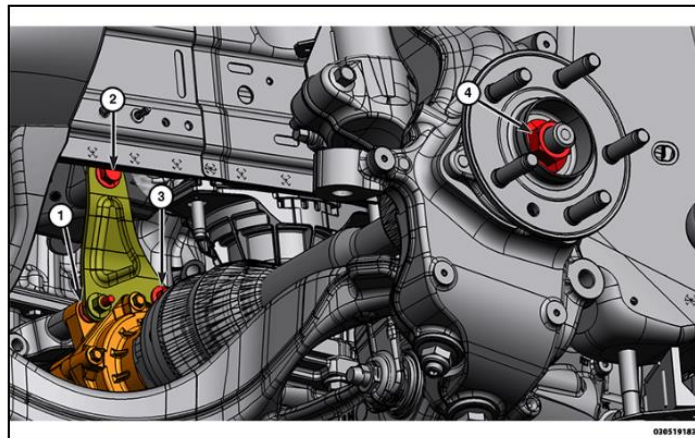
Discussion: Inspect front axle shaft retaining nut torque. The nut is a 1 time only use fastener and must be replaced anytime it is removed for servicing. Refer to Service Library 03 - Differential and Driveline / SHAFTS, Axle/Drive/Half / Removal and Installation for repair information.

CALLOUT	DESCRIPTION	SPECIFICATION	COMMENTS
1	Front Axle Disconnect (FAD) to Engine Bolt (Double Ended Stud)	55 N-m (41 Ft. Lbs.)	-
2	Front Axle Disconnect (FAD) Bracket Bolt	35 N-m (26 Ft. Lbs.)	-
3	Front Axle Disconnect (FAD) Bracket Nut	30 N-m (22 Ft. Lbs.)	-
4	Halfshaft Hub Nut	310 N-m (229 Ft. Lbs.)	If removed, NEW nut must be installed and tightened to specifications
