NUMBER: 02-008-22

GROUP: 02 - Front Suspension

Clunk Noise Is Heard When Driving Over Bumps

2022 (WS) Grand Wagoneer/Wagoneer

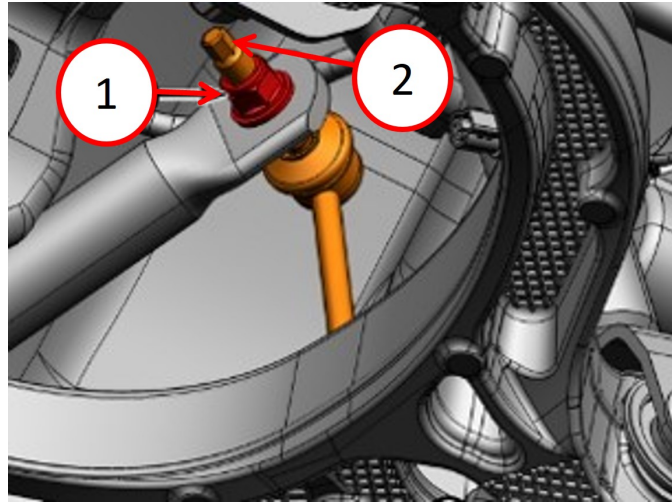
Fig. 1

- Clunk noise is heard when driving over bumps.

Bar To Link Joint Nut And Hex Stud

2. Tighten **both the left and right** front stabilizer bar to end link joint nuts to 175 N·m (129 ft. lbs.) (Fig. 1) .

NOTE: Tighten the front stabilizer bar to end link joint by holding the hex stud tip on the ball joint (Fig. 1) and driving the nut in the tightening direction.
