**NUMBER:** 08-039-22 REV. C

2022 R1 High Radio Update to S24.18

This bulletin involves inspecting the software level and updating the software to S24.18

2022	(WL)	Jeep Grand Cherokee
2022	(RU)	Chrysler Pacifica/Voyager
2022	(WS)	Grand Wagoneer/Wagoneer

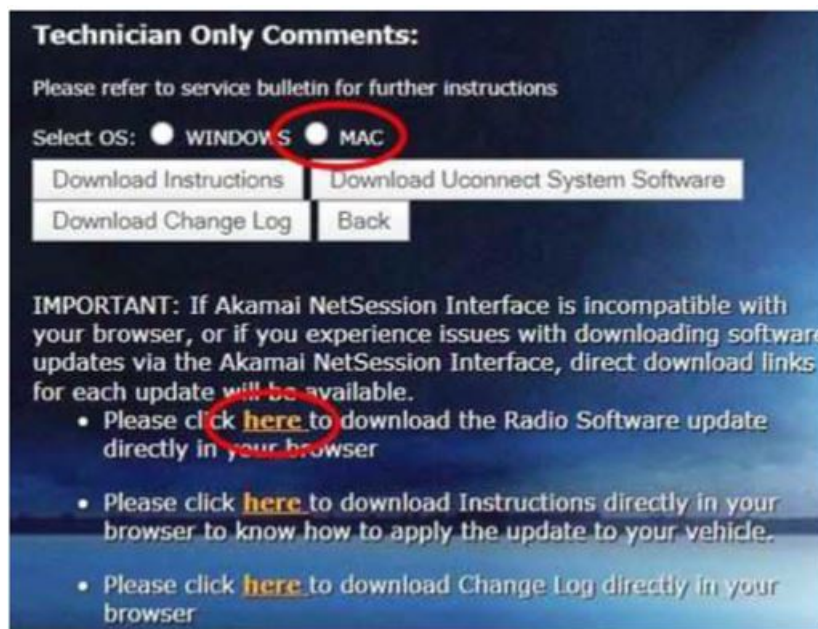
**Fig. 1  
MAC Download Steps**

6. Download the software update file to your local PC’s desktop. Make sure to select the “MAC” radial button for all downloads ([Fig. 1](#)) .

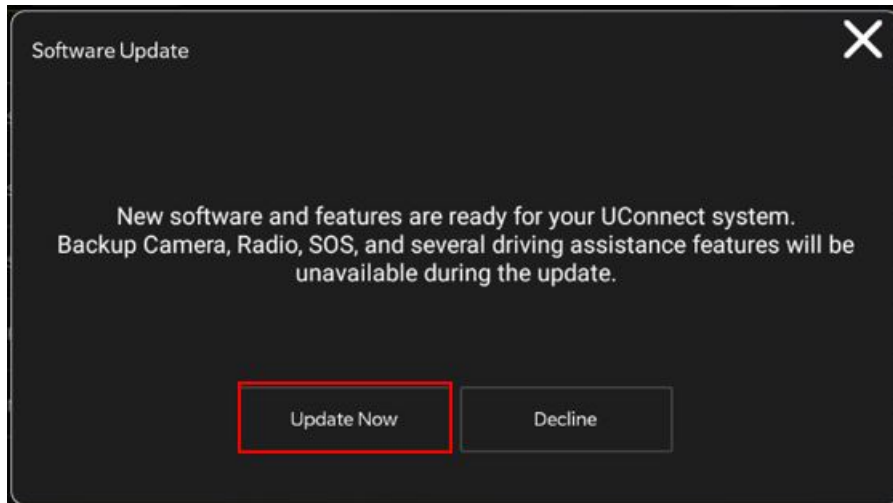
**Fig. 2  
Software Update Is Available**

12. Once the system has verified there is an available update, press the “Update Now” button. Make sure the vehicle is in park. **Do NOT turn the ignition off until the two minute timer has expired. The ignition doesn’t have to be turned off to update the radio’s software (Fig. 2) .**

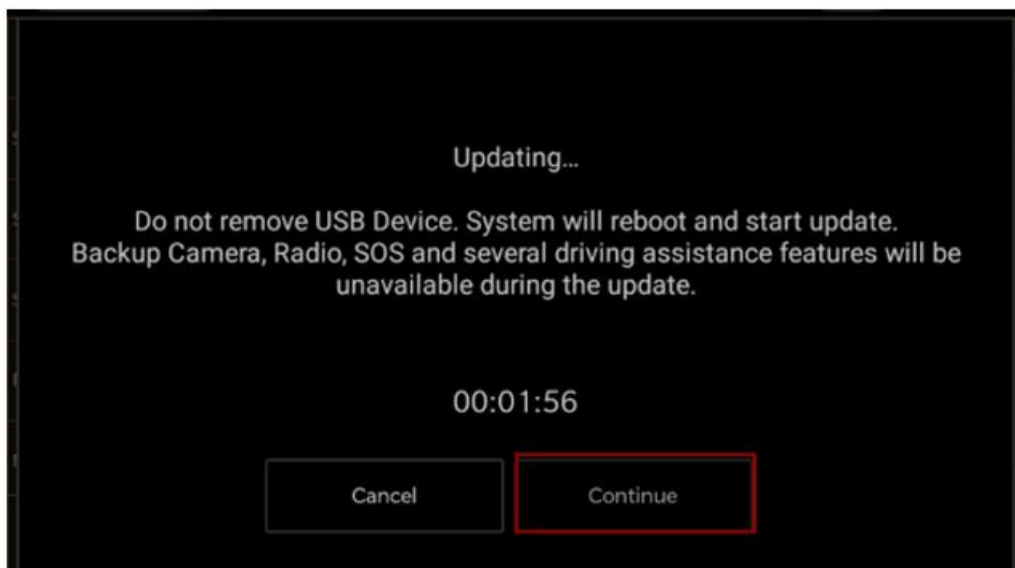
**Fig. 3  
Continue Display Screen**

13. Press the “Continue” on the display screen (Fig. 3) .

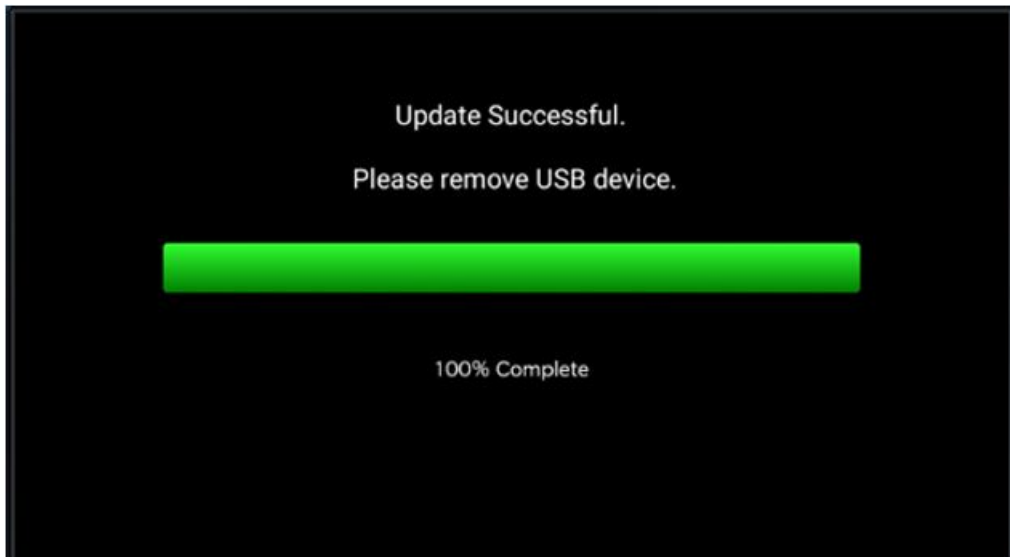
**Fig. 4**  
**Software Update Completed**

14. The radio will reboot and the update will begin. The update should only take 30 minutes (Fig. 4) .

**NOTE: Do NOT turn off the vehicle when the software update is completed and told to remove the USB flash drive.**

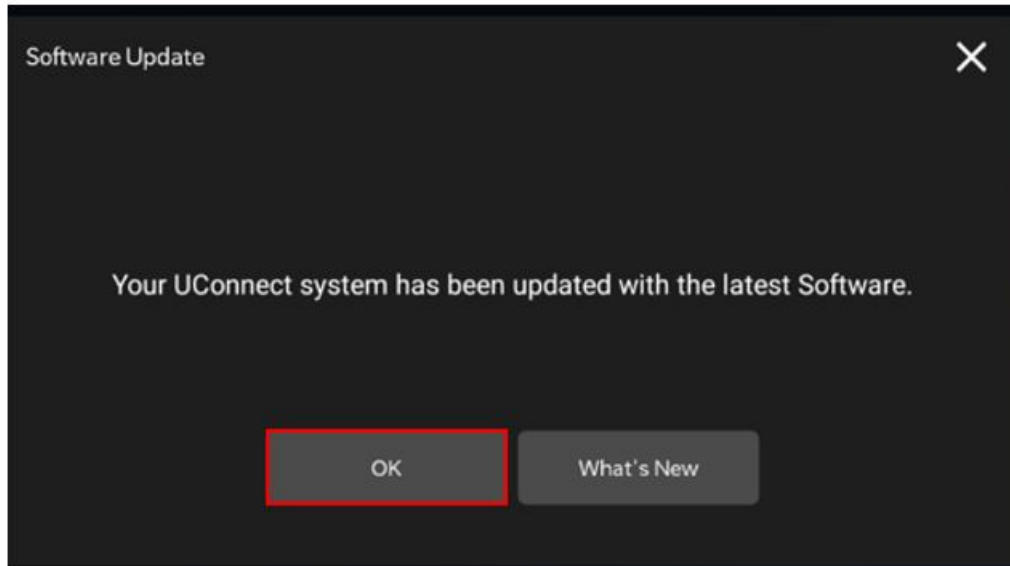
Fig. 6

17. Press “OK” to continue (Fig. 6) .

**Radio Software Has Been Updated**
