NUMBER: 08-095-22 REV. A

GROUP: 08 - Electrical

DATE: November 16, 2022

UAX And UCX KR20.12 To PR40.1 Software Version Updates

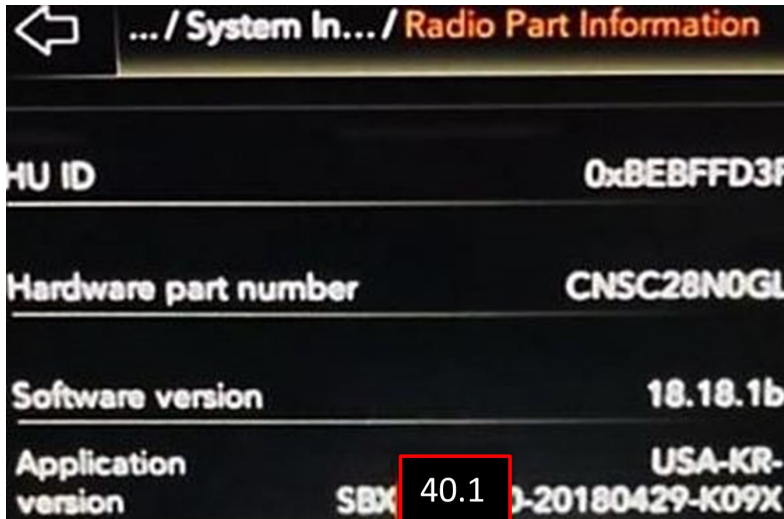
Fig. 1
Radio Software Level Screen

1. Verify the radio software version. Radio must be in Dealer Mode to verify by following these steps:
 - a. Press and hold both lower corners of the display screen, until the Dealer Mode screen appears (approximately seven seconds). Release corners.
 - b. Select "Radio Part Information". The software version will be listed next to "Application Version" (Fig. 1) .

2. What is the radio software level (Application Version) at?
 - ****40.1** or higher** >>> The radio software is already up to date. Normal diagnostics should be performed.
 - **At or above 34.2 and under **40.1**** >>> The radio will only need **one** USB flash drive to update the radio. Create a USB flash drive with ****40.1**** software. Proceed to [Step 1](#) of the Repair Procedure.
 - **At or above **20.12** and under 34.2** >>> The radio will need **two** USB flash drives to update the radio. Create two USB flash drives with 34.2 and ****40.1**** software. Proceed to [Step 1](#) of the Repair Procedure.
