RAPID UPDATE 562

Rapid Update 562

M15x MY22-23 - Potential Maserati Logo Detachment

DATE: DECEMBER 14 2022

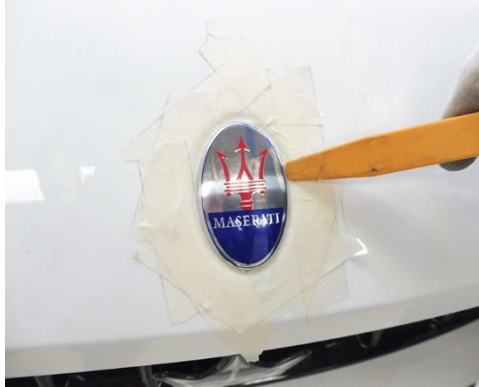
1. Always check ModisCS+ to see if the vehicle is involved in this action and if it has not been previously performed.
2. Protect the area around the logo with masking tape.
3. Check if the Maserati EMBLEM can be easily detached from its holder using a suction cup or a suitable Teflon wedge. In some cases, it may be necessary to only apply a little force for the inspection.

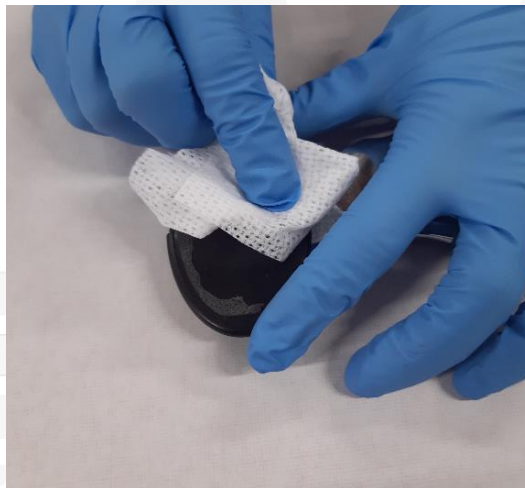
- If the inspection is GOOD and the EMBLEM adhesion is strong. The inspection procedure is finished.
 - If the inspection is NO GOOD and the EMBLEM is loose and detaches from the holder. Proceed to **Step 4**.
4. Remove the EMBLEM from the holder and clean the area between the holder and the EMBLEM with Isopropyl - alcohol wipes. Clean off all glue residue, then allow it to dry for 5 minutes.
