MAS003383 RU 22-02

RAPID UPDATE 573

Rapid Update 573 MC20 Seat Rattle Noise

DATE: DECEMBER 14 2022

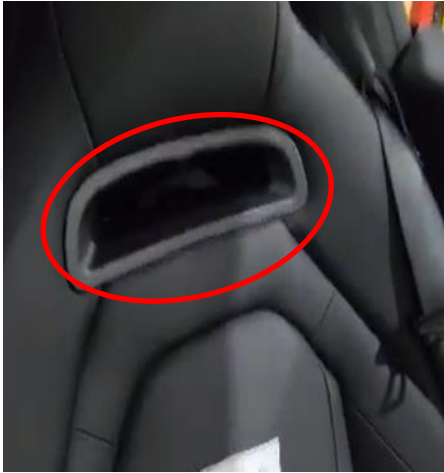
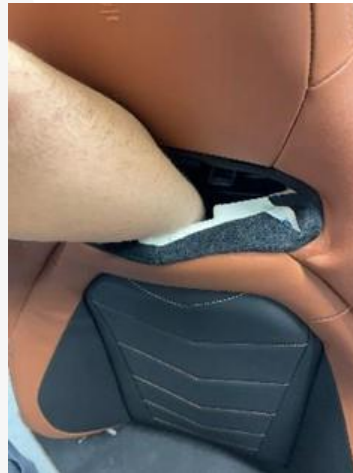
1. Always check in ModisCS+ to see if the vehicle is involved in this campaign and if the The campaign has not been previously performed.
2. Before performing this operation, please follow the below indicated procedure for interior protection and use clean gloves. **00.AA.005 - INTERIOR VEHICLE PROTECTION**
3. Move the seat completely backwards. Then remove the passenger seat seatback upper carter, following the below procedure **09.38.013 - PASSENGER SEAT SEATBACK UPPER CARTER - Removal/refitting or replacement**
4. Insert the hand behind the foam to reach the center of the backrest.

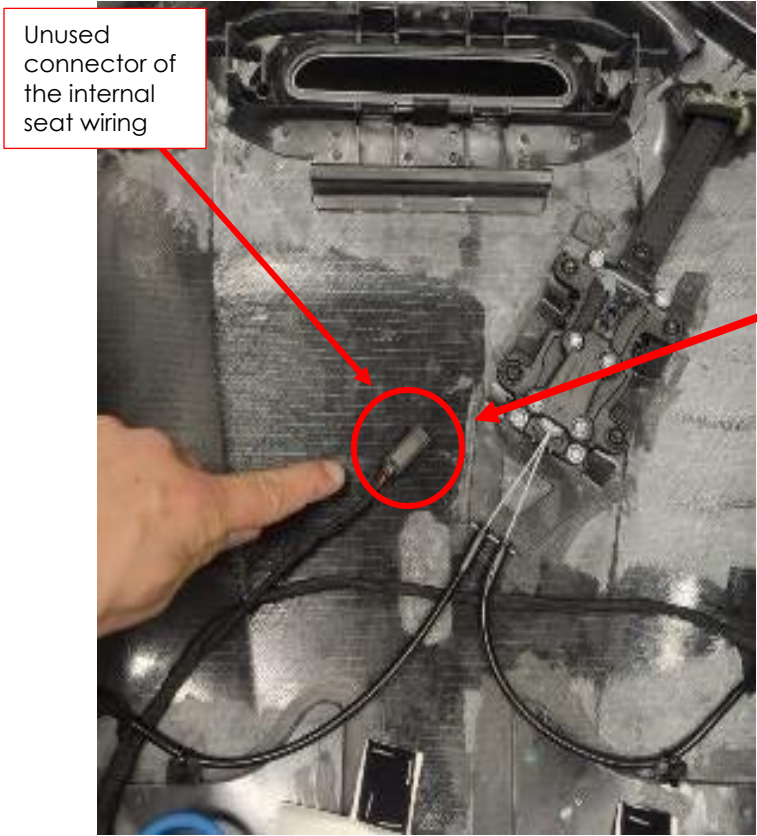
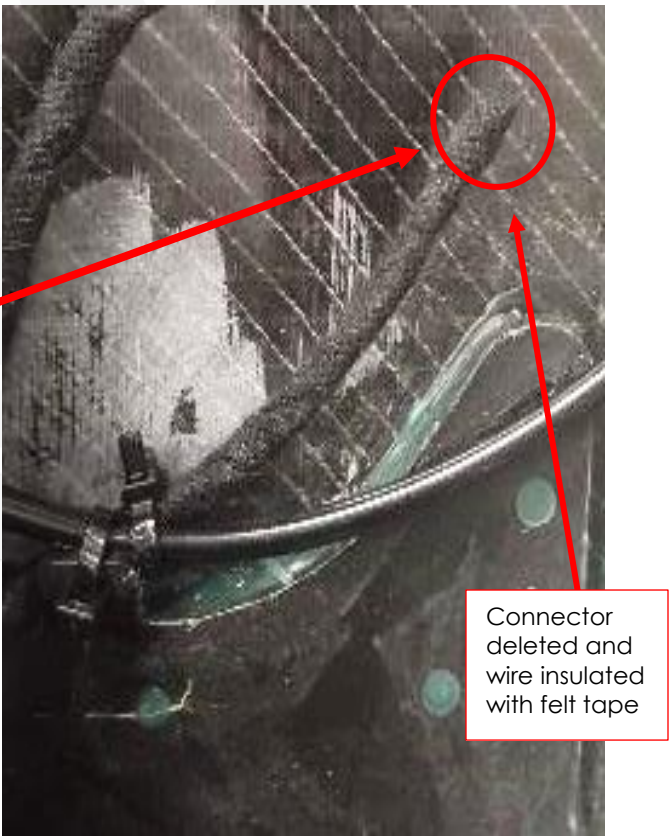
This action is needed to eliminate the source of the noise. MC20's without heated seats, are equipped with an unused connector included with the internal seats wiring harness. This connector, in some cases, could shake hitting the shell, creating the reported noise. To prevent this, the connector must be deleted by cutting it off from the harness.

Note: The images shown below are for illustrative purposes only and are just meant to clarify the connector to be identified and cut. This is a blind operation performed entering from the seat back upper carter hole. No dismantling should be carried out.

5. Identify the unused connector and cut it off by cutting the wire just below the connector and removing it, as shown below.

Make sure that the wire is cut clean with no copper wire exposed from the wire insulation!

6. After the cut, insulate the wire harness using wire insulating felt tape.
7. Refit the passenger seat seatback upper carter.

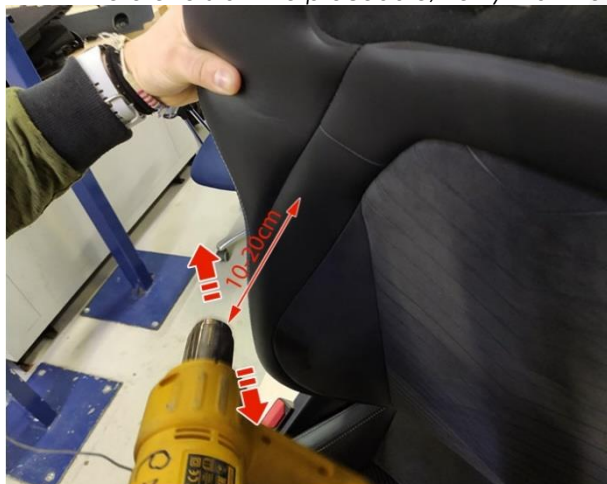
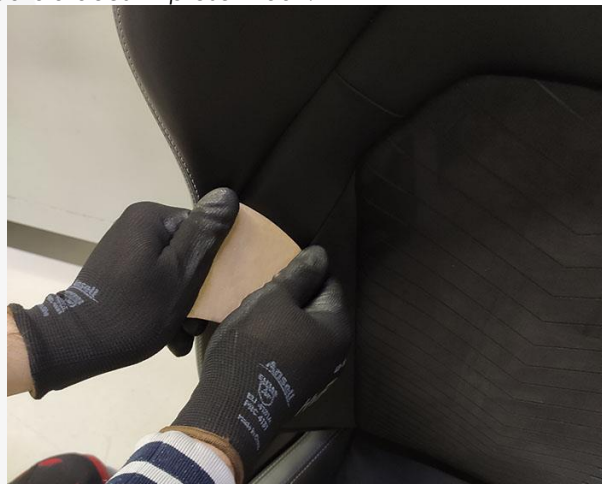
If during the operation there should be wrinkles on the leather of the seat, it is possible to eliminate them using a heat gun and smoothing the surface with a smooth spatula.

- Keep the gun at a distance of at least 10-20 cm;
- Never linger on the same point with the gun to avoid damaging the leather;
- Before to start the procedure, verify that the spatula doesn't present burr.
