Flash: Telematics Box Module (TBM) Updates

This bulletin involves updating the TBM with the latest software.

2022 (WL) Jeep Grand Cherokee

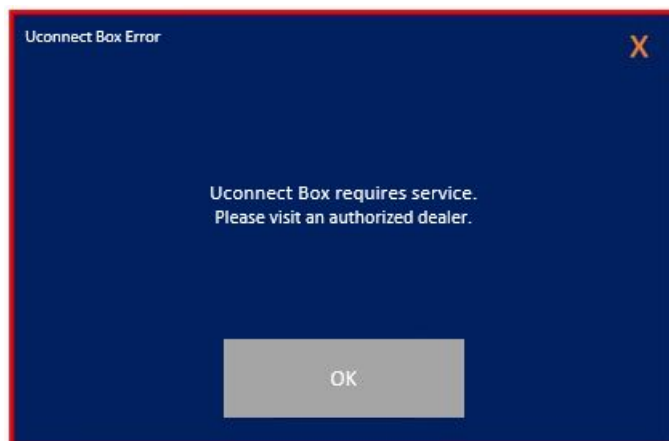
- Message display on the radio screen, “Uconnect Box requires service. Please visit an authorized dealer” (Fig. 1) , with no active or stored Diagnostic Trouble Codes (DTCs) set by TBM.

Fig. 1
Error Message

1. Reprogram the TBM module with the latest software. Detailed instructions for flashing control modules using the wiTECH Diagnostic Application are available by selecting the application's "HELP" tab.
2. Wait two minutes after the TBM flash has been completed.
3. Reset the Electric Power Steering (EPS) - Guided diagnostics menu -> ECU reset -> EPS, Click Continue and follow wiTECH prompts.
4. Clear all DTCs that may have been set in any module due to reprogramming. The wiTECH application will automatically present all DTCs after the flash and allow them to be cleared.
