NUMBER: 08-211-22

GROUP: 08 - Electrical

DATE: November 18, 2022

Radio Over The Air Software Version Updated to S26.17

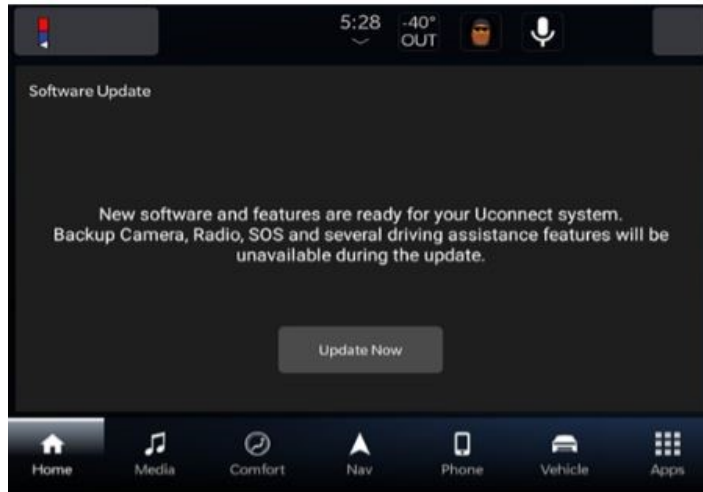
Fig. 1
Software Acceptance Screen

1. The vehicle needs to be in 'park'. The ignition needs to be in the off position.
2. If the customer selects "Update Now" they can shut off the vehicle and leave. The update will be completed automatically.

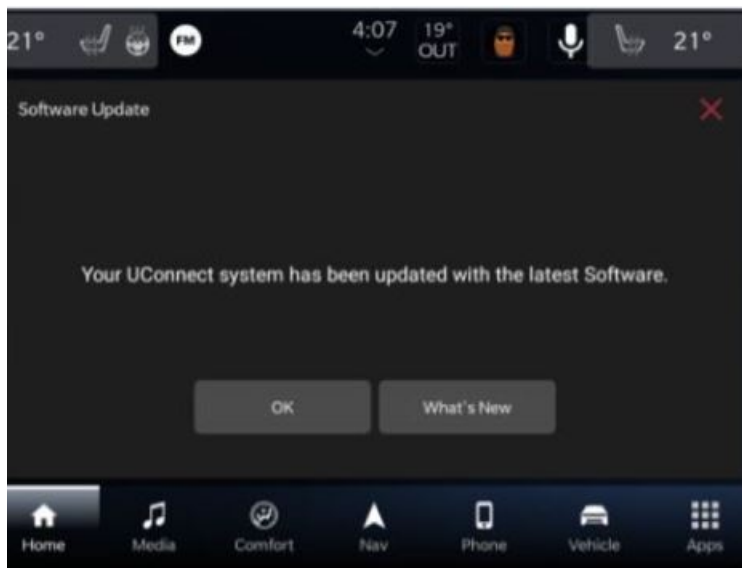
Fig. 2
Software Update Confirmation Screen

3. Upon completion of update, the radio will display a confirmation message ([Fig. 2](#)) .
