NUMBER: 08-214-22

DATE: November 24, 2022

Radio Over The Air Updates to JR34.3/JR34.4 and JR34.41

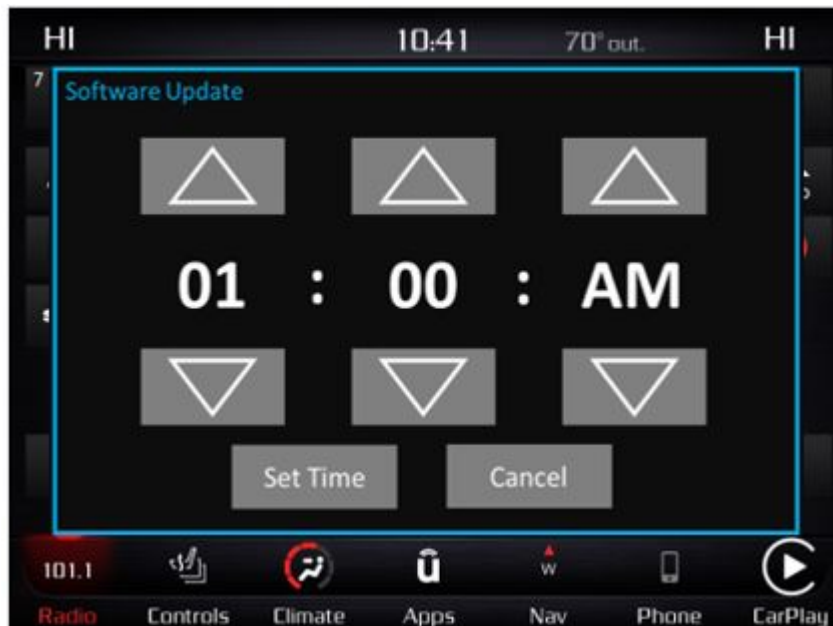
Fig. 2

NOTE: If selecting “Schedule Update” the screen below will be displayed. The customer can select the exact time they want the update to begin (Fig. 2) .

Schedule Update Screen

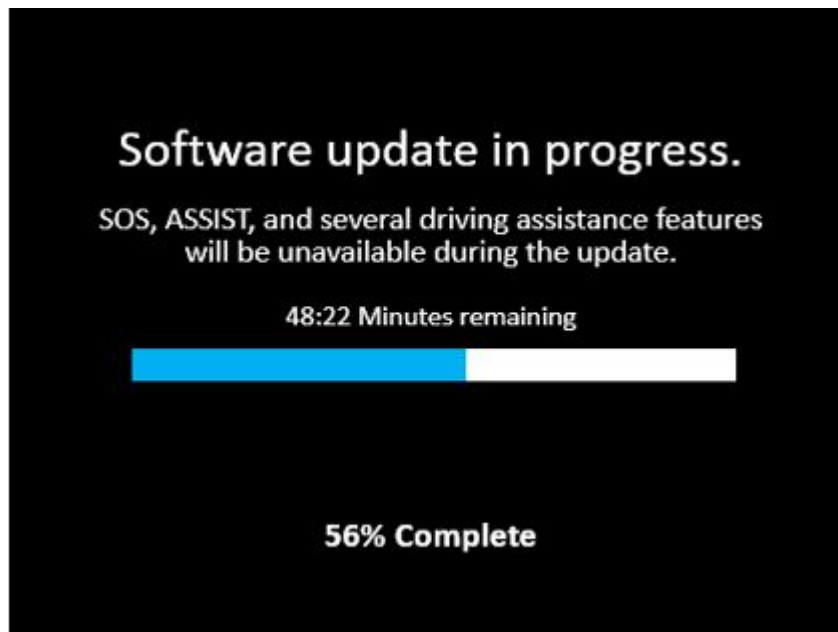
Fig. 3
Update In Progress Screen

- Whether the customer selects “Update Now” or “Schedule Update” and sets a time, they can shut off the vehicle and leave. The update will be completed automatically (Fig. 3) .

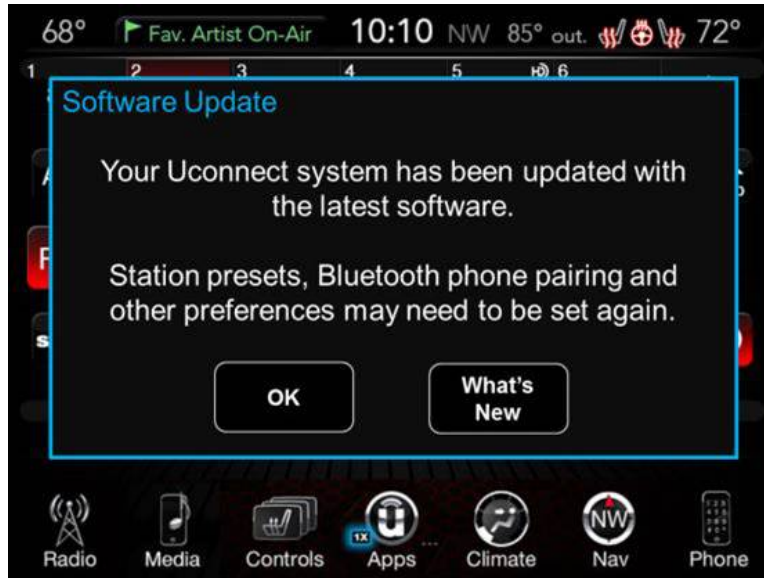
Fig. 4
Confirmation Screen

- Upon completion of update, the radio will display a confirmation message (Fig. 4) .
