Preliminary Information

PIC6429A Addressing Customer Concerns on Brake Noises

Brand:	Model:	Model Years:	VIN:		Engine:	Transmissions:
			from	to		
Chevrolet	Corvette	2020 - 2023	All	All	All	All

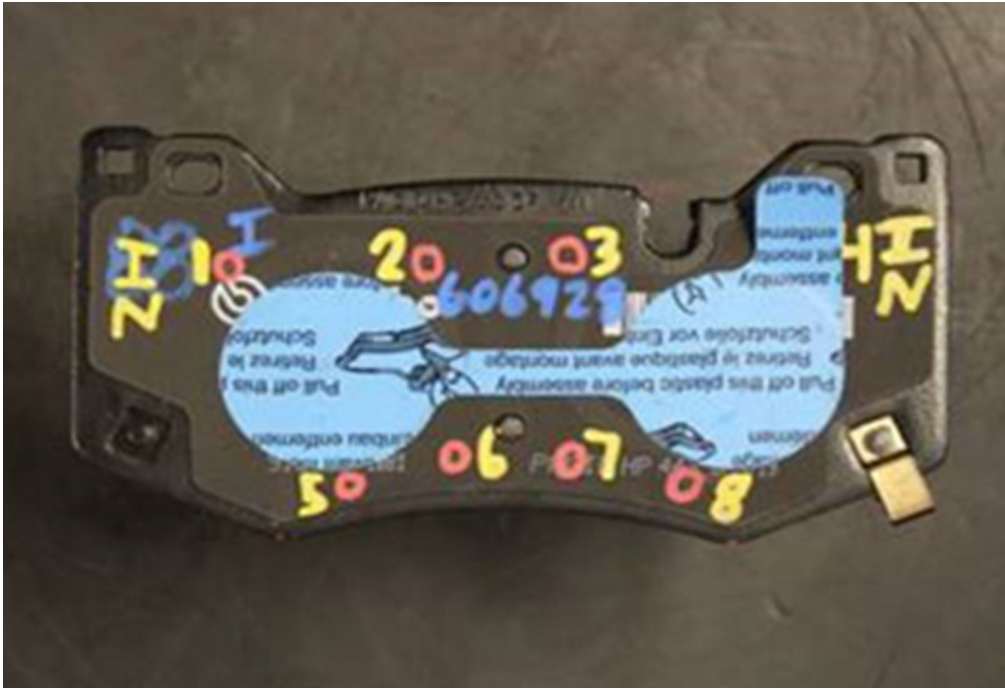
If the customer describes a brake noise coming from the vehicle, perform bulletin [17-NA-040](#) as described. When removing the front brake pads on a Z51-equipped vehicle, the servicing technician should notice that there is a piece of double-sided tape that secures the front brake pads firmly to the caliper pistons. See the photo below as an example. The blue area is this peel-and-stick double sided tape.

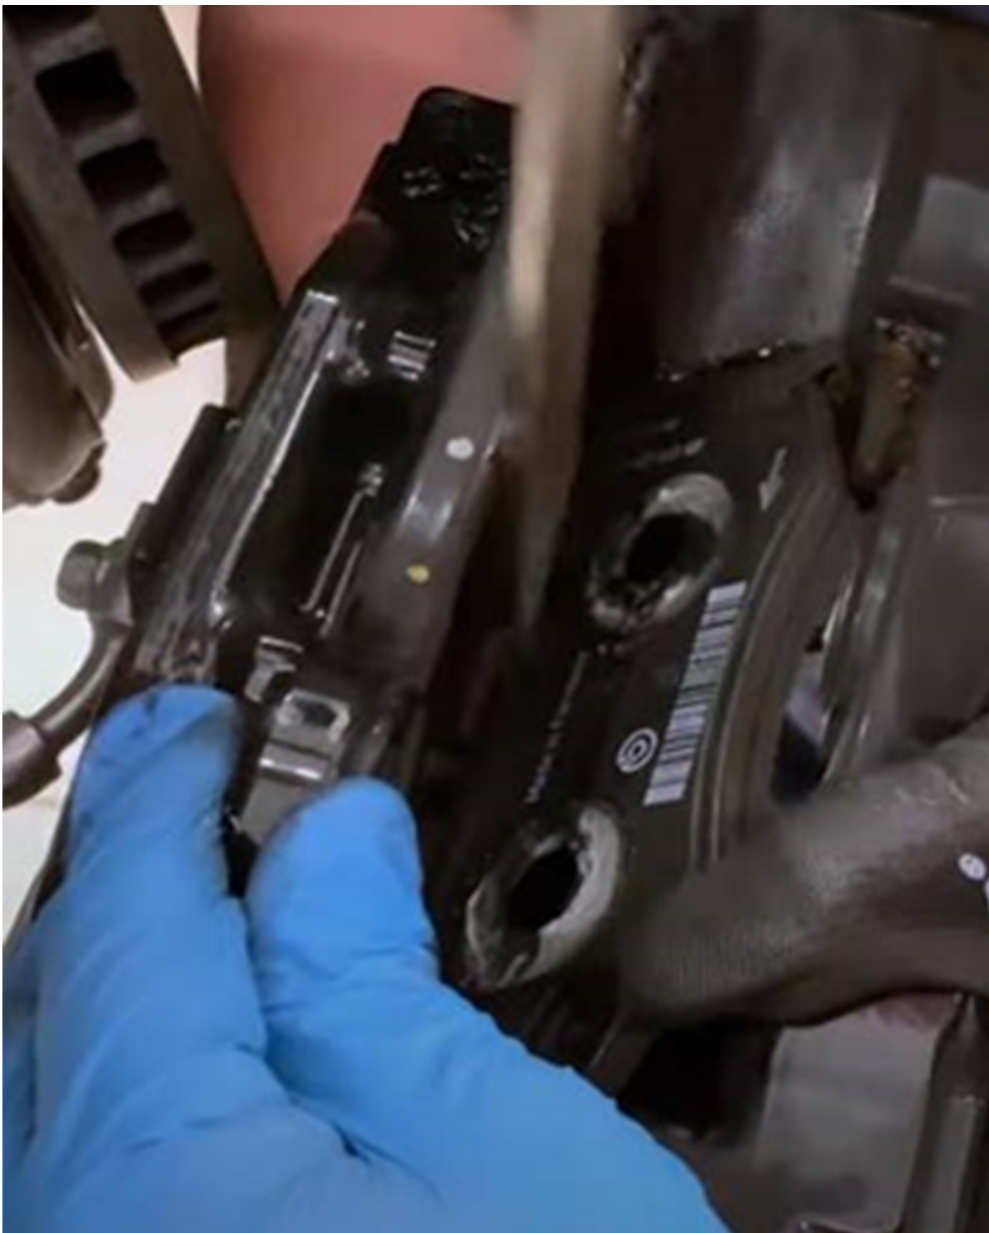
To apply the paste correctly, the pads must be removed from the calipers. See the photo below for an example of what the front brake pads look like once they have been separated from the caliper pistons.

This is normal when the front pads have been removed. When this has been done, remove as much of the remaining tape residue as possible. Then, apply the copper paste as directed in the bulletin. Once the copper paste has been applied correctly to the front brake pads, simply reinstall them into the calipers. There is no need to replace the front brake pads during this service because of the double-sided tape.
