Technical Journal

Cannot lock/unlock vehicle with remote control key

REF NO: TJ 36195.14.1	ISSUING DEPARTMENT: Technical Service	CAR MARKET: United States and Canada	
PARTNER: 3 US 7510 Volvo Car USA		ISSUE DATE: 2022-11-30	STATUS DATE: 2022-11-30
FUNC GROUP: 3666	FUNC DESC: Access (central looking & remote)	Page 1 of 6

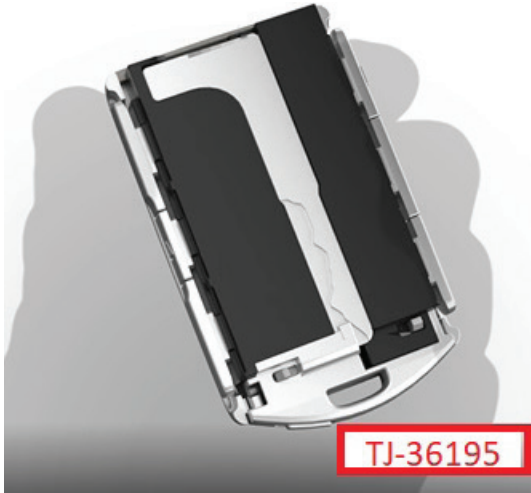
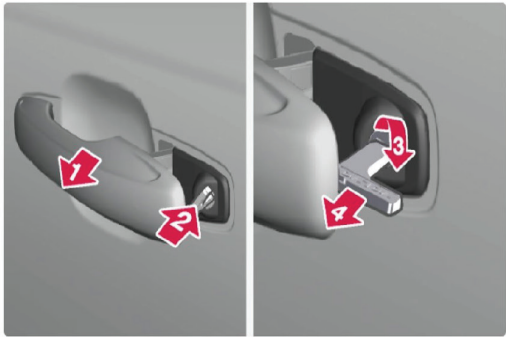
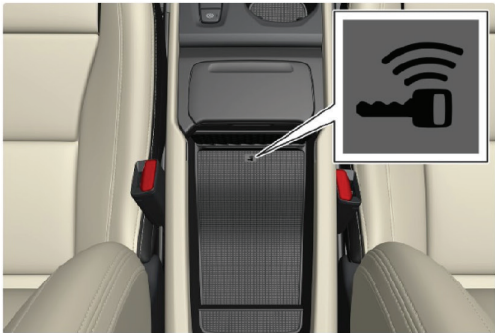
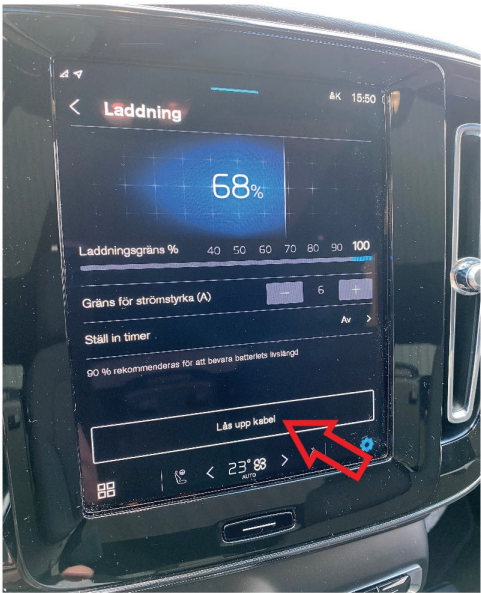
1. If Symptom #1 has been confirmed and the vehicle cannot be started with the “RCK” in the backup position due to not being able to disconnect the charging cable, please see the “Charging Cable Removal” section under Service section below and also the following attachments:
TJ-36195 BEV.jpg or TJ-36195 PHEV.jpg

- PHEV:
 1. Unlock the vehicle with the mechanical key blade inside the “RCK”.
 2. Place the “RCK” in the backup position.
 3. Turn the ignition switch.
 4. If the vehicle “wakes up”, press the central unlock button according to attachment (visualization of the steps in attachment TJ-36195 PHEV.jpg).
- BEV:
 1. Unlock the vehicle with the mechanical key blade inside the “RCK”.
 2. Place the “RCK” in the backup position.
 3. If the vehicle “wakes up”, press the release the cable message in the CSD (visualization of the steps in attachment TJ-36195 BEV.jpg).
