SIB 17 06 17

## COOLANT LEAK FROM LOW TEMPERATURE COOLING CIRCUIT (N63R)

This Service Information Bulletin (Revision 7) replaces SI B17 06 17 **dated July 2020**

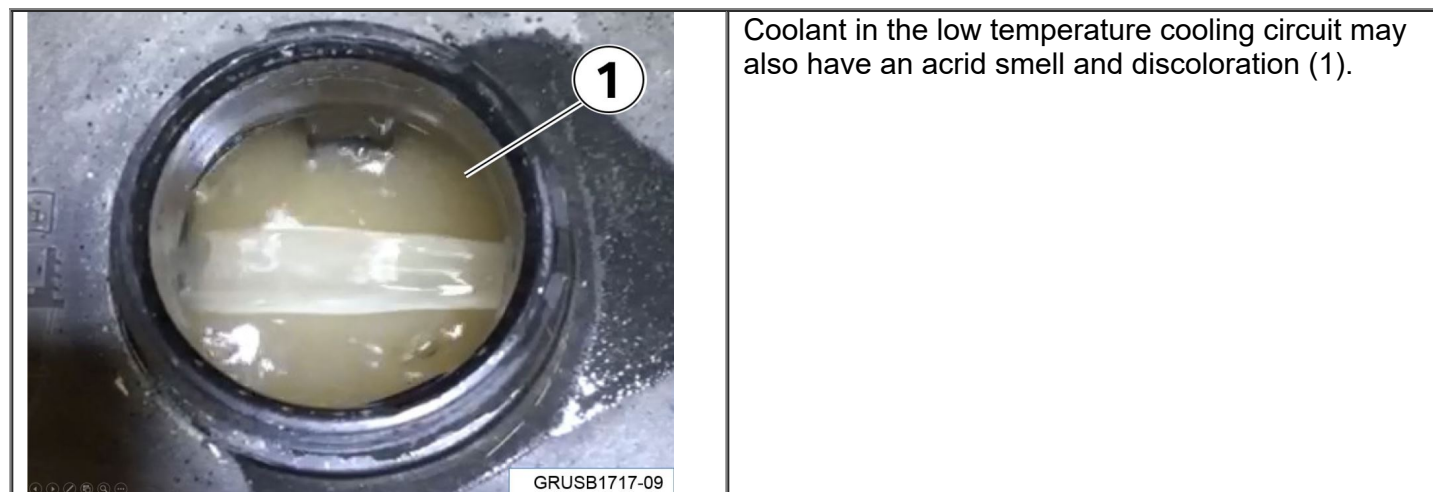
Coolant leaking from the engine compartment. Traces of coolant leaking from the expansion tank of the low temperature cooling system.

Aluminum corrosion in the charge air intercoolers, or in the radiator for the low temperature cooling is causing an unfavorable chemical reaction to the coolant.

Replace the radiator and both charge air coolers for the low temperature cooling circuit. Allow all the coolant in the system to drain during repairs (do not clamp off hoses).
