SIB 24 02 22

## METALLIC CRACKING NOISE IN DRIVELINE DURING LOAD REVERSAL

### MODEL

**Rear Wheel Drive Variants only with the 8HP51 automatic transmission (No xDrive models)**

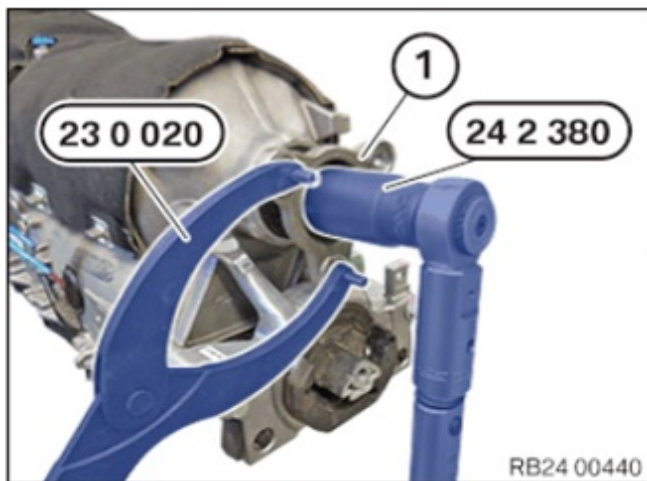
Unfavorable tolerances of the output flange to the automatic transmission.

Replace the collar nut (1) and tighten to 60 Nm. Peen the nut with an 8 mm punch.
