SIB 26 04 22

WHISTLING NOISE 30 – 37 MPH WITH LOW OUTSIDE TEMPERATURES

G01 (X3 Sports Activity Vehicle)	G05 (X5 Sports Activity Vehicle)	G12 (7 Series Sedan)	G20 (3 Series Sedan)
G30 (5 Series Sedan)

Pertains only to the Plug-in Hybrid (“PHEV”) versions of the above listed models

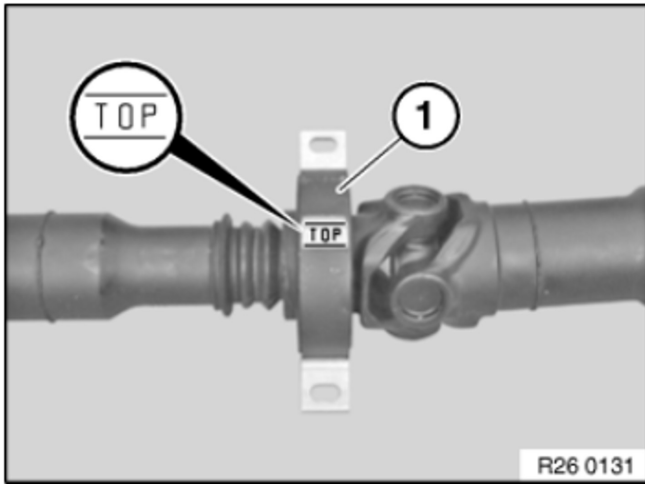
NOTE: The “TOP” designation on the center bearing points upwards towards the transmission tunnel.

Follow Repair Instruction **26 12 001 “Replacing the complete propeller shaft center bearing”**.
