SIB 51 20 22 CRACKING SOUND IN THE HEADLINER AREA

2022-12-15

This Service Information Bulletin (Revision 1) replaces SI B51 20 22 dated November 04, 2022.

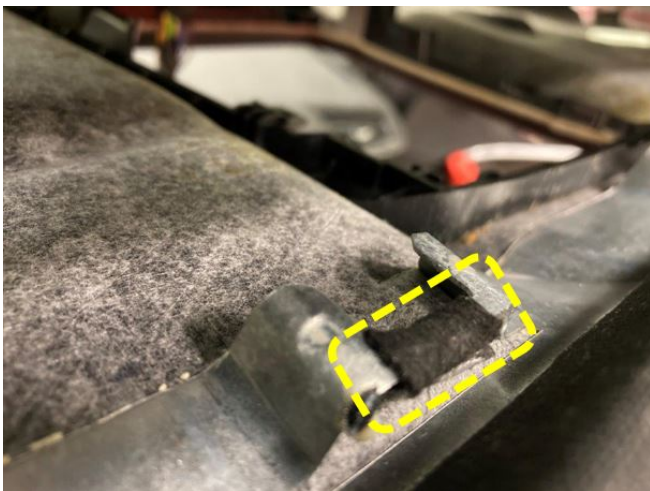
While driving on rough roads, a cracking sound is heard coming from the headliner area.

Movement of the headliner holding clips.

- Lower the headliner following the repair instructions listed in AIR/ISTA (51 44 915).
 - Note: The headliner only needs to be lowered, and not removed**
- Remove all the clips from the headliner.

- Cut felt strips to 20 mm x 10 mm dimensions and apply it to all the brackets on the headliner (shown).

- Reattach the clips back onto the headliner and check for movement of the clips (the clips should be able to move with little effort).
