SIB 63 08 22

UNEVEN AMBIENT LIGHTING EMISSION ON THE DOOR TRIM PANEL

F95 (X5 M Sports Activity Vehicle)	F96 (X6 M Sports Activity Coupe)	F97 (X3 M Sports Activity Vehicle)	F98 (X4 M Sports Activity Coupe)
G01 (X3 Sports Activity Vehicle)	G02 (X4 Sports Activity Coupe)	G05 (X5 Sports Activity Vehicle)	G06 (X6 Sports Activity Coupe)
G07 (X7 Sports Activity Vehicle)

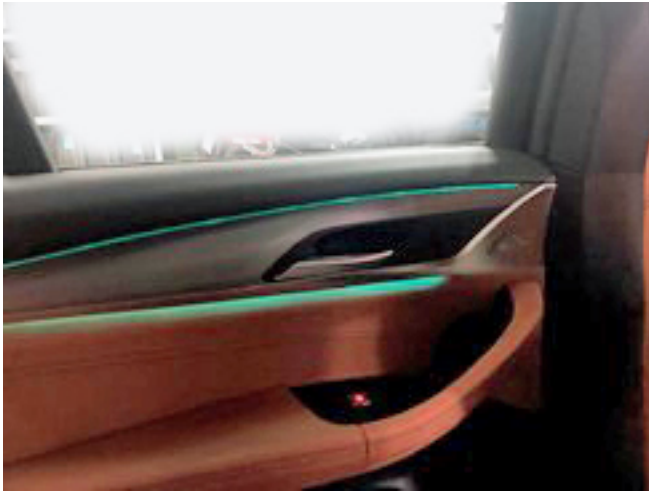
Uneven ambient lighting emission (bright spots/dark spots) on the door trim panel.

- Fault in the wiring from and to the LED module
- Fault in the connector on the LED module
- Faulty LED module

Determine the cause of the failure, and repair as needed.

1. Inspect the routing of the wiring from and to the LED module.
2. Inspect the connector at the LED module.
3. If the wiring and connector to the LED module are OK, replace the LED module.
4. Reassess the vehicle once repair is completed.
