SIB 66 03 22

2022-12-22

DRIVER ASSIST REDUCED CCM DISPLAYED, BLINDSPOT WARNING, PDC, FRT FOG LIGHTS INOP

E-Series	Model Description	Production Date
G07	X7 Sports Activity Vehicle (SAV)	December 1, 2018 – July 31, 2021

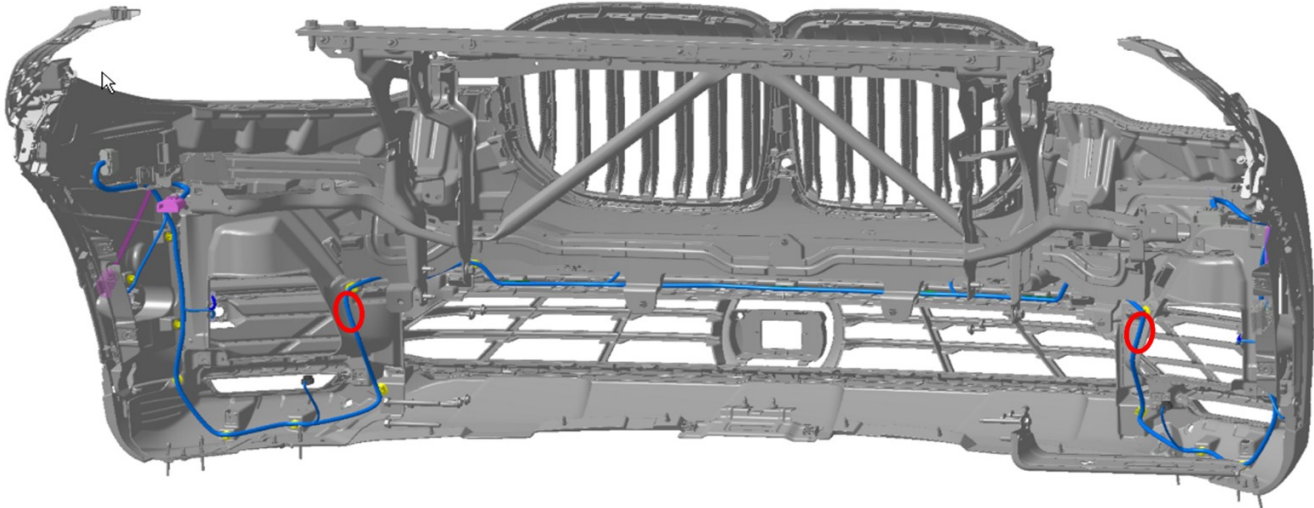
SRR wiring harness is pinched (shorted) between the bumper and the bumper support. This requires removal of the bumper and close inspection of the harness. The wire harness may require unwrapping to find the pinched wires.

4. Carefully inspect the front bumper wiring harness. Refer to illustration above with locations circled. You may need to unwrap the harness for inspection.

5. Replace the front bumper wiring harness with an optimized cable set. Proceed to step 8.

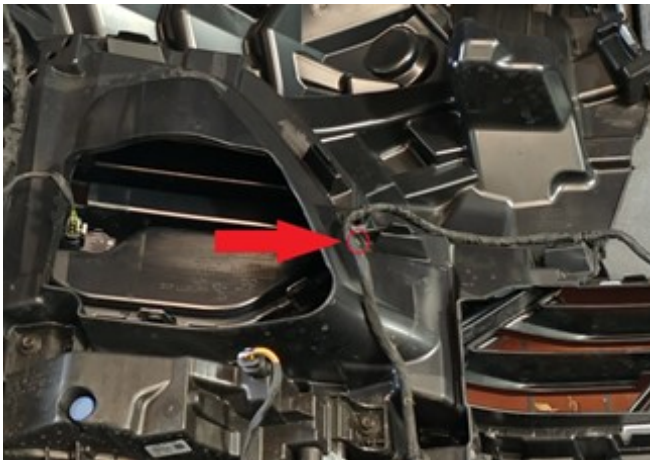
6. Is the harness shielded by corrugated tubing circled in the photo?

No: Wrap wiring in abrasion resistant tape.
