**SIB 72 04 17**

**FALSE WARNING OF OCCUPIED FRONT PASSENGER SEAT
WITHOUT BUCKLED SAFETY BELT**

This Service Information Bulletin (Revision 14) replaces SI B72 04 17 dated **December 2021**.

F90 (M5 Sedan) produced to July 31, 2018
--

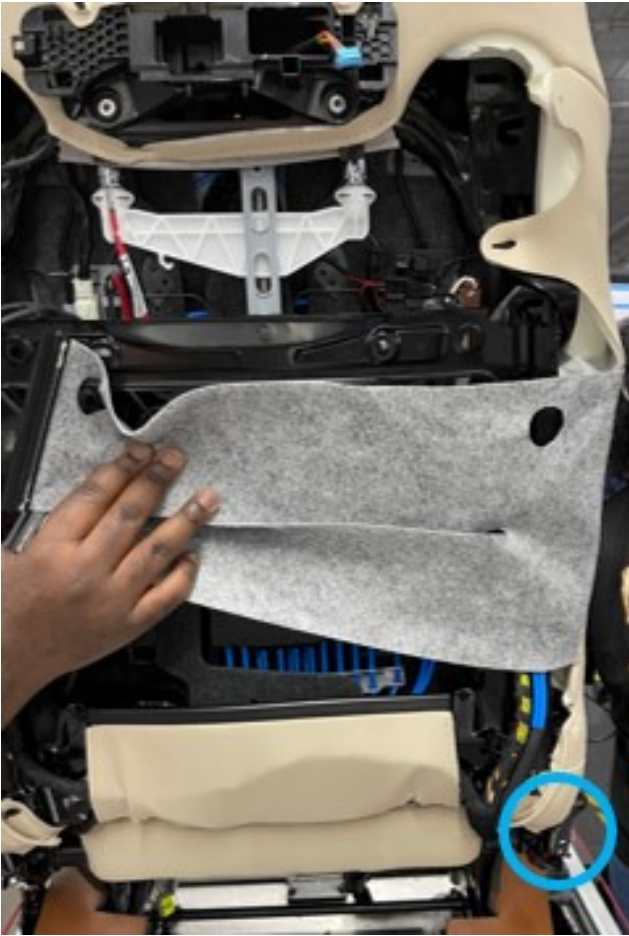
3. The passenger restraint warning message can be triggered due to partial or no contact between the CIS ground wire and the seat structure/frame.

Prior to replacing components, inspect the connection of the CIS ground wire to the structure at the lower right side of the backrest (circled). The eyelet on the ground wire should make solid connection to the structure with no free play. If free play is identified, repair as needed.

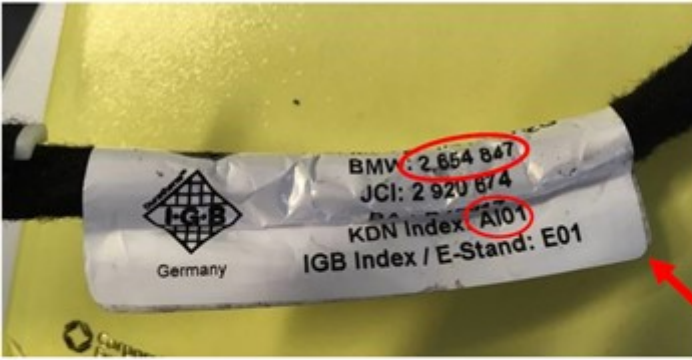
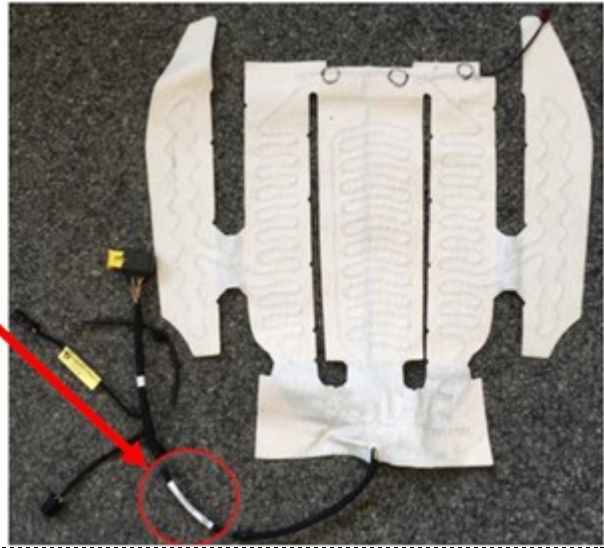
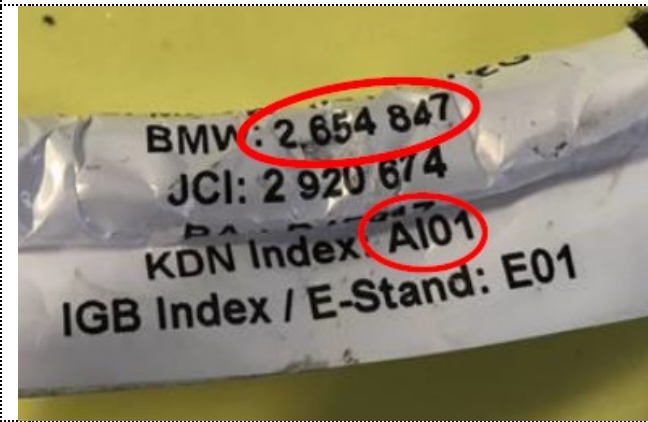
BMW Part Number 2654847 is shown (circled).

AI Change Index of 01 is shown (circled).

- If the Change Index is already **greater** or **equal** than specified above, then continue diagnosis with ISTA. The seat mat does not need to be replaced.
- If the Change Index is **lower** than specified above, then the CIS seat mat must be replaced and coded/enabled with ISTA
- If the part number is one of the following, then the CIS seat mat must be replaced and coded/enabled with ISTA:
 - 52 10 2 654 846
 - 52 10 2 654 847
