# INSTRUCTION TO SERVICE

<b>ITS: 60597</b>		<b>12/22/2022</b>
<b>SECTION:</b>	201-Bumpers	
<b>WRITTEN BY:</b>	Kalman Takacs	
<b>SUBJECT:</b>	Inspect welds around the mounting bracket of pulleys inside front bumper and reweld if required	
<b>ISSUE:</b>	Quality of weld may not meet our standards.	
<b>SUMMARY:</b>	Inspect weld and if required repair per this ITS.

# ITS60597

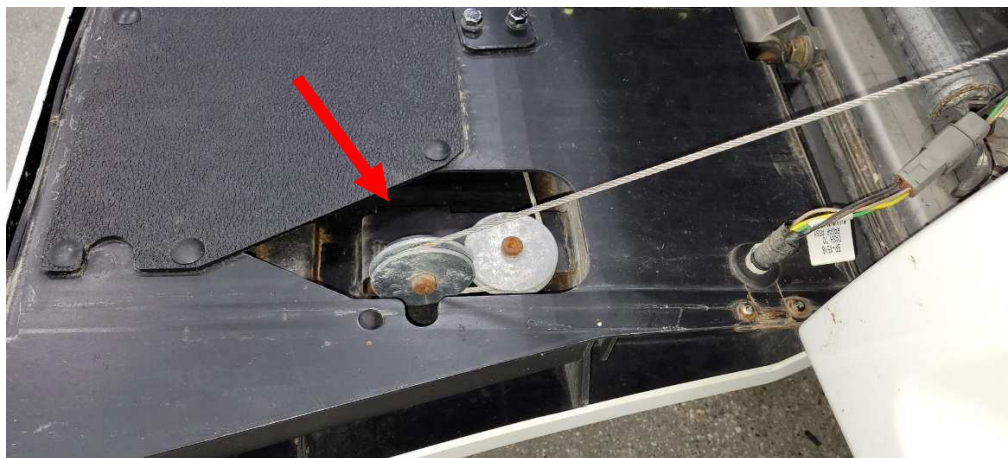
**Figure 4: Pulleys bracket**

6. Locate the pulleys bracket at the left side of the door. Refer to Figure 4.

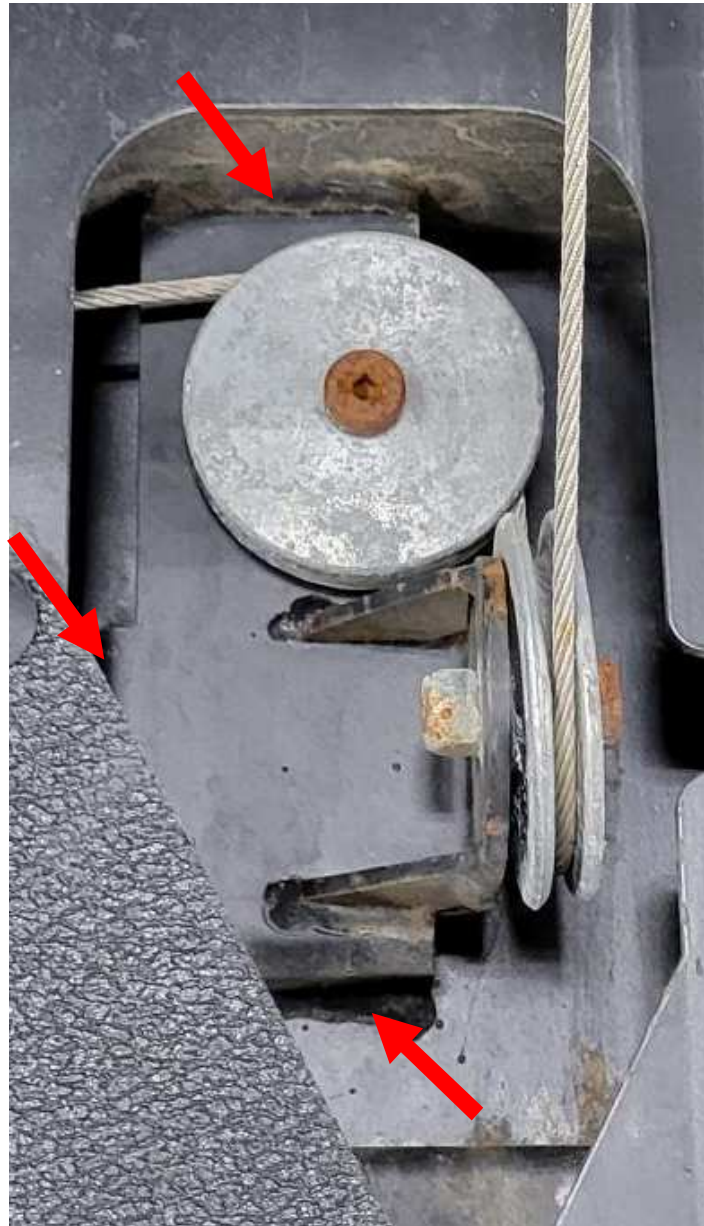
**Figure 5a: Location of the welds that need to be inspected**

7. Visually inspect the welds around the bracket. look for missing welds, inconsistent bead-size, holes on weld bead, asymmetrical weld penetration (weld is attached to one component only). Use magnifying glass, flash light or take photos then zoom in the picture to find flaws if any. Document the condition of the welds (whatever their condition is) by taking photos. Refer to Figures 5a and 5b.

8. If the visual inspection reveals questionable weld quality, then use a prybar and see if there is any movement between the bracket and the base of the bumper along the welds that would indicate a weld separation or incomplete weld.
9. If welds pass the inspection, then no further action is required. Close and lock front bumper-door, lock the left side forward access door, remove wheel chocks and turn battery disconnect switch to the "ON" position.
10. If welds failed the inspection, then proceed with the repair as detailed below.
