Technical Journal

TITLE:					
Charge lid difficult to open/close					
REF NO:	ISSUING DEPARTMENT:	CAR M	ARKET:		
TJ 36439.1.0	Technical Service	United States and Canada			
	PARTNER:	ISSUE DATE:	STATUS DATE:		
3 US 7	7510 Volvo Car USA	2022-12-21	2023-01-03		
FUNC GROUP:	FUNC DESC:				
8331	Tank hatch with hinge	Page 1 of 5

vor		/olvo	Car Customer Service	TJ	Instructio	on VCC-525490-1
Title		Charge (Connector Door		Page	1 (3)
Action	l	Adjustme	ent		Operation nu	umber:
Issue	Date		Reason			
1	2022-1	12	First issue

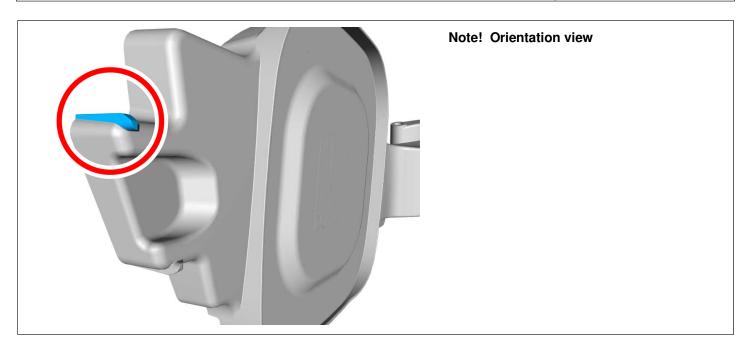
Release the catch. Remove the marked part.

Adjust the charge lid according to attached method.
