Left-hand Side Outer Rear-view Mirror Vibration While Driving

Service Category Vehicle Exterior

Section Mirror (ext)

Some 2022 – 2023 model year NX 250, NX 350, NX 350h, and NX 450h+ vehicles may exhibit a condition in which the left-hand side outer rear-view mirror vibrates during vehicle operation. The mirror vibration can be observed while driving at speeds of 35 mph (56 km/h) or above. Follow the Repair Procedure in this bulletin to address this condition.

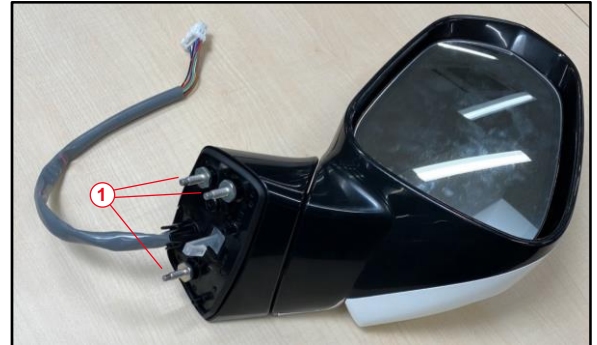
Figure 1.

1	Original Mirror-mounting Stud Bolts
----------	--

5. Remove and replace the mirror-mounting stud bolts with the NEW mirror-mounting stud bolts.
 - A. Remove the three original mirror-mounting stud bolts.

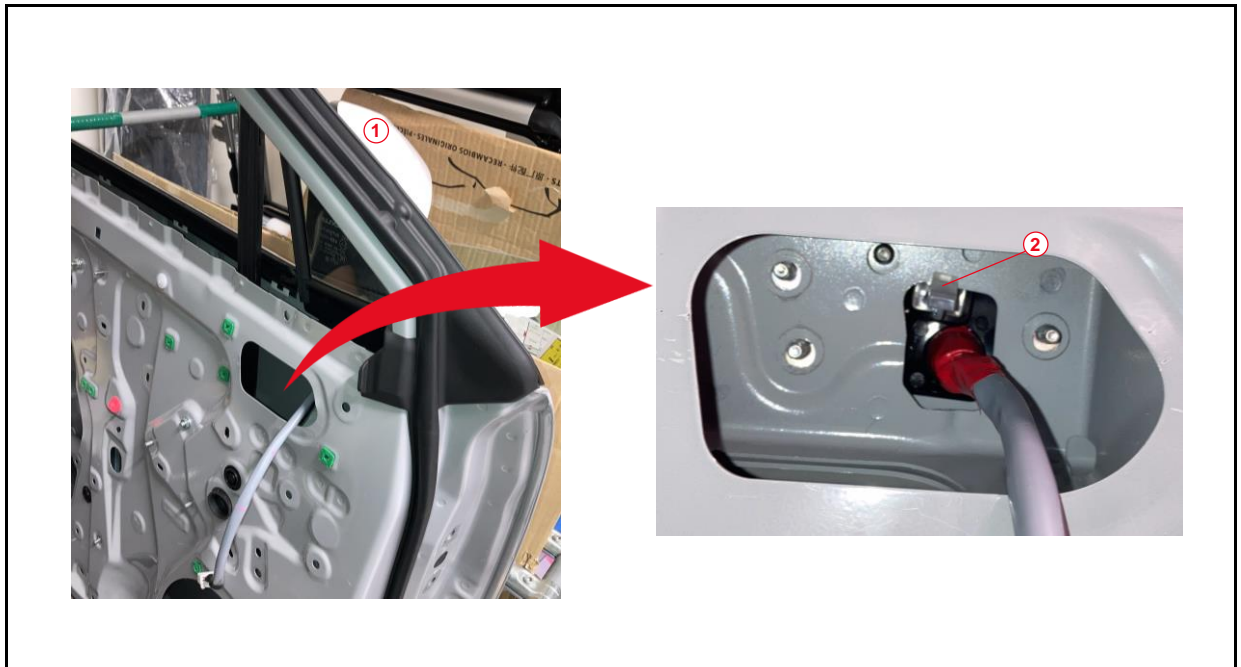
Figure 4.

1	Left-hand Side Outer Rear-view Mirror
----------	--

2	Temporarily Hold the Mirror With a Clip
----------	--

6. Insert the left-hand side outer rear-view mirror into the door panel and temporarily hold it in place with a clip.

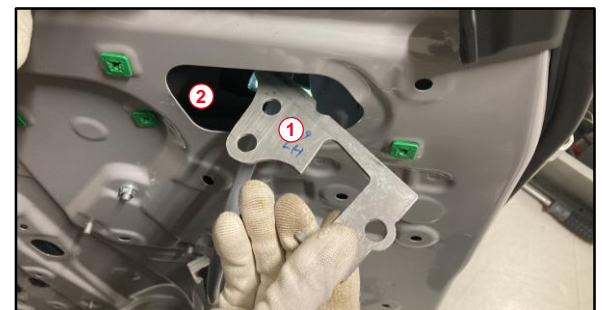
Figure 5.

1	Reinforcement Bracket
2	Service Hole

7. Install the NEW reinforcement bracket to the door panel.
 - A. Insert the reinforcement bracket through the service hole.
