Technical Service Bulletin (TSB)
Multiple Erroneous Diagnostic Trouble Codes (DTCs), Warning Lights or Possible No Start

REFERENCE:	TSB: 18-055-23 GROUP 18 - Vehicle Performance	Date:	May 3, 2023	REVISION:	–
VEHICLES AFFECTED:	2022 (DS) RAM 1500 Pickup This bulletin applies to vehicles built on or after February 01, 2022 (MDH 0201XX) and on or before September 13, 2022 (MDH 0913XX) equipped with 3.6L V6 24V VVT Engine (Sales Code ERB).			MARKET APPLICABILITY:	
				<input checked="" type="checkbox"/> NA	<input type="checkbox"/> MEA
				<input checked="" type="checkbox"/> SA	<input type="checkbox"/> IAP
				<input type="checkbox"/> EE	<input type="checkbox"/> CH
CUSTOMER SYMPTOM:	Customers may experience a Malfunction Indicator Lamp (MIL) or warning lamp illumination. Upon further investigation the technician may find that the multiple erroneous DTCs have been set: Customer may also experience intermittent no starts.				
CAUSE:	Possible cause may be the orange electrical connector to the Powertrain Control Module (PCM) is not in the locked position.

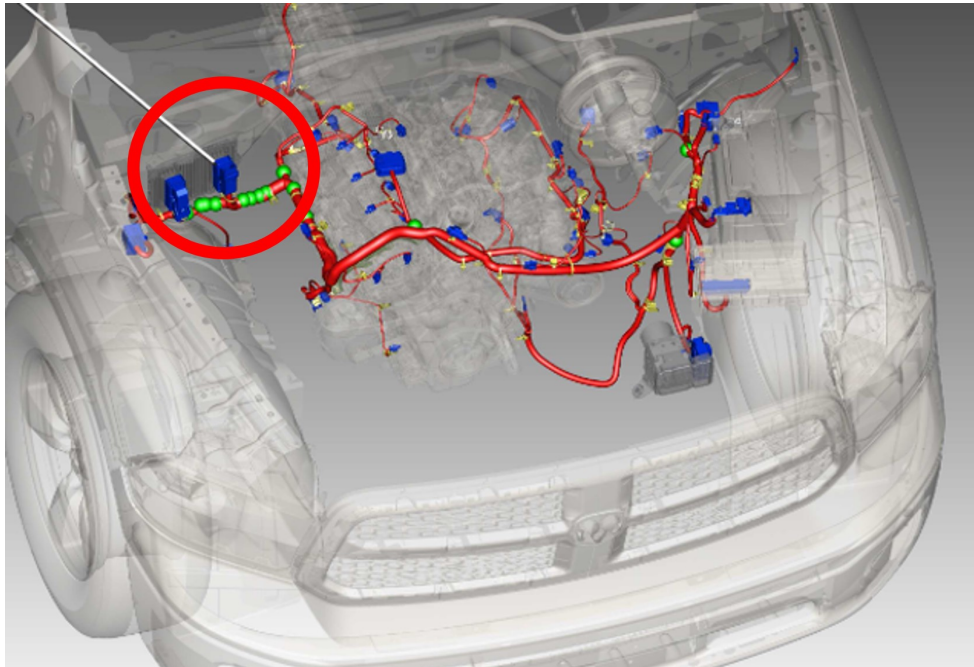
Fig. 1

This bulletin involves ensuring the PCM C1 connector D3821A (inboard side) is fully seated/locked into position and that the engine harness takeout for PCM is not interfering with connector lock down.

PCM Inboard Connector

1. If multiple DTCs are showing up on wiTECH, check the orange PCM inboard connector (Fig. 1) .
2. Disconnect the negative battery cable.
3. Remove and re-seat the connector locking it into place (Fig. 1) .

NOTE: Make sure the PCM wiring harness does not interfere when locking the electrical connector (Fig. 1) .
