EXHAUST ODOR IN VEHICLE**TSB 17-0044****FORD:**

2016-2017 Explorer

ISSUE

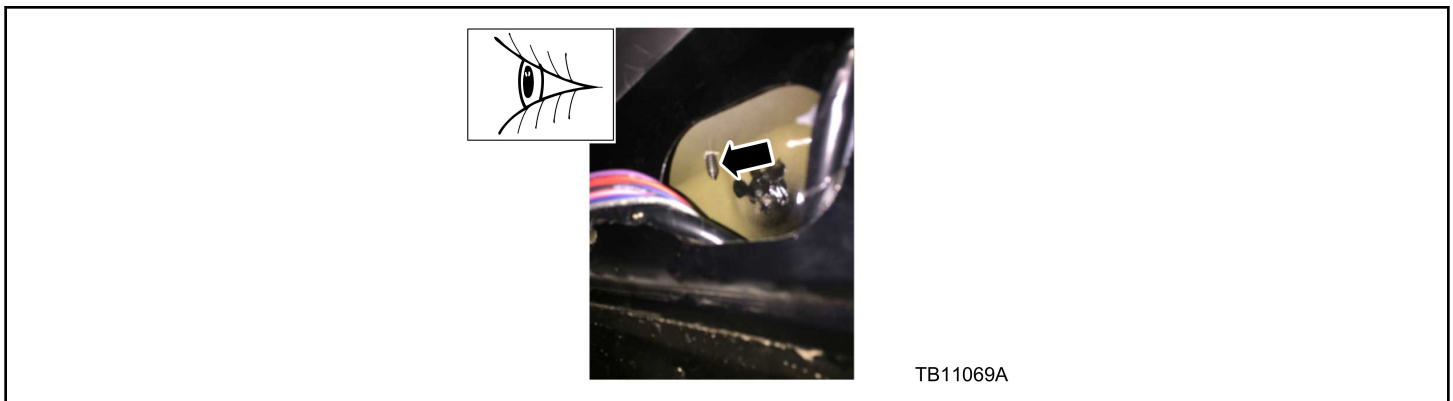
Figure 1 - Article 17-0044

Any hole or added fasteners in the body must be thoroughly and permanently sealed with Motorcraft® Seam Sealer or foil backed mastic patch. (Figure 1)

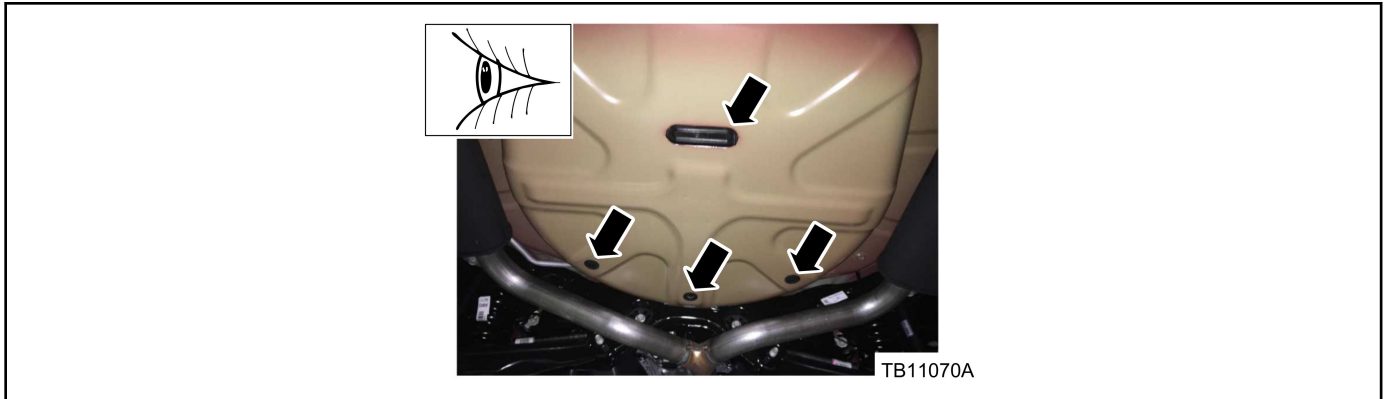
Figure 2 - Article 17-0044

- d. Rear end underbody sheet metal/body plugs. (Figure 2)

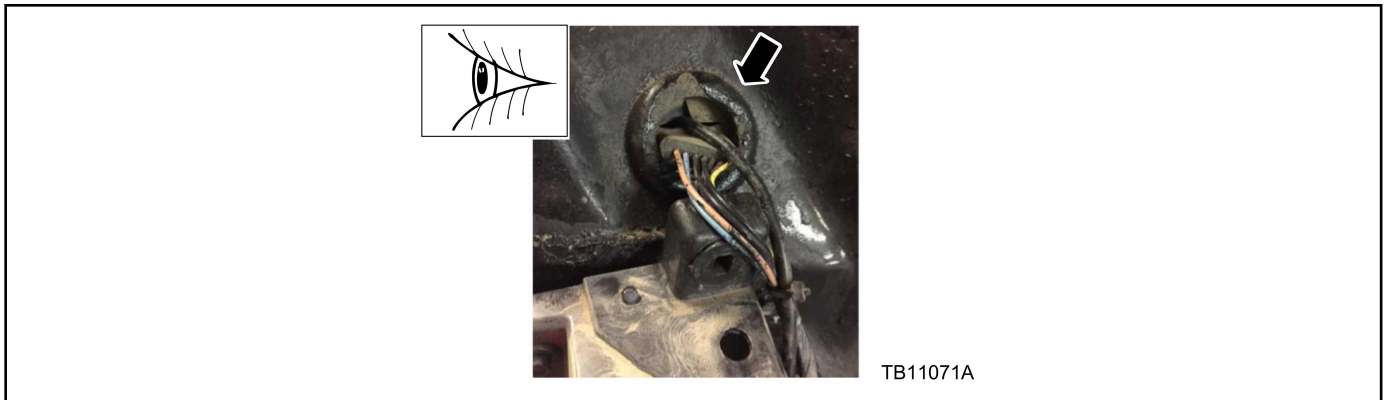
Figure 3 - Article 17-0044

- e. Behind left and right rear lamp assemblies. (Figure 3)

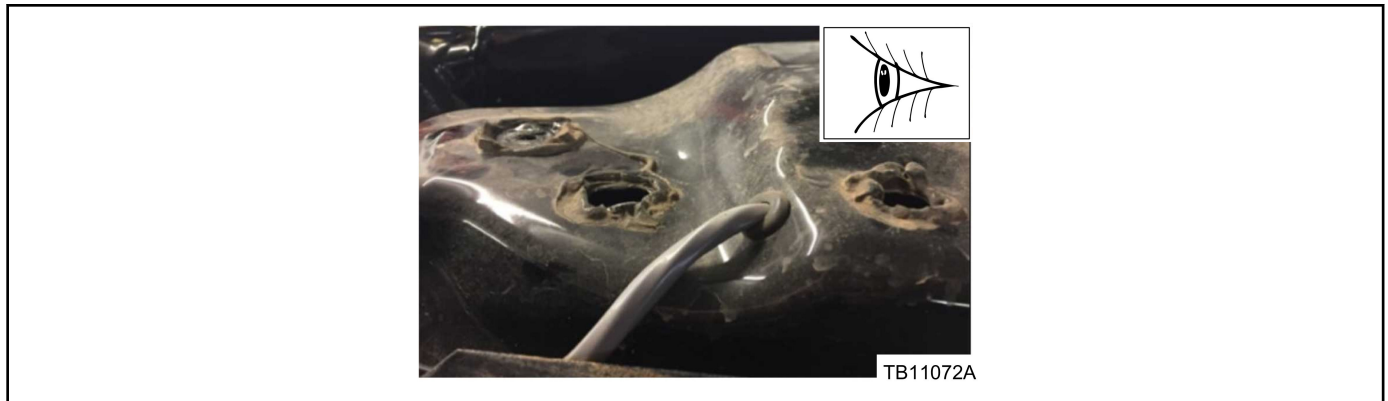
Figure 4 - Article 17-0044

- f. Spoiler attachment to the liftgate sheet metal. Improper spoiler sealing. (Figure 4)

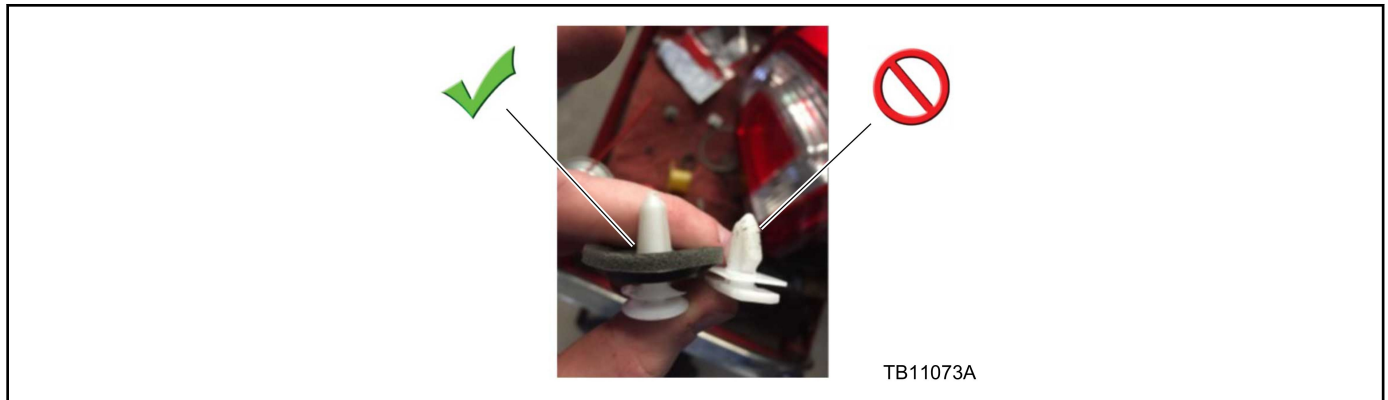
Figure 5 - Article 17-0044

- (1) Correct spoiler to liftgate fastener (left) incorrect fastener (right) (Figure 5)

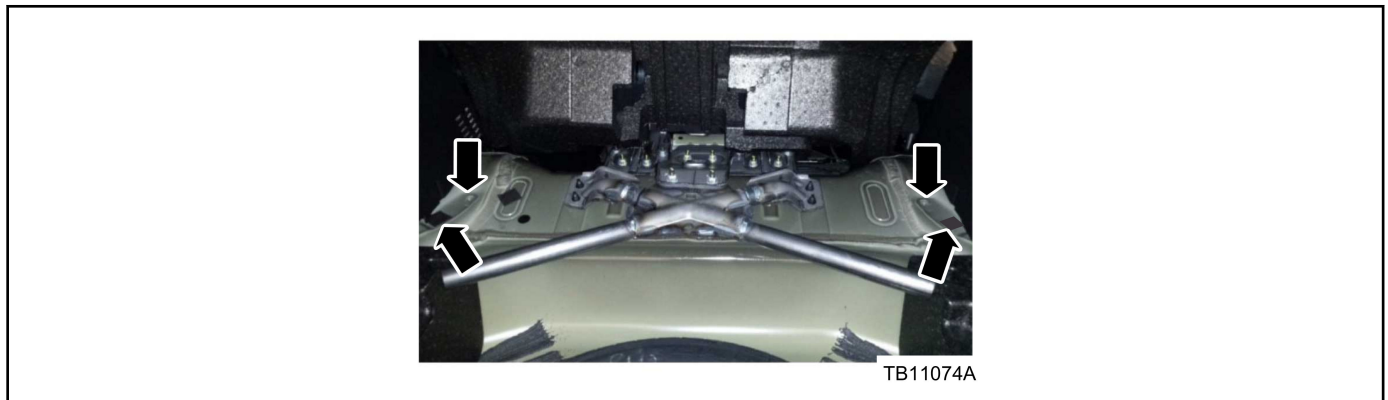
Figure 6 - Article 17-0044

- g. Rear load floor bolt holes (may require removal of hardware and/or electronics). Under the rear load floor there are 4 threaded bolt holes (2 on the left side and 2 on the right). On police units with no third row seat the front bolt hole is used to secure the load floor. The rear load floor bolt hole on each side should be sealed with mastic patch. (Figure 6)

- (1) Verify that patches are present over the rear hole on the left and right sides. Complete removal of the load floor may not be required. Remove the two fasteners and partially raise the load floor to inspect for the mastic patch. Seal with mastic patch if not present.

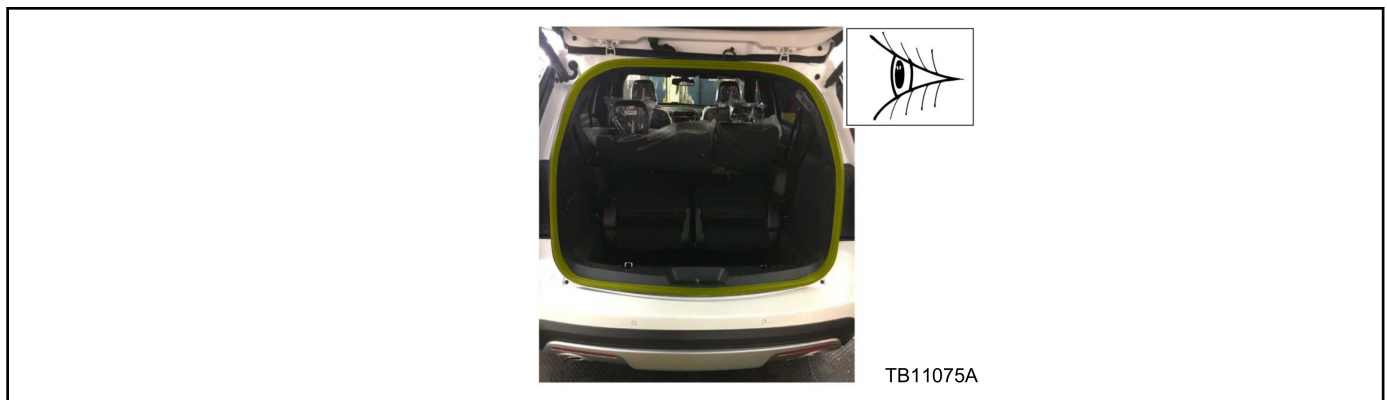
Figure 7 - Article 17-0044

- a. Check for a seal contact mark around the entire liftgate sealing surface. View the weatherstrip contact mark from different angles to make sure that it can be seen clearly. The appearance of a slight gap at the bottom center of the liftgate near the latch area is normal and corresponds with the weatherstrip joint seam. Refer to Workshop Manual (WSM), Section 501-03 to reposition the liftgate as required to obtain a proper seal. (Figure 7)

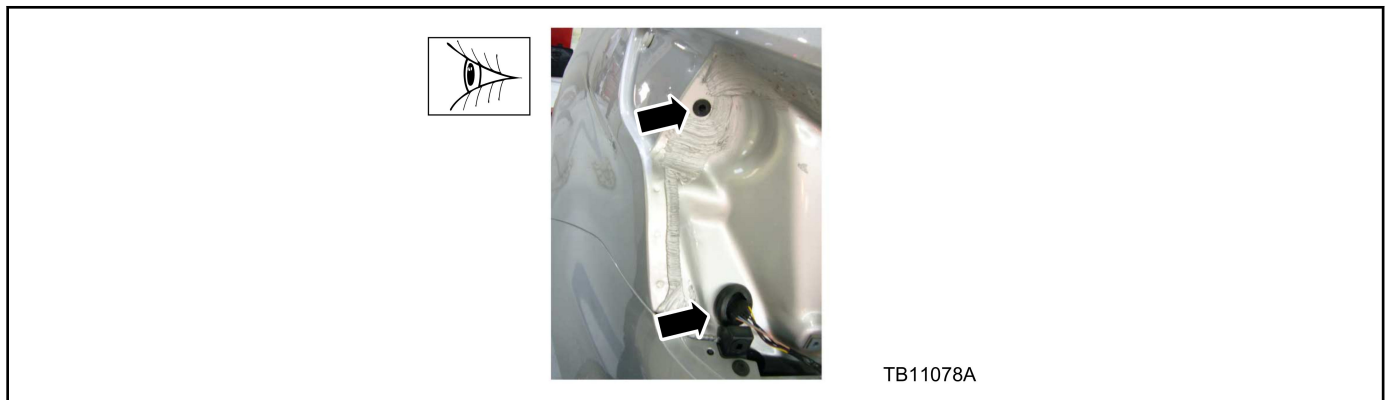
Figure 10 - Article 17-0044

6. Verify all rear lamp mounting and wiring harness grommets are sitting flush against the body.
 - a. Inspect for excess body sealer beneath the grommet preventing it from fully seating thereby creating a leak. (Figure 10)

- b. Remove any excess body sealer and seal the grommet.
7. Remove the right and left rear quarter panel mouldings. Refer to WSM, Section 501-08.

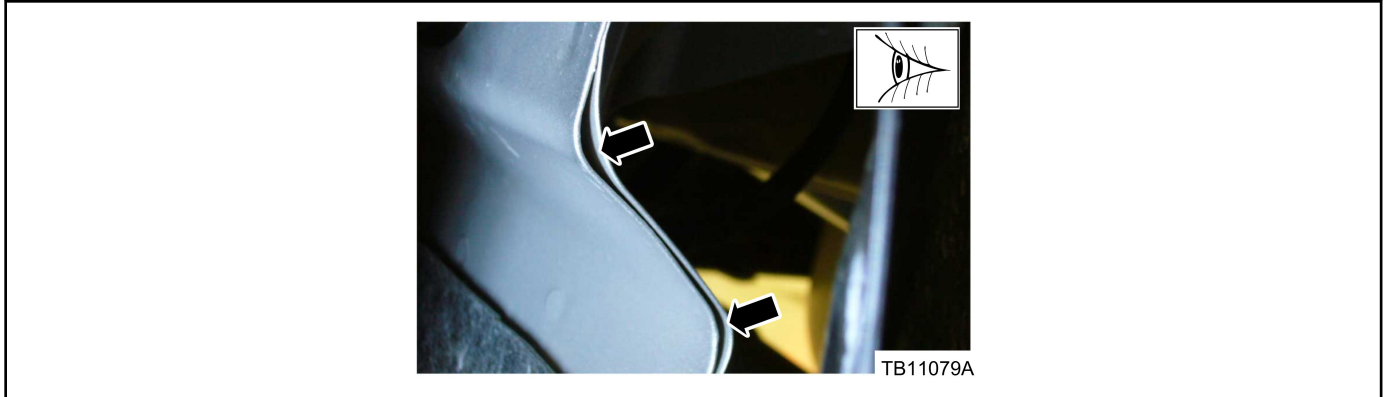
Figure 11 - Article 17-0044

8. Remove the right and left rear quarter panel splash shields. Refer to WSM, Section 501-08.
9. Inspect the joined lower inner panels for gaps and/or missing sealer.
 - a. Inspect the lower edge of the wheel arch for gaps. Seal as necessary using Motorcraft® Seam Sealer or equivalent. (Figure 11)

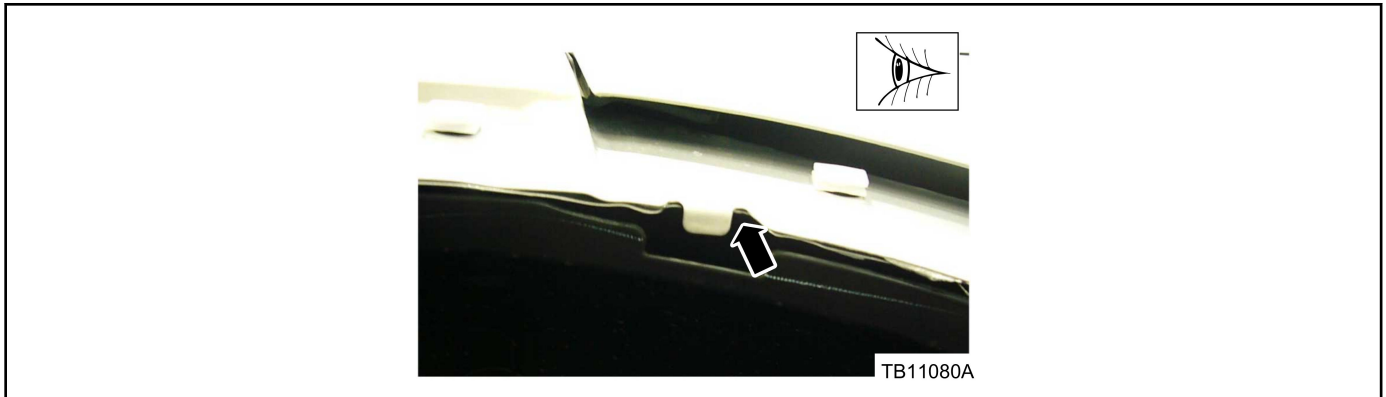
Figure 12 - Article 17-0044

- b. Inspect the upper edge of the wheel arch for gaps. Seal as necessary using Motorcraft® Seam Sealer or equivalent. (Figure 12)

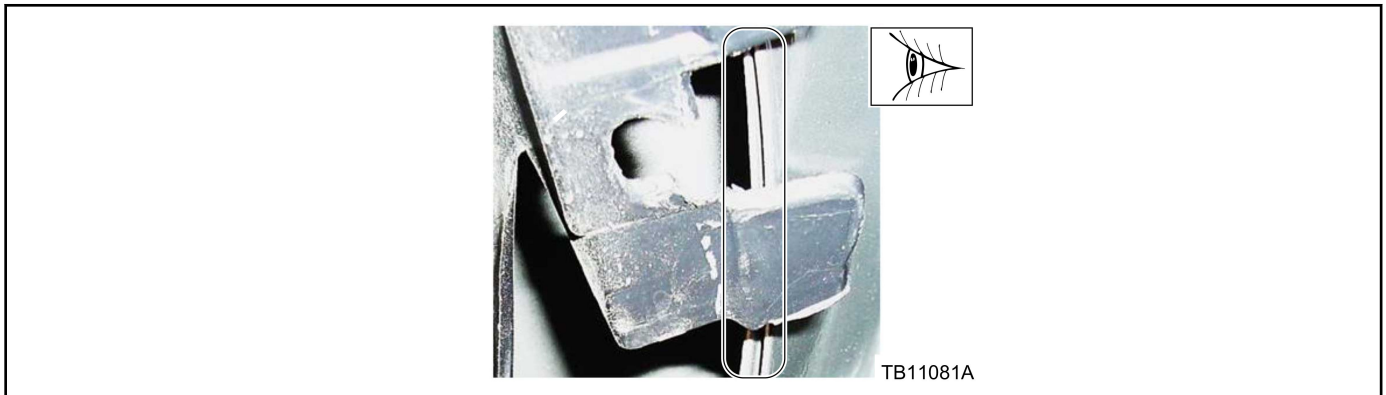
Figure 13 - Article 17-0044

- c. Inspect the lower front edge of the wheel arch for gaps. Seal as necessary using Motorcraft® Seam Sealer or equivalent. (Figure 13)

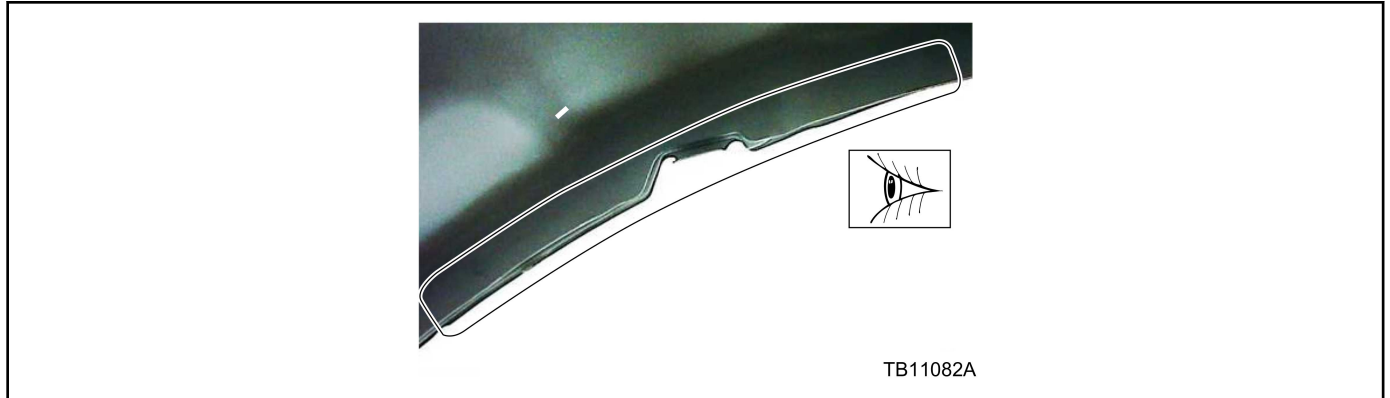
Figure 14 - Article 17-0044

- d. Inspect the backside of the upper wheel arch area for gaps. Seal as necessary using Motorcraft® Seam Sealer or equivalent. (Figure 14)

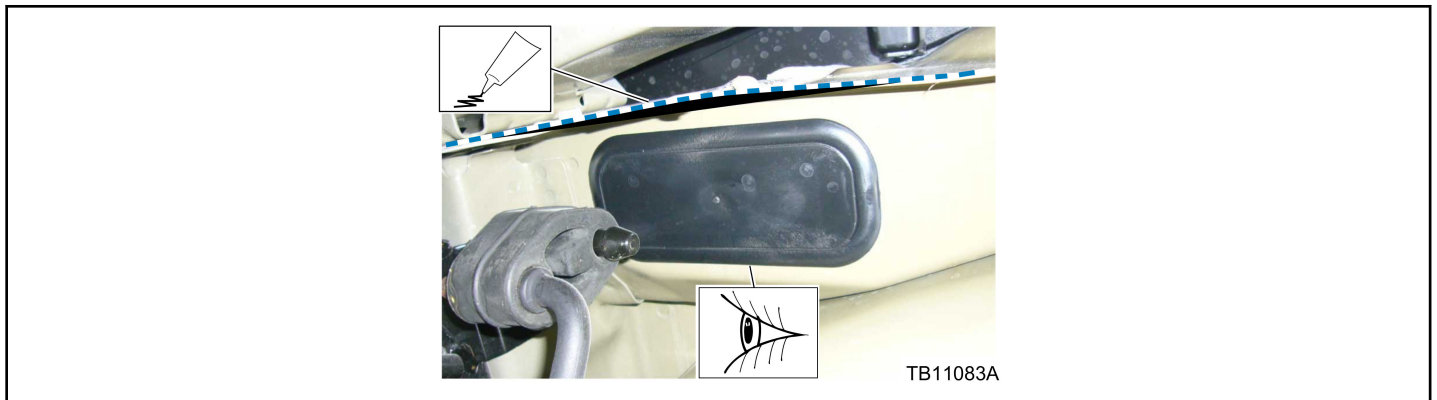
Figure 15 - Article 17-0044

10. Remove the rear bumper cover. Refer to WSM, Section 501-19.
11. Inspect the rear underbody spare tire pan plugs and verify plugs are properly installed. (Figure 2)
12. Inspect the left and right rear rectangular underbody plugs and verify plugs are properly installed. (Figure 15)

13. Seal the entire length of the seam that runs rearward of the body plugs.
 - a. Left side shown, right side similar. (Figure 15)
14. Closely inspect the left and right side boxed sections of the vehicle underbody. Inspect for gaps and/or missing body sealant at joined panels that may allow air to pass through. (Figure 16)

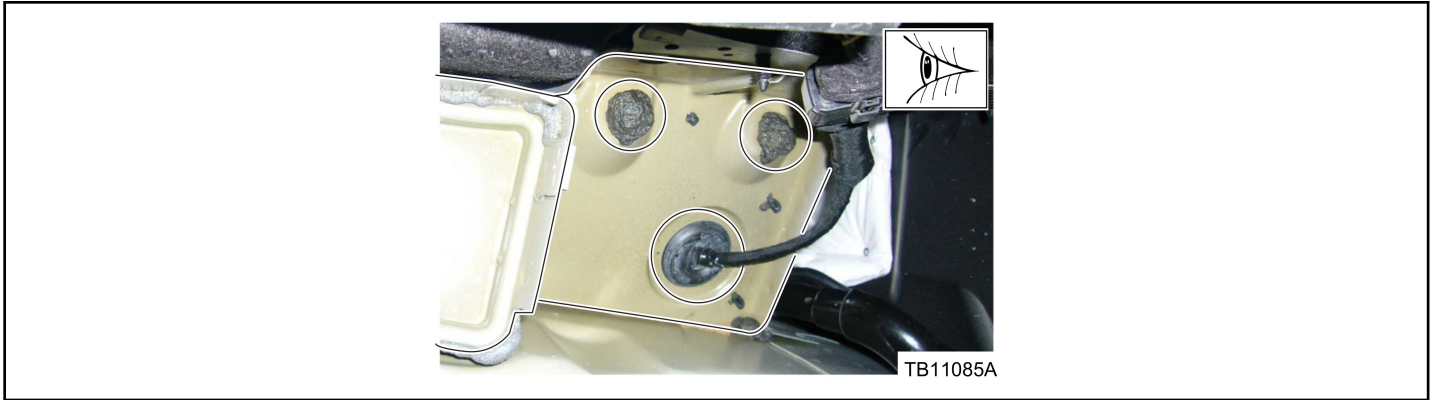
Figure 17 - Article 17-0044

15. Inspect the seams of all joined panels at the rear underside of the vehicle for any gaps or missing seam sealer. (Figure 17)

a. If any gap and/or missing body sealer is present, enough that may allow air to pass through, seal with Motorcraft® Seam Sealer or equivalent.

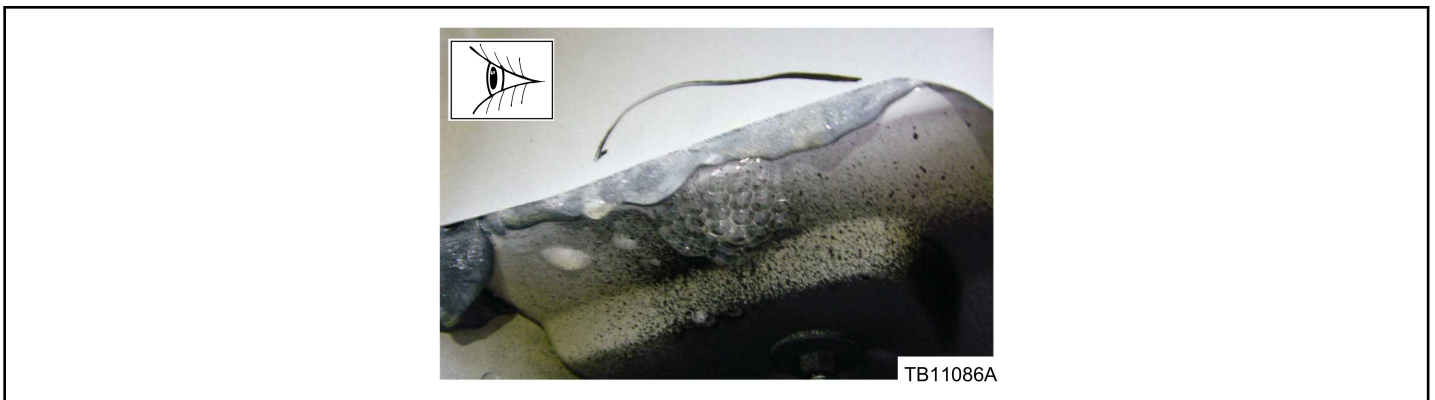
Figure 18 - Article 17-0044

16. Inspect the area behind the wheel arch and reseal if necessary. (Figure 18)

a. A leak in this area may only show up during a cabin pressurization test.

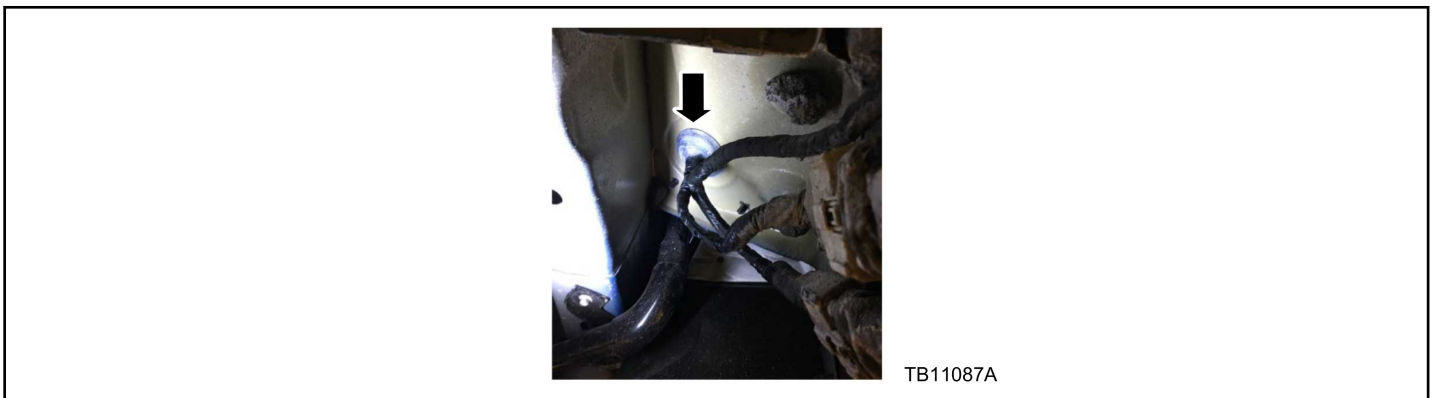
Figure 19 - Article 17-0044

17. Locate the wiring/grommet in the right rear floor area (Figure 19)

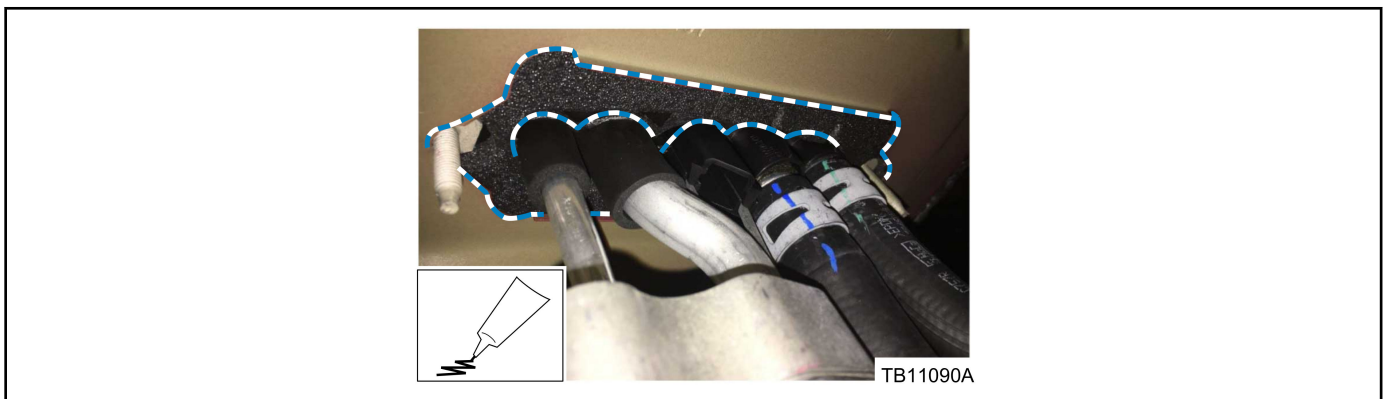
Figure 22 - Article 17-0044

18. Inspect the rear evaporator inlet line seal where the evaporator lines enter the vehicle. Make sure the foam seal is undamaged and fully seated with no gaps between the seal and the body and the seal and the evaporator pipes.
 - a. Rear evaporator inlet line seal viewed from underneath. Inspect for gaps and seal if needed with Motorcraft® Seam Sealer. (Figure 22)

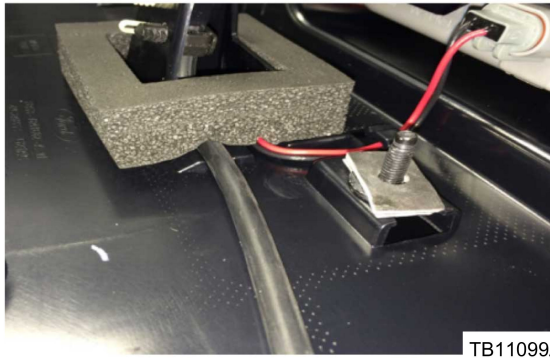
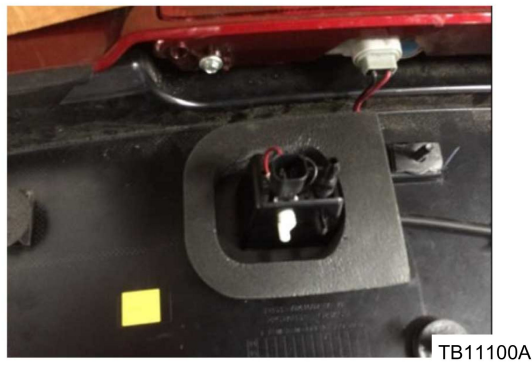
21. Remove the rear spoiler. Refer WSM, Section 501-08.
22. Inspect the foam tower seal and make sure the wiring and washer line are routed properly and are not compromising the sealing interface. There are two designs of the tower foam. Both designs are acceptable to use. (Figures 29-30)

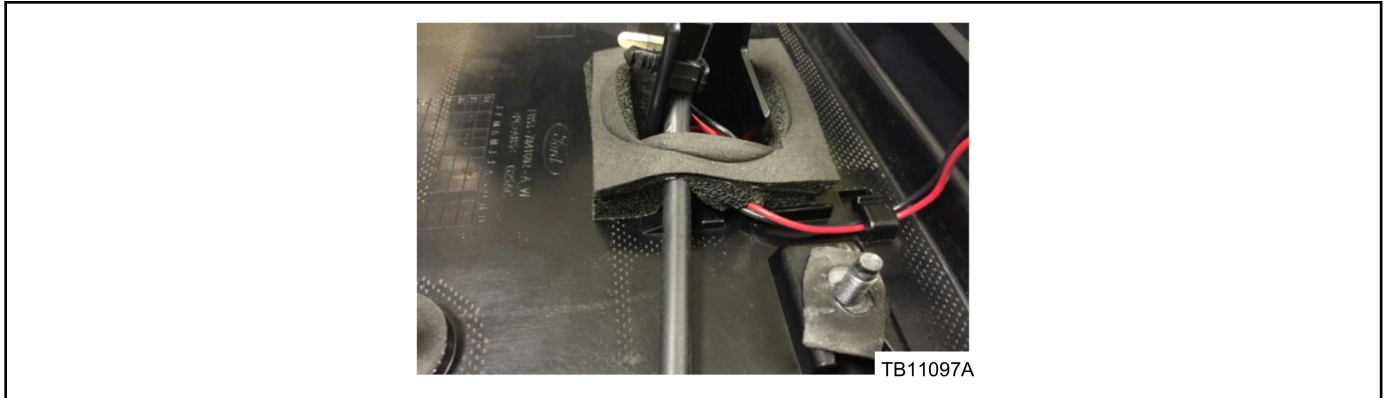
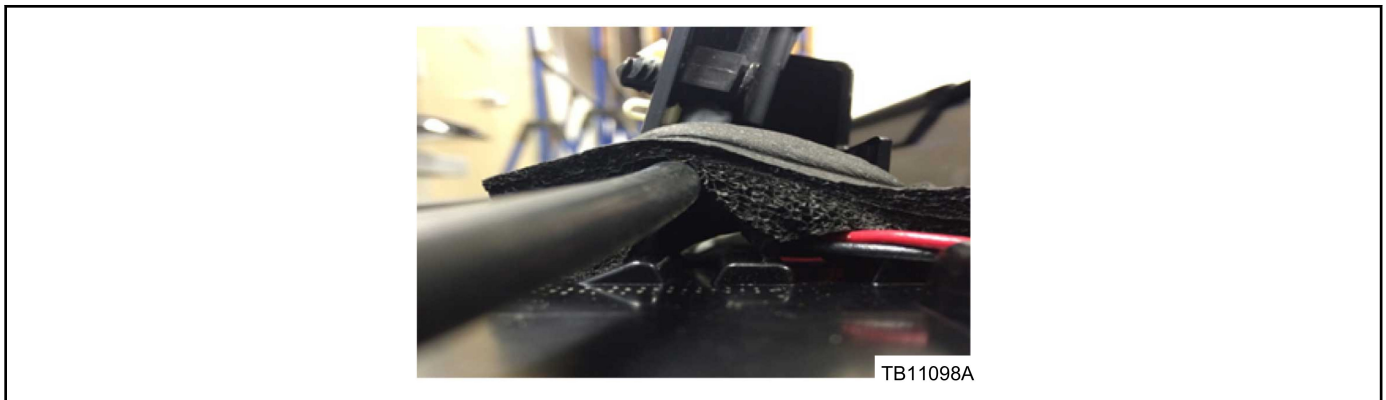
- a. Washer line routed improperly. Line is not seated between locating tabs and sealing foam highly compressed. (Figures 31-32)

- b. Washer line routed properly. Line is seated in locating tabs and sealing foam relaxed. (Figure 29)
- c. Repair and reseal as necessary using Motorcraft® Seam Sealer or equivalent
23. Replace the plastic spoiler retention w-clips with the clips and foam washers from the spoiler service kit.
24. Inspect the liftgate sheet metal for distortion at the 4 clip locations and flatten with a rubber mallet as needed. Reinstall the spoiler. Refer to WSM, Section 501-08.
25. Pressure test the cabin for any additional leaks.
- a. Before beginning the pressurization process, allow all recently sealed areas to dry for 30 minutes.

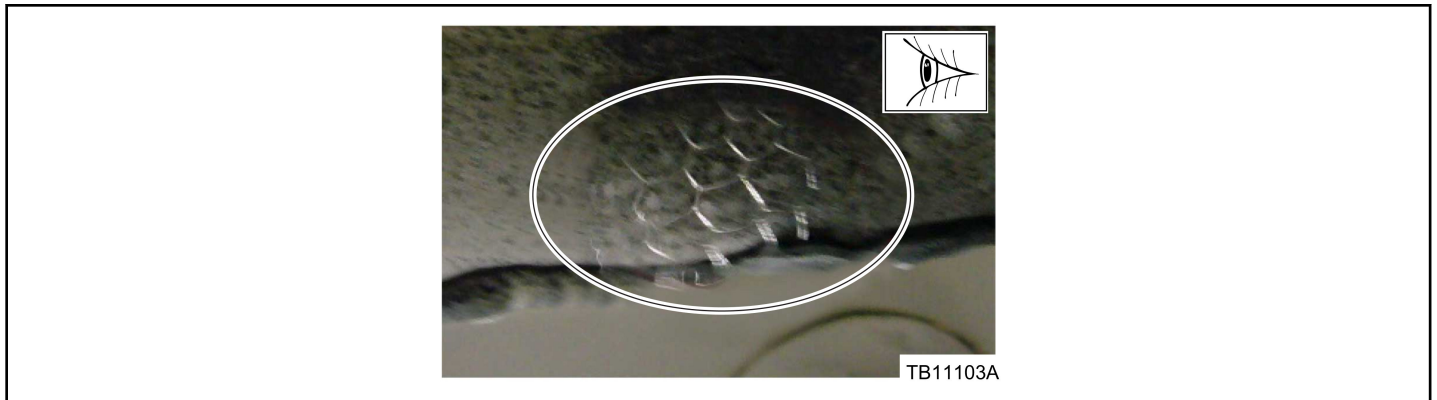
Figure 35 - Article 17-0044

26. Air leaks can be identified by the presence of air bubbles. (Figure 35)

27. Mark all areas identified to have air leaks.
28. Turn off A/C.
29. Turn off vehicle.
30. Clean and dry all areas marked earlier.
31. Seal using Motorcraft® Seam Sealer or equivalent.
32. Allow sealant to dry for 30 minutes and retest.
33. Remove the masking tape applied in Step 25.
34. Inspect the left and right side air extractors for proper fit to the body and operation/sealing of the rubber flaps.
 - a. Replace the air extractor if it is warped or damaged or flaps do not lay flush to their sealing surface. (Figure 36)
