GLOBAL SAFETY FIELD INVESTIGATIONS  
DCS6395  
URGENT - DISTRIBUTE IMMEDIATELY

Subject: REVISION: N222372590-01 - Service Update  
Charge Air Cooler Icing  
Revised Attention Box, Models Section, and Dealer Responsibility  
Section

## N222372590 Charge Air Cooler Icing

<b>Condition</b>	Certain vehicles listed above may have a condition in which ice or sludge can accumulate in the Charge Air Cooler (CAC) or Closed Crankcase Ventilation (CCV) system when driving in extremely cold weather conditions (-18°C (0°F) or less).
<b>Correction</b>	Dealers will install a TCV thermal wrap and, if applicable, reprogram the Engine Control Module.

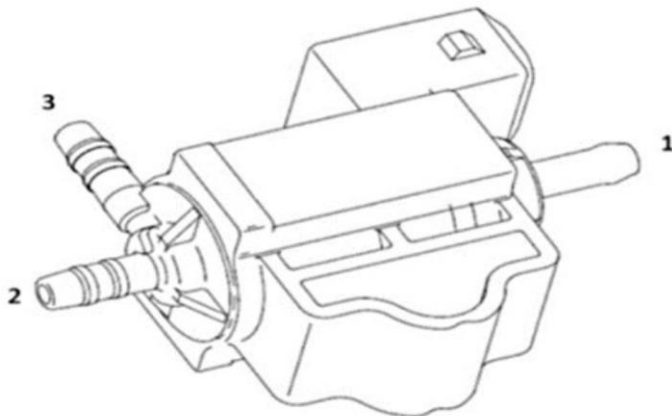
6055068

**Note:** Check port #2 to assure the spring gets lifted off the seat. This will be determined by the compressed air not dead heading when applied to port #2. When applying air to this port, a small amount of air should be observed at port #3 and even less air will be noticed at port #1. If this does not happen, the TCV plunger may have hardened deposits from hot operating conditions which will impede TCV plunger movement, and the TCV should be replaced.

3. Using clean shop air regulated to 80-100 PSI, blow through all three ports (1, 2 & 3) for 5 seconds each.
  - Repeat step 3 twice.
