GLOBAL SAFETY FIELD INVESTIGATIONS
DCS6400
URGENT - DISTRIBUTE IMMEDIATELY

Subject: REVISION: N212354520-05 - Customer Satisfaction Program
Heated Vented Seats Retrofit
Front Seat Heater Vent Module and Programming
Revised Service Procedure

N212354520 Heated Vented Seats Retrofit - Front Seats Only

Revision: 05

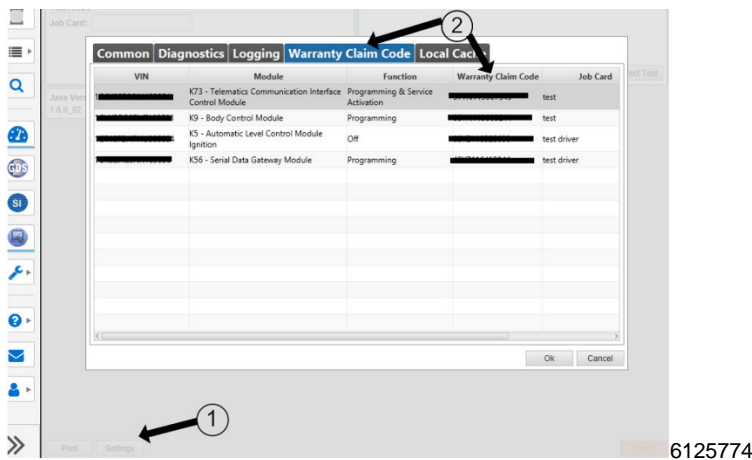
6125774

If the Warranty Claim Code was not recorded on the Job Card, the code can be retrieved in the SPS2 system as follows:

1. Open TLC on the computer used to program the vehicle.
2. Select and start SPS2.
3. Select Settings (1).
4. Select the Warranty Claim Code tab (2).

The VIN, Warranty Claim Code and Date/Time will be listed on a roster of recent programming events. If the code is retrievable, dealers should resubmit the transaction making sure to include the code in the SPS Warranty Claim Code field.

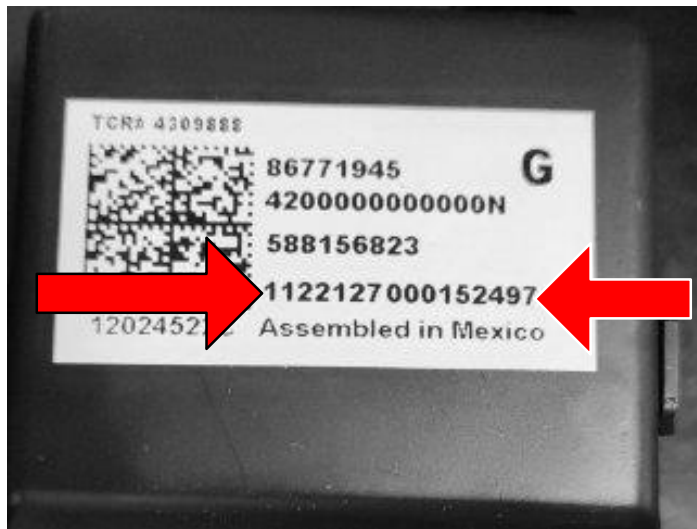
Record the serial number on the front seat heater vent control module labels.

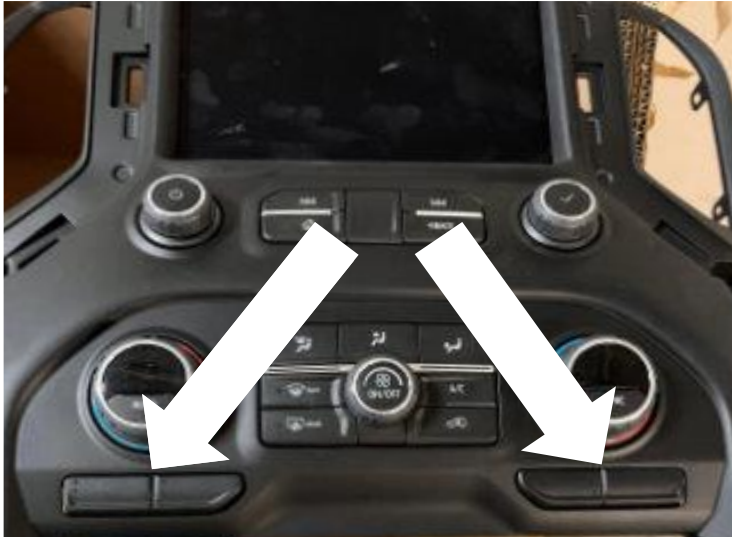
6191038

Note: A small number of Silverado and Sierra vehicles may have been built without heated seat controls as indicated in the graphic above. If no heated seat controls are installed on the vehicle, use step #4 in the service procedure.

2. Record the serial number of the new seat heater vent control module (see instructions above).
3. Install the new service front seat heater vent control module. Refer to *Front Seat Heater Vent Control Module Replacement* in SI.
4. For Silverado and Sierra only. If required, replace the heater and air-conditioning user interface control. Refer to *Heater and Air Conditioning User Interface Control Replacement* in SI.

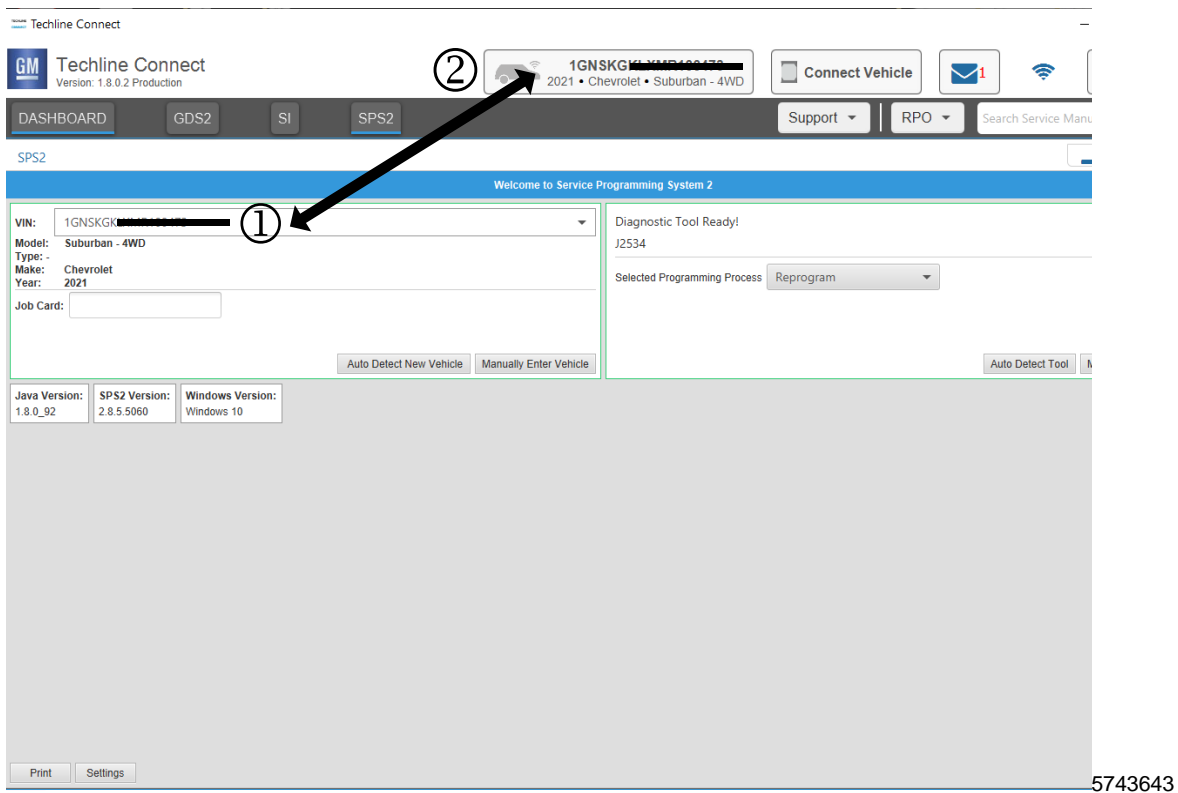
Caution: Be sure the VIN selected in the drop-down menu (1) is the same as the vehicle connected (2) before beginning programming.

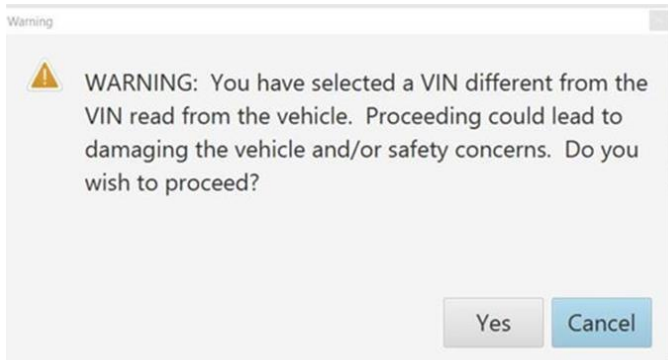
Important: If the vehicle VIN DOES NOT match, the message below will be shown.

- If the VIN that shows up in the TLC top center window after correctly reading the VIN from the vehicle does not match the VIN plate of the vehicle, manually type in the VIN characters from the vehicle VIN plate into the TLC top center window and use these for programming or reprogramming the subject module with the correct vehicle VIN and software and/or calibrations.
