Subject: N222378271 - Customer Satisfaction Program
Vehicle Software Configuration Management Update

Models: 2023 Cadillac LYRIQ

N222378271 Vehicle Software Configuration Management Update

Condition	Certain 2023 model year Cadillac LYRIQ vehicles may have multiple software issues such as no audio, flashing cornering lamps, or lighting concerns.
Correction	Dealers will confirm the over-the-air updates are installed. Various modules will be manually updated by the dealer with the latest software.

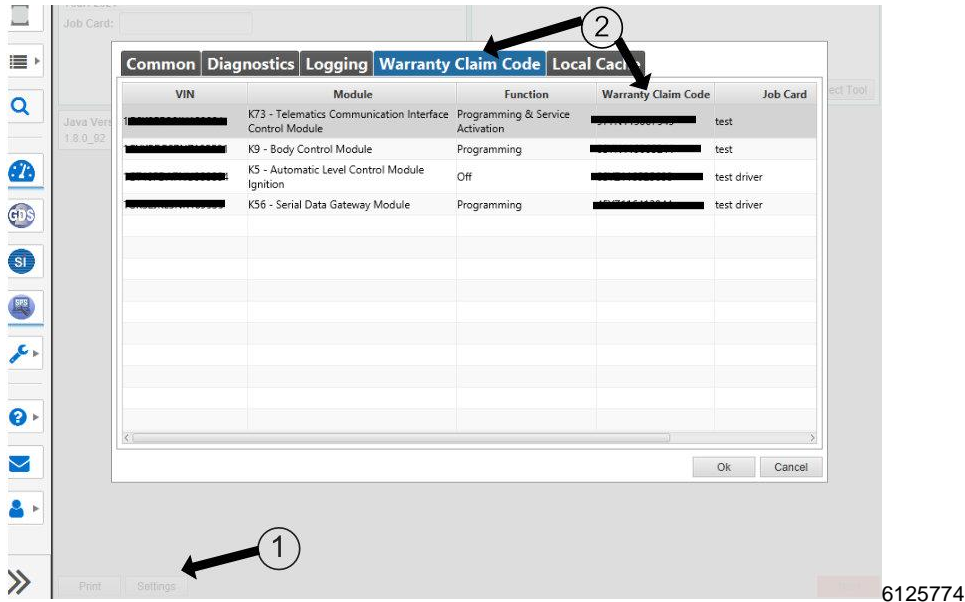
If the Warranty Claim Code was not recorded on the Job Card, the code can be retrieved in the SPS2 system as follows:

- Open TLC on the computer used to program the vehicle.
- Select and start SPS2.
- Select Settings (1).
- Select the Warranty Claim Code tab (2).

The VIN, Warranty Claim Code and Date/Time will be listed on a roster of recent programming events. If the code is retrievable, dealers should resubmit the transaction making sure to include the code in the SPS Warranty Claim Code field.

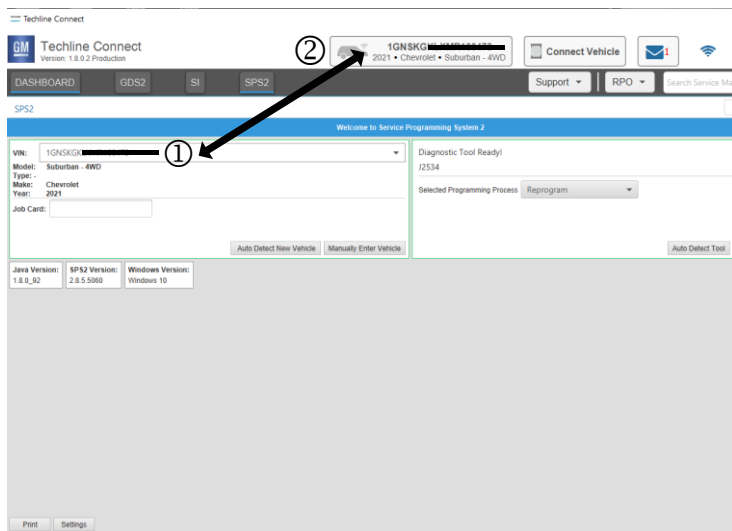
5743643

Caution: Be sure the VIN selected in the drop-down menu (1) is the same as the vehicle connected (2) before beginning programming.

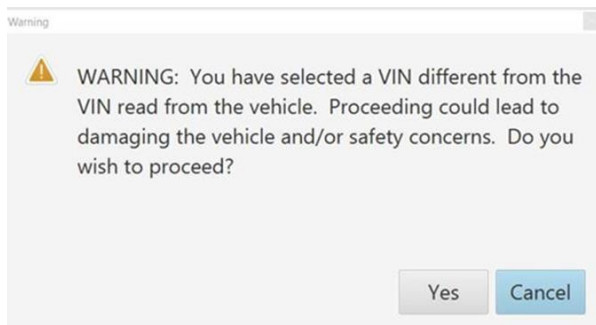
5877000

Important: If the vehicle VIN DOES NOT match, the message below will be shown.

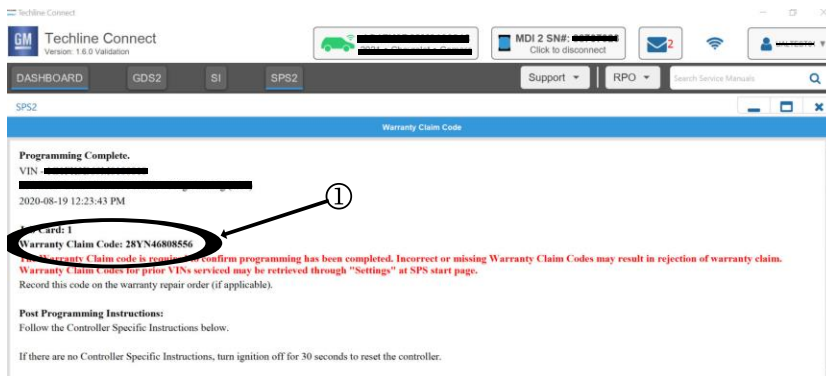
5644478

Important: To avoid warranty transaction rejections, you MUST record the warranty claim code provided on the Warranty Claim Code (WCC) screen shown above on the job card. Refer to callout 1 above for the location of the WCC on the screen.

1. Reprogram the Forward Range Radar Sensor – Long Range, Power Steering Control and Front View Camera modules. Refer to *B233B Forward Range Radar Sensor - Long Range: Programming and Setup*, *K43 Power Steering Control Module: Programming and Setup* and *B174W Front View Camera - Windshield: Programming and Setup* in SI.
