Left-hand Side Outer Rear-view Mirror Vibration While Driving

Service Category Vehicle Exterior

Section Mirror (ext)

Market USA and Mexico

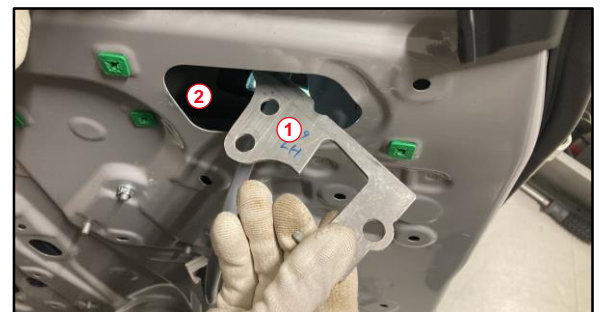
Figure 5.

1	Reinforcement Bracket
2	Service Hole

7. Install the NEW reinforcement bracket to the door panel.
 - A. Insert the reinforcement bracket through the service hole.
