GLOBAL SAFETY FIELD INVESTIGATIONS DCS6411

Subject: REVISION: N222378560-03 - Customer Satisfaction Program

Front Seat Cushion Vent Blowers Retrofit with RPO 04O

N222378560 Front Seat Cushion Vent Blowers Retrofit

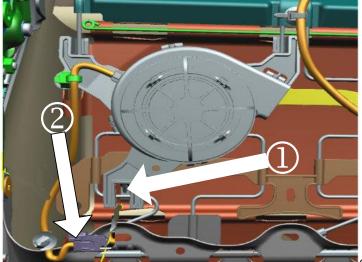
6194793

Wiring Harness Electrical Connector (2) Vent Blower Assembly Release Tab (1)

2. Disconnect and reposition the left and right seat cushion vent fan wiring harness as necessary (2).
