GROUP	MODEL			
ELE	2022MY			
	K5 (DL3a)			
	w/o Smart Cruise			
NUMBER	w/o Smart Cruise DATE

TECHNICAL SERVICE BULLETIN

SERVICE ACTION: STEERING WHEEL REPLACEMENT FOR INCORRECT BUTTONS (SA505)

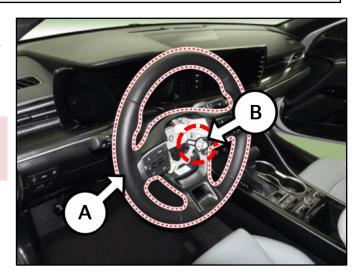
This bulletin provides information to replace the steering wheel on some 2022MY K5 (DL3a) vehicles produced from June 13, 2022 through June 21, 2022, which may have had the incorrect steering wheel assembly installed during production. These vehicles are not equipped with the Smart Cruise control feature. There are no warning lights or features causing concerns from having the incorrect steering wheel. Follow the procedure outlined in this publication to replace the steering wheel assembly with the new steering wheel assembly. Before conducting the procedure, verify that the vehicle is included in the list of affected VINs.

Replace the steering wheel (A) by referring to "Steering System → Steering Wheel → Repair procedures (Removal)" in the applicable Shop Manual on KGIS.

The steering wheel lock bolt (B) CANNOT be reused. Install a new bolt.
