01-20-03TT - MIL ON, NOx Sensor Circuit Range/Performance Fault P2201

THIS IS A TECH TIP, NOT A TECHNICAL BULLETIN.

Model(s)	Year	Eng. Code	Trans. Code	VIN Range From	VIN Range To
Passat	2012-2014	2.0L TDI (CKRA)	All	All	All

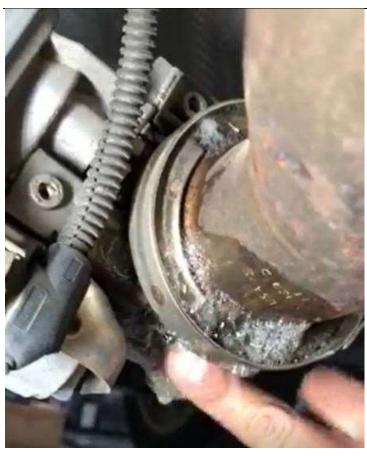
The newest variant of the -*J583*- NOx Sensor, part number 03L 907 807 **AF**, is known to be robust. If there is a fault with a vehicle equipped with the "AF" index NOx sensor variant, there may be other factors (such as exhaust leaks upstream of NOx Sensor or a wiring connector fault) contributing to the DTC.

Figure 1. Example of exhaust leak at exhaust flap.

- 2.) If the "AF" index sensor is already installed on the vehicle, do not replace sensor on the first repair visit. Verify wiring by referring to Safety Recall 23T3 and there are no leaks in the exhaust system upstream of the NOx Sensor, which may be contributing to erroneous sensor values. The VAS1687 tool is useful in pressurizing the exhaust, and a soapy water mixture works well to find leak areas. Pay close attention to the exhaust pipe connections on the exhaust flap for the low pressure EGR system. If leaks are identified, repair them as necessary. If the exhaust is verified to be leak free and an "AF" sensor variant is installed, replace the sensor if directed by GFF.
