## 01-22-05 - Update Programming Engine/Motor Control Module - J623- for Various Concerns

Release date: 1/17/2023

Applicable Vehicles					
Model(s)	Year	Eng. Code	Trans. Code	VIN Range From	VIN Range To
Taos	2022	1.5T (DNKA)	All	All	All

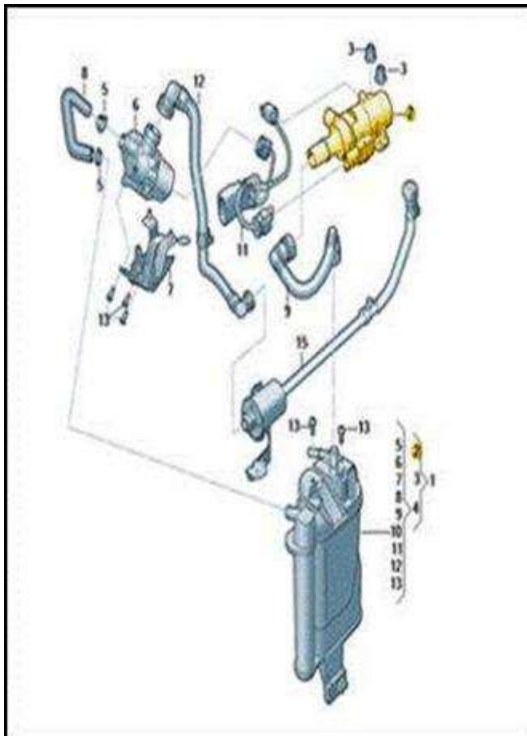
Figure 1.

In addition to the software improvement, there is also an improvement to the FTIV (fuel tank isolation valve/tank switch-off valve -**N288**-) (Figure 1.), which is necessary in preventing erroneous occurrences of the P2421 fault code.

The FTIV / Tank switch-off valve -**N288**- currently installed on the vehicle must be inspected, to verify whether an improved part has already been installed. The FTIV / Tank switch-off valve -N288- is mounted to the EVAP canister assembly, as shown below.

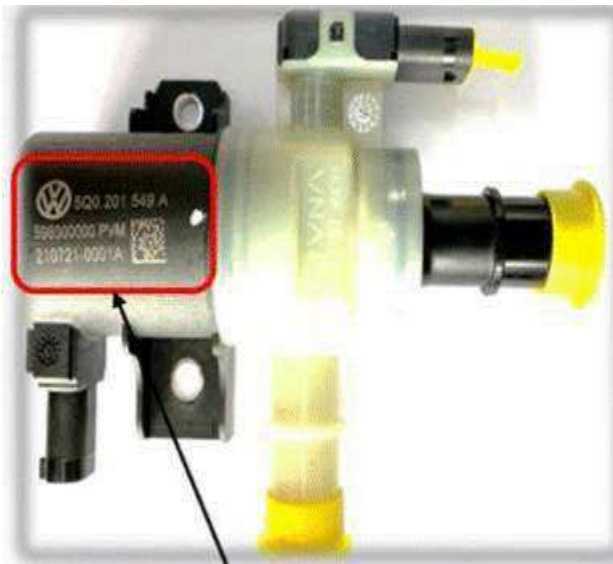
Figure 2.

Remove the EVAP canister assembly and inspect the face of the FTIV / Tank switch-off valve -**N288**-. If the part is already updated, it will have a white paint marking or "02S" printed after the part number, as shown in Figure 2 and Figure 3. **Alternatively, part number 5Q0 201 549 C is also up to date.**

- If the component has the latest part number, has a white paint mark, or has "02S" printed after the part number, the FTIV / Tank switch-off valve -**N288**- is already the updated component. In this case DO NOT replace it, and instead reinstall the EVAP canister assembly. Only the software update will be required.
- If the component does not have the latest part number, there is no white paint mark, or "02S" is not printed after the part number, the FTIV / Tank switch-off valve -**N288**- must be replaced in addition to the software update. Always refer to ETKA for the most up to date part number information.
