# Service Bulletin

Bulletin No.: 15-06-01-002M

**Subject:** Engine Misfire/Tick Noise, Malfunction Indicator Lamp (MIL) Illuminated - DTC P0300 Set

**Models:** 2015–2020 Cadillac Escalade  
2016–2019 Cadillac CTS-V  
2014 Chevrolet Silverado 1500  
2014–2019 Chevrolet Corvette  
2015–2018 Chevrolet Silverado  
2015–2020 Chevrolet Suburban, Tahoe  
2016–2023 Chevrolet Camaro  
2019 Chevrolet Silverado LD  
2014 GMC Sierra 1500  
2015–2018 GMC Sierra  
2015–2020 GMC Yukon, Yukon XL  
2019 GMC Sierra Limited  
Equipped with 5.3L Engine (RPOs L83, L8B) or 6.2L Engine (RPOs L86, LT1, LT4)

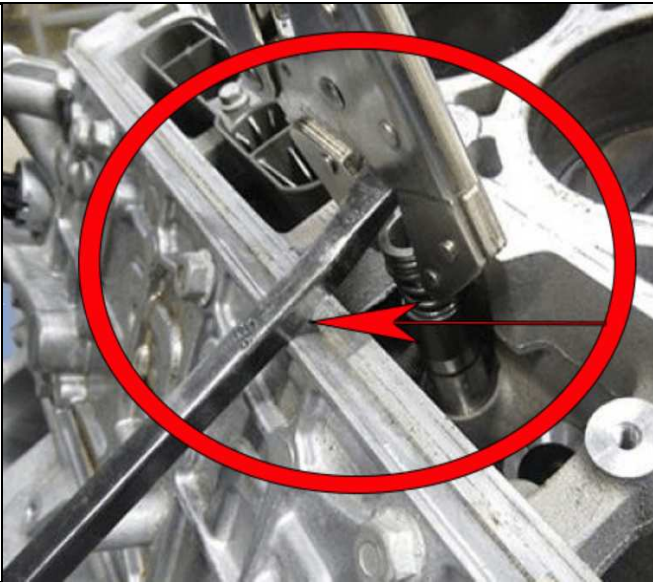
4921302

**Note:** Be sure **NOT** to pry on the sealing surface of the block, as shown in the illustration above.

2. Use vice grips with a small pry bar.
