GLOBAL SAFETY FIELD INVESTIGATIONS DCS6421 URGENT - DISTRIBUTE IMMEDIATELY

Subject: N222362040 - Service Update

Rear Brake Line Inspect for Clearance

Models: 2022 Chevrolet Silverado 1500 LTD

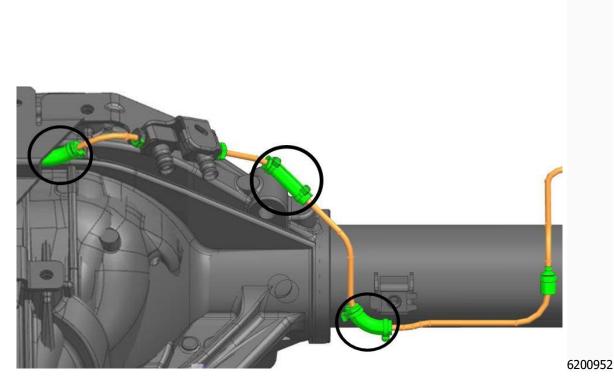
Condition	Certain 2022 model year Chevrolet Silverado 1500 LTD/New and GMC Sierra 1500 Limited/New				
	vehicles may have a condition where the brake line contacts the rear axle.				
Correction	Dealers are to inspect the rear brake lines for clearance and replace if necessary.

- 2. Inspect the rear brake lines at the three areas indicated above to ensure there is at least 3mm (1/8 inch) of clearance between the brake pipe and the rear axle. Additionally ensure that no contact has occurred between the two due to vibration or otherwise look for witness marks or chipped coating.
 - If contact has occurred at any of the three locations indicated, replace the brake pipe in question. Refer to Rear Brake Pipe Replacement Left Side or Rear Brake Pipe Replacement Right Side in SI.
 - If no contact has occurred, and clearance is less than 3mm (1/8 inch), install a rubber bumper at each of the three locations indicated. Secure the bumper with a zip tie at each end.
 - If no contact has occurred, and clearance is GREATER than 3mm (1/8 inch), no further action is required.
- 3. Lower the vehicle. Refer to Lifting and Jacking the Vehicle in SI.
