# Service Bulletin

Bulletin No.: 20-NA-142

**Subject:** Shudder/Surging While Driving

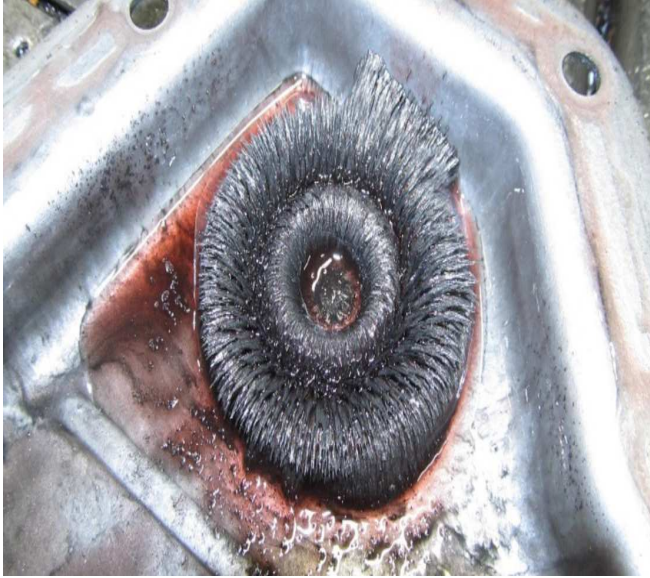
<b>Involved Region or Country</b>	North America, Russia, Middle East, Israel, Palestine, Chile, Columbia, Ecuador, Paraguay, Peru and Thailand.
<b>Condition</b>	Some customers may comment that a surging condition is felt when driving. Some technicians may find while performing Torque Converter Diagnosis per Service Information, may identify the surging as a torque converter shudder condition.
<b>Cause</b>	This condition may be caused by additives in the transmission fluid may have been depleted during vehicle operation. – Some of these additives assisted with regulating a consistent slip rate of the clutches.
<b>Correction</b>	<p><b>Note:</b> This bulletin should only be used on vehicles with 50,000 km (30,000 miles) or less. For vehicles with over 50,000 km (30,000 miles) the torque converter and transmission oil filter should be replaced following published Service Information.</p> <ol style="list-style-type: none"> <li>1. Raise the vehicle.</li> <li>2. Remove the transmission pan.</li> </ol>

<p style="text-align: right;">5360216</p> <ul style="list-style-type: none"> <li>• If metallic debris is present (similar to graphic above), remove transmission and replace the torque converter and replace the transmission filter. Refer to Torque Converter Replacement in SI.</li> <li>• If metallic debris is not present, drain and clean the oil pan, replace transmission fluid filter and reinstall transmission oil pan <b>following Service Information</b> and follow the Service Procedure below that corresponds with the vehicle fill setup.</li> </ul>
