Service Bulletin

Bulletin No.: 20-NA-187

Subject: Delayed and/or Harsh Engagement of Transmission Shift After Vehicle Sitting with Engine Off

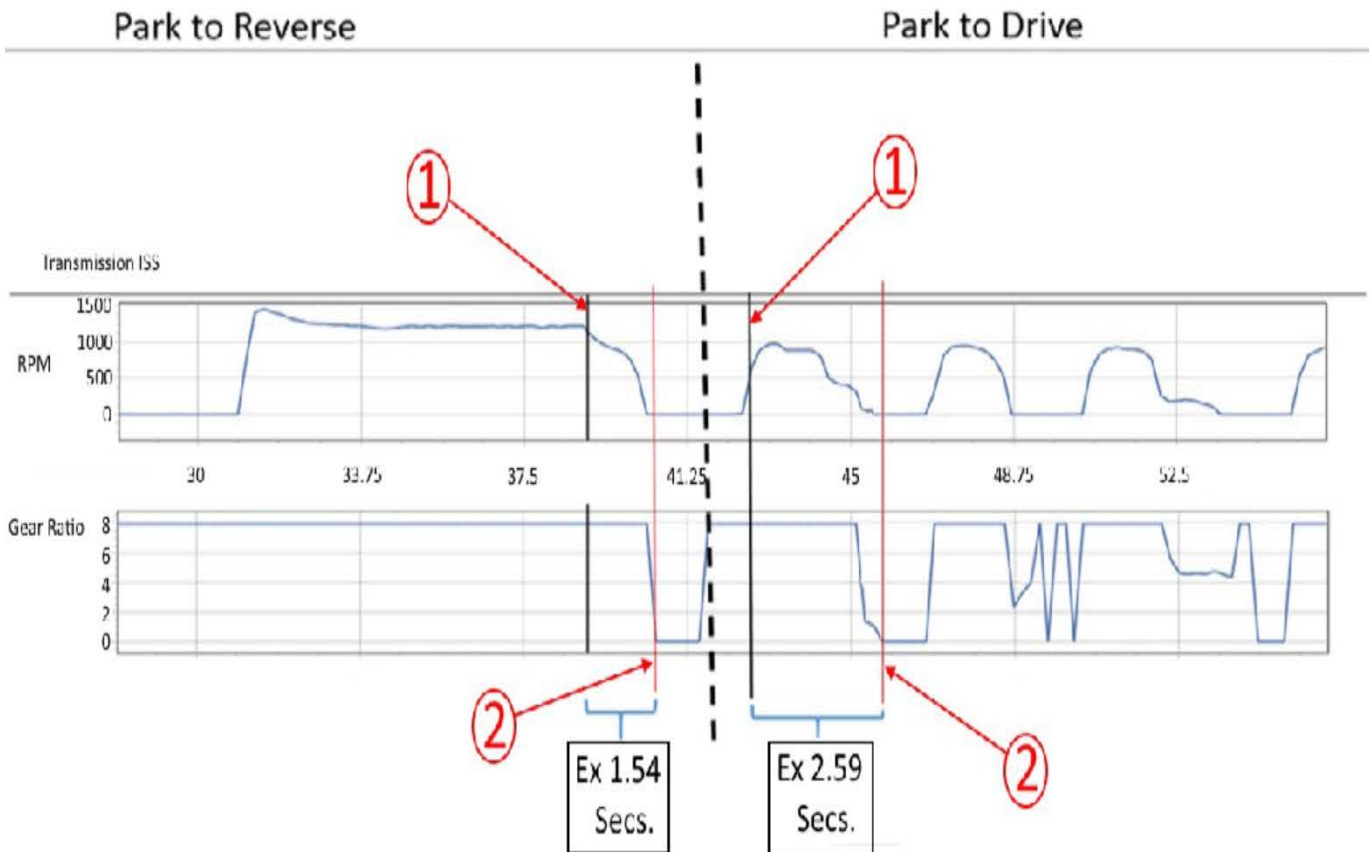
Delayed Engagement Park to Reverse or Drive is present if the time difference between Gear Selected (Pt. 1) and Transmission Input Shaft Speed reaching 0 RPMs (Pt. 2) exceeds 3 seconds. Foot is HELD on Brake during maneuver.
