# Service Bulletin

Bulletin No.: 21-NA-081

**Subject:** Malfunction Indicator Lamp (MIL) Illuminated - DTCs P3108, P310B, P3111, P311A, P3409, P3411, P3417, P3419, P3433, P3435, P3457, P3459, P3499, P349A, P349C and/or P349F Set

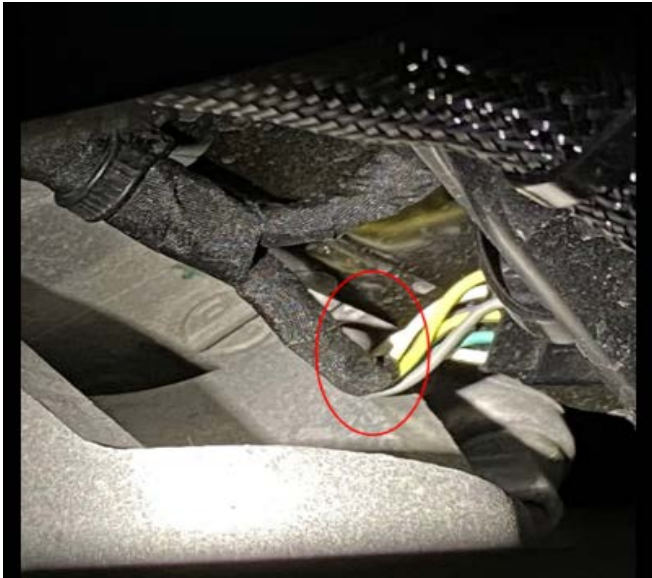
<b>Involved Region or Country</b>	United States, Canada, Mexico, Europe, Russia, Middle East, Chile (West), Columbia (West), Ecuador (West), Paraguay (West), Peru (West), Uruguay (West), Japan, Cadillac Korea (S. Korea), Thailand (ASEAN), Australia and New Zealand.
<b>Condition</b>	Some customers may comment that the MIL lamp is illuminated or was illuminated and turned off. Some technicians may find one or more of the following DTC's active or stored in history: • P3108, P310B, P3111, P311A, P3409, P3411, P3417, P3419, P3433, P3435, P3457, P3459, P3499, P349A, P349C and P349F.
<b>Cause</b>	This condition may be caused by a chaffed wire(s) at the X155 connector.

<p style="text-align: right;">5785914</p> <ul style="list-style-type: none"> <li>- This connector is in the engine compartment, near the idler pulley support bracket, at the front left of the engine block as shown in the graphic above.</li> <li>- If a damaged wire at this location is found, it could cause a short to ground or open circuit fault thus setting one of the associated DTCs.</li> </ul>
<p><b>Correction</b></p>	<p>if you encounter a vehicle with any of the DTC's noted above, it will be necessary to inspect the X155 connector for any wiring concerns. Inspect the wires for any signs of chaffing and terminal tightness.</p> <ul style="list-style-type: none"> <li>• If you find a concern with any wire, repair the wire connection in accordance with standard practices.</li> <li>• If no trouble is found at this location, refer to service information for the applicable DTCs that are set for further information and diagnosis procedures.</li> </ul>

For wiring repairs covered under warranty, please refer to latest version of bulletin 10-00-89-005 for warranty information on wire/connector repairs.
