Technical Service Bulletin

70 Rattle from rear subwoofer grille

70 23 78 2044503/4 January 17, 2023. Supersedes Technical Service Bulletin Group 70 number 19-69 dated November 21, 2019, for reasons listed below.

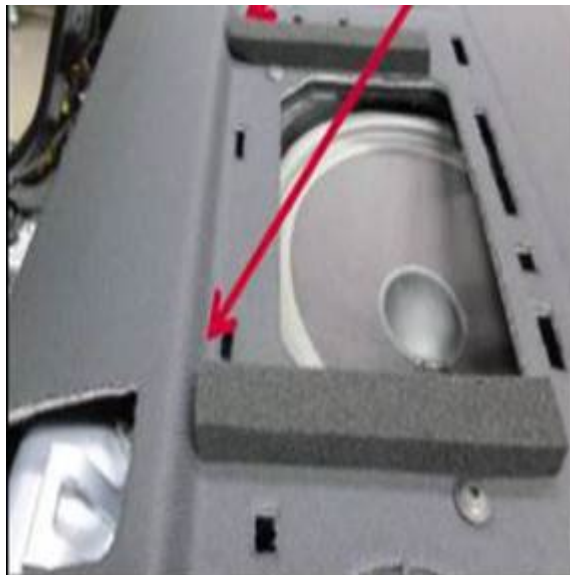
The rear parcel shelf speaker grille will rattle when loud music with heavy bass is being played.

Figure 1. Foam strip installation for vehicles with Audi sound (PR code 9VD).

Bond the damping strip (Figures 1 and 2) on the left side of the rear shelf.

The 150mm damping strips must reach up to the edge, see arrows.

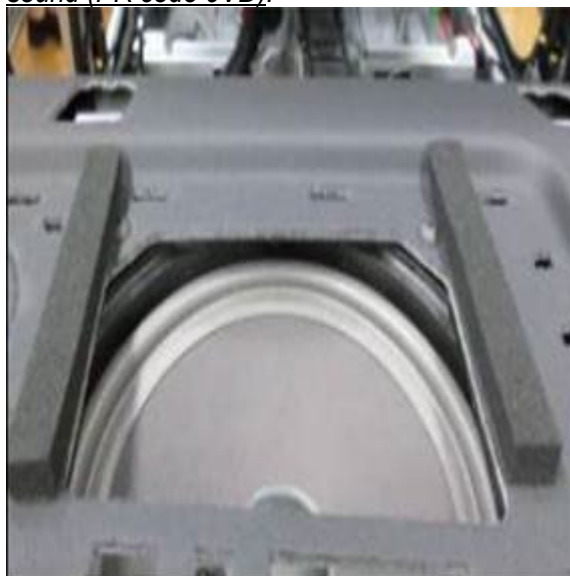
Figure 2. Foam strip installation for vehicles with Audi sound (PR code 9VD).

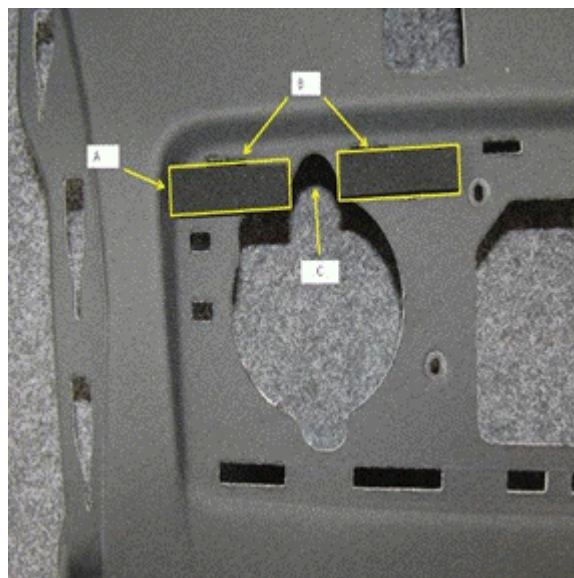
Figure 3. Foam strip installation for vehicles with Bang and Olufsen (PR code 9VS)

Observe the following positioning (Figure 3):

A = bond the damping strip on the edge.

B = bond on the rim of the perforation.

C = keep clear of the speaker section.
