01/11/2023  
CAL FTL 54-027

## Subject: New Cascadia Vehicles Equipped With D-Climate P4 Ground Cable Anti-Corrosion Sealer Issue

**Models Affected: 2020 to 2022 New Cascadia vehicles built from July 8, 2020, through September 1, 2022.**

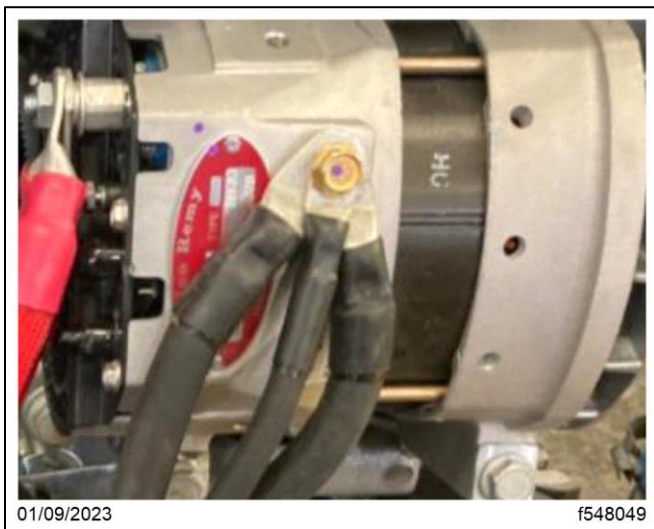
**Fig. 1, Ground Cables Mounted on the Alternator**

Some New Cascadia vehicles equipped with the D-Climate system have the ground cables installed on the alternator body in a manner where the cables are not fanned or flat, as shown in [Fig. 1](#). Once the spray is applied, it can interfere with the proper or clean grounding of the alternator as well as other components. See [Fig. 2](#).

1. Park the vehicle on a level surface, shut down the engine, and set the parking brake. Chock the tires.
2. If the vehicle is having electrical issues, remove the ground cable mounting screw, and clean the mating surfaces and the cable ends with a scotch brite pad or similar product. Assemble the cable ends as shown in [Fig. 1](#).
3. Make sure that the mounting eyes on the cables are properly fanned out to allow full contact of all the cables with the alternator case.
4. Tighten the ground capscrew 65 lbf.in (734 N.cm).
5. Add corrosion-inhibiting spray or dielectric grease to the correctly installed cable ends.
