Jib Support Replacement (Effer — Campaign ID: CL202217)

CIRCULAR LETTER

Campaign id: CL202217

JIB support replacement

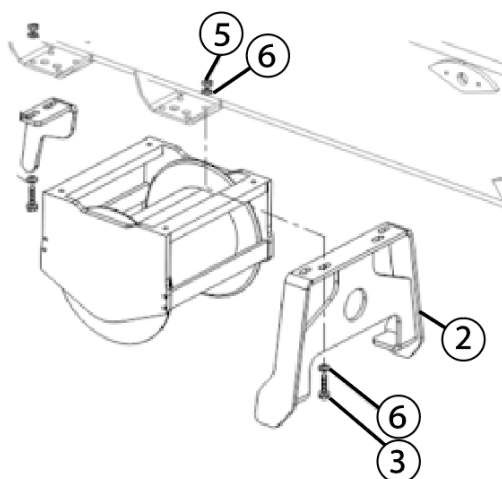
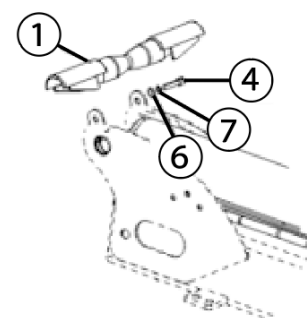
Based on information from the market, we found a problem with the JIB support in crane model EFFER 505. During the transport of the crane, we could see some bouncing movements of the JIB against its support. Thus, Effer R&D decided that in these cases it is necessary to replace the JIB support.

First, replace the JIB support.

N. in the picture	p/n
1	2K86121
2	5R86002
3	8229700GE
4	8263500GE
5	84080147
6	8521100GE
7	8526300GE

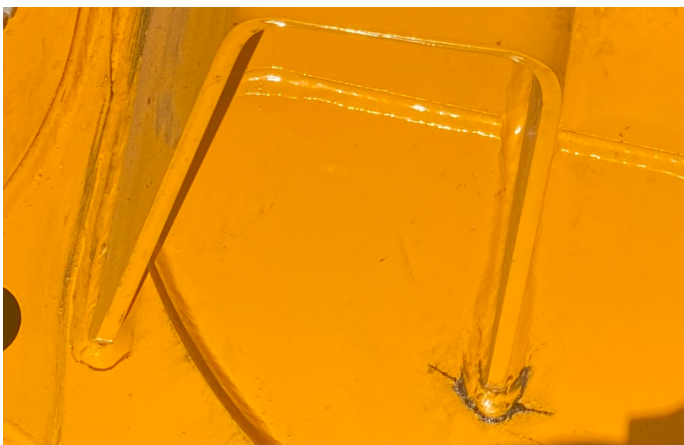
Then, check if there is any crack in the 2nd boom as shown in the following picture. If you find a crack, see the instruction below. If there is no crack, no preventive action is required.

If during the inspection, the 2nd boom is cracked, please contact H&SH Technical Support. In the following 4 cranes, we know that the 2nd boom is already cracked:

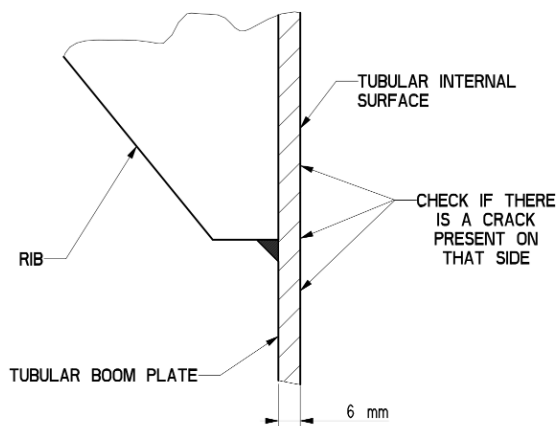
STEP 1

Where the rib is welded to the tubular of the boom, the crack is probably on all the thickness of the tubular plate. If the crack is not visible to the unaided eye, perform an LPI (Liquid Penetrant Inspection) or similar test on the internal surface (Step 1 in the drawing below). If the crack is passing through the plate (so it is also in the internal surface), start to repair it by grinding from inside the boom (Steps 2, 3, 4, and 5 in the drawings below). If the crack is not inside, you can repair it only from the external side (Steps 4 and 5 in the drawings below).

1. Remove the boom from the crane.
2. Remove the extensions and all the parts that can hinder the repair of the boom.
3. Clean, remove the paint from the affected area(s) and degrease the boom before proceeding with the next steps. Clean accurately the surface inside the tubular of the 2nd boom.
