Service Update

N212338810 Body Mount Stress Concentration, Noise, Rattle

Release Date: January 2023

Revision: 02

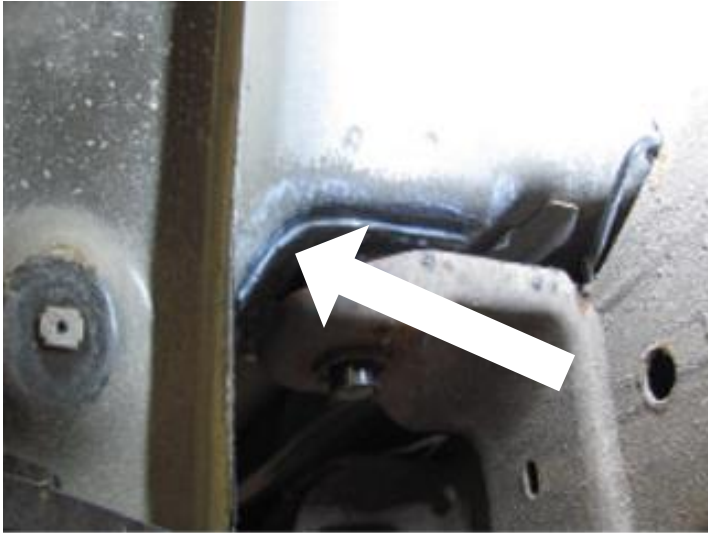
6254853

- Lift the vehicle. Refer to *Lifting and Jacking the Vehicle* in SI.
- Inspect the left rear body to frame mount forward of the rear wheel.

- If the reinforcement is installed, no further action is required, return the vehicle to the customer. If the reinforcement is not installed, proceed to step #1.
1. Disconnect the negative battery cable. Refer to *Battery Negative Cable Disconnection and Connection* in SI.
 2. Remove the left rear wheelhouse liner. Refer to *Rear Wheelhouse Liner Replacement (LWB)* in SI.

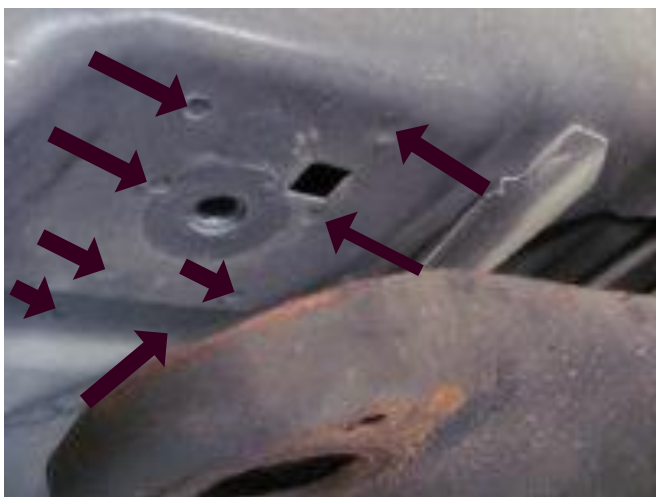
5937186

4. Inspect the 10 spot welds in the body mount area.
 - If the welds look sound and show no tearing, cracking or distortion, proceed to step #5.
 - If any welds show signs of damage, tearing, cracking or distortion, do not proceed with the repair, follow the **Field Product Report (FPR)** process at the end of these steps.
