TECHNICAL SERVICE BULLETIN

Rough Idle - Built On Or After 22-July-2022

22-2500

Ford 2022 Mustang Shelby GT500	Built on or after 22-Jul-2022
--	-------------------------------

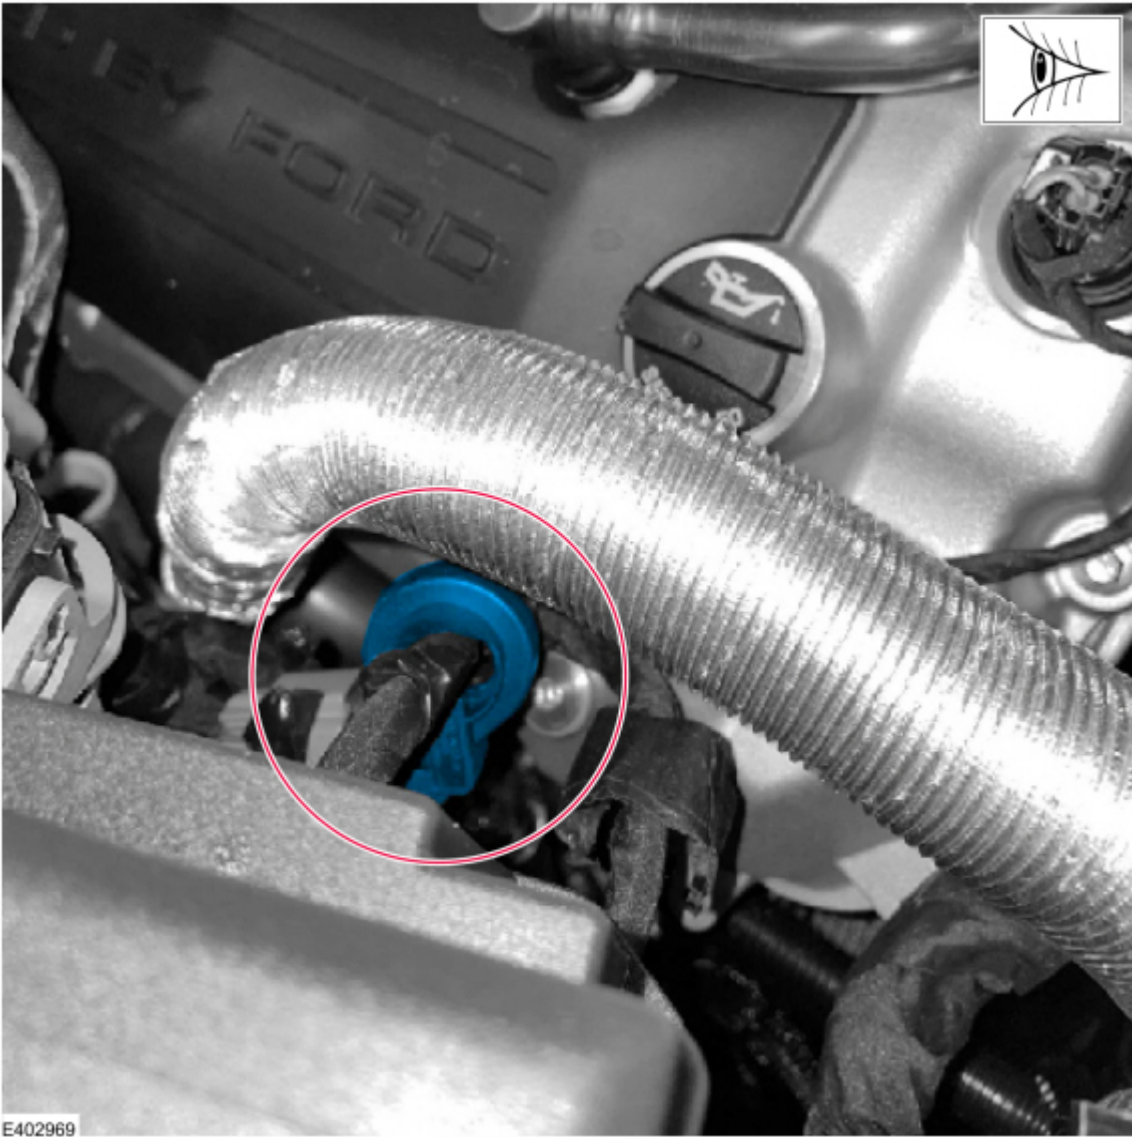
Figure 1

1. Locate and inspect the generator current sensor. (Figures 1-2)

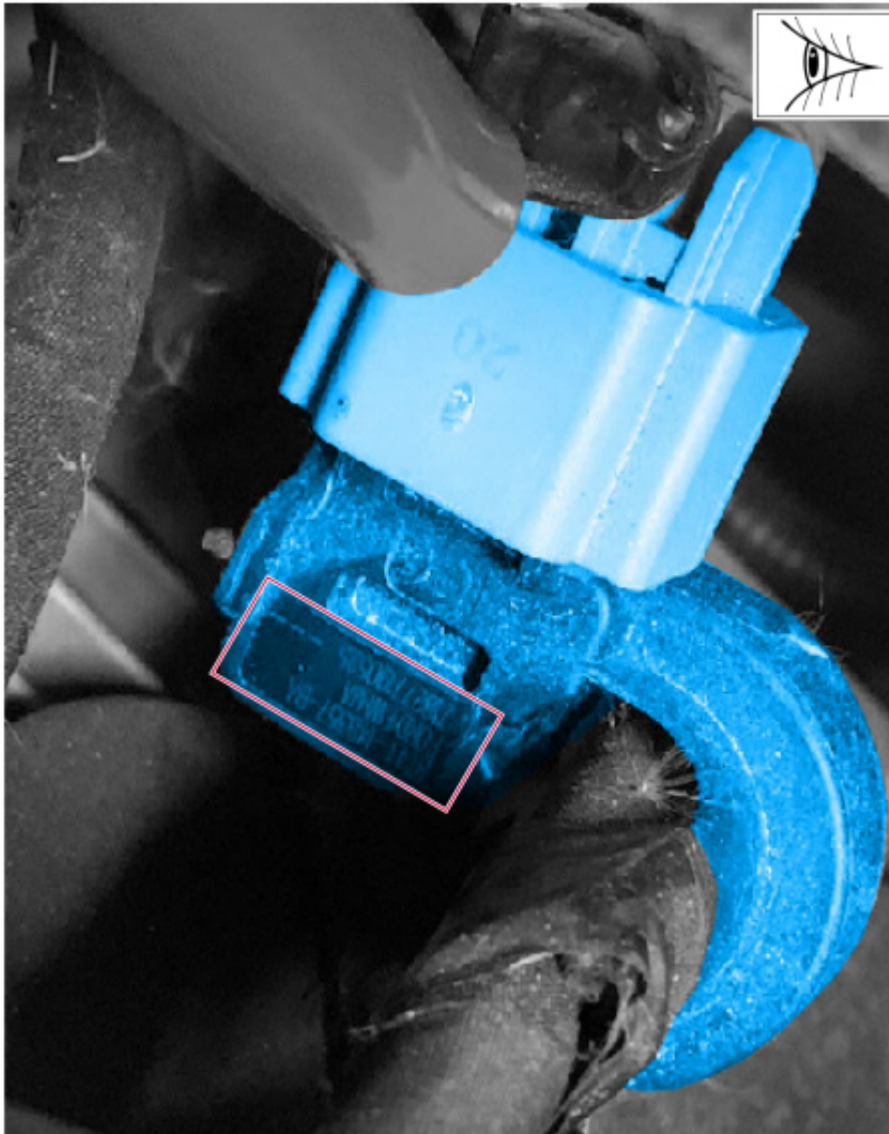
Figure 3

2. Is the part number on the sensor BT4T-14B357-AA? (Figures 3-4)

- (1). Yes - replace the generator current sensor. Refer to WSM, Section 414-01.
- (2). No - this article does not apply. Refer to the Workshop Manual (WSM) for normal diagnostics.
