Technical product information

Topic	Clicking noises from the left and/or right front corner(s)
Market area	Bentley: worldwide (2WBE)
Brand	Bentley
Transaction No.	2052853/11
Level	EH
Status	Approval
Release date

Bentayga series

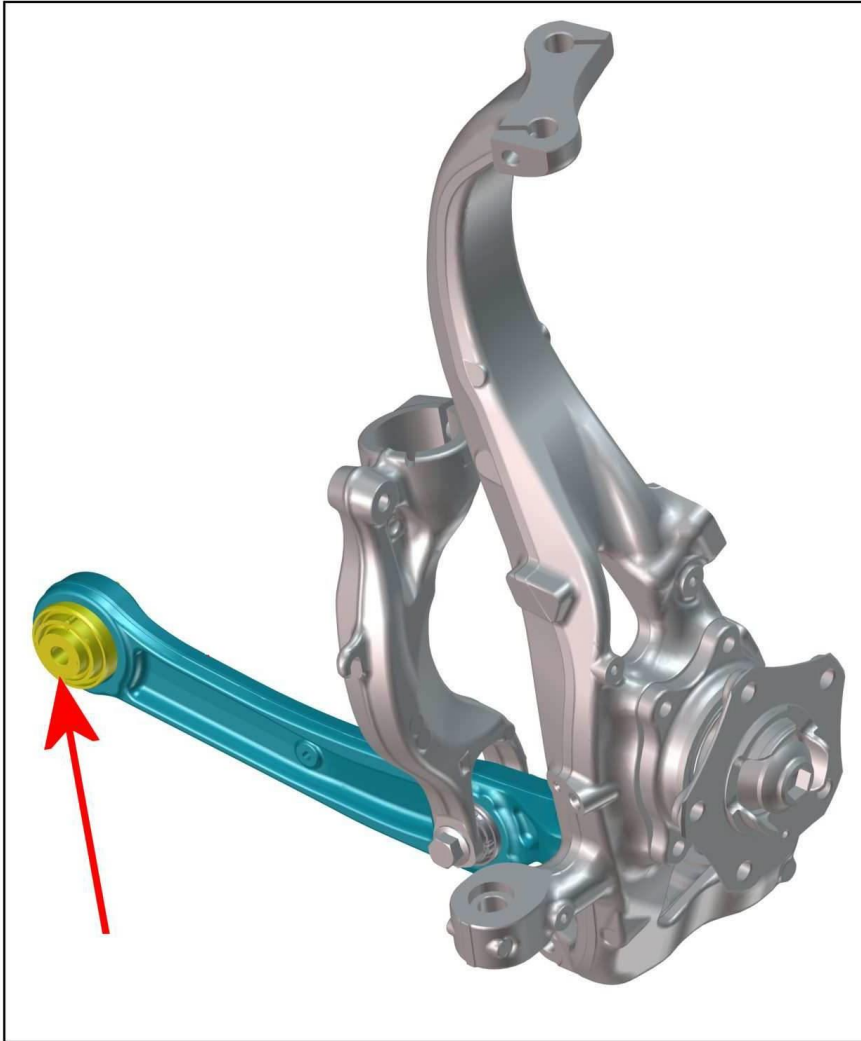
Figure 1

Single click from the front wheel corner(s) when the steering is moved from lock to lock whilst **stationary**

- If so then replace both front lower inner control arm bushes (Figure 1)

IMPORTANT: Please check the vehicle Repair History to confirm if the inner bushes have been previously replaced, if they have been replaced once before, **You must then replace the complete arm, Do Not carry out the bush replacement procedure more than once (per lever)**

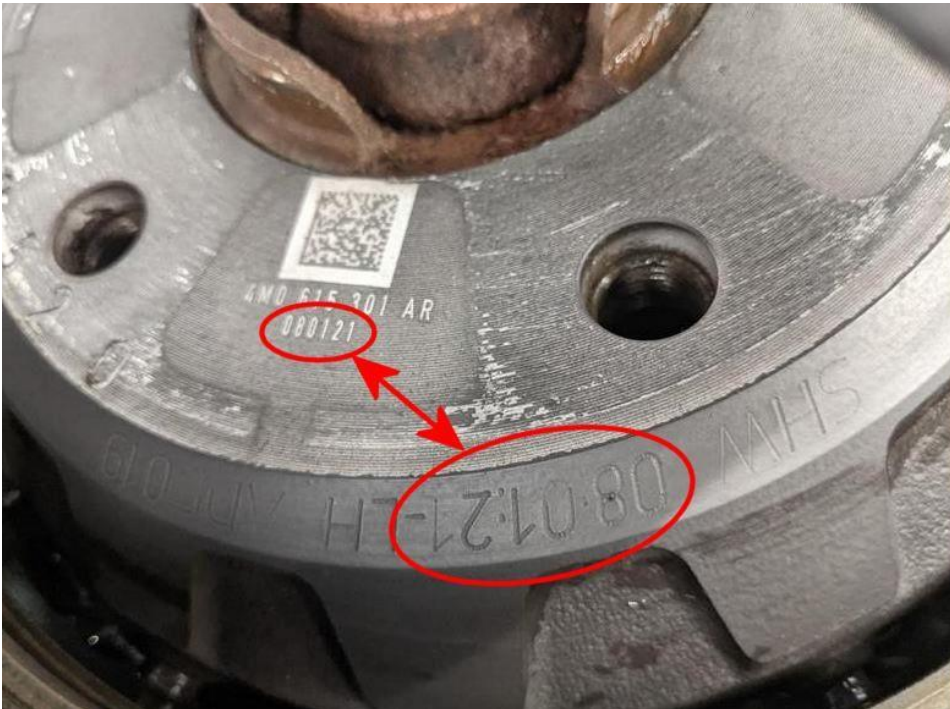
- Provide clear photographs of the mating surfaces between both front wheels, brake discs, hubs and photographs of the front brake disc date of manufacture stamp as shown in Figure 2

- Provide comments/feedback regarding any surface imperfections such as uneven wear, surface damage or fretting, or paint overspray
- If any of the above is present, ensure clear photographs are attached to a new or existing DISS query, and then replace the brake discs and wheel bolts
- If the fault remains the same, the operative should raise a new or existing DISS query and await feedback before conducting any other work
