Technical product information

Topic	Foremost lower trailing arm bush leaking
Market area	Russische Föderation (5RU),Australia E04 Bentley rest Asia and Australia (6E04),China 796 VW Import Comp. Ltd (Vico), Beijing (6796),Germany E02 Bentley rest Europe (6E02),Japan E03 Bentley Japan (6E03),Korea, (South) E08 Bentley South Korea (6E08),United Arab Emirates E06 Bentley Middle East and Africa (6E06),United Kingdom E01 Bentley UK (6E01),United States E05 Bentley USA and rest America (6E05)
Brand	Bentley
Transaction No.	2069159/1
Level	EH
Status	Approval
Release date

Bentayga series

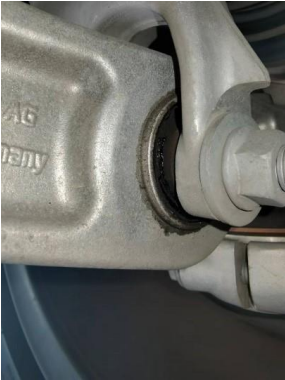
Figure 1

Leakage found on the foremost lower trailing arm bush as shown in Figures 1 and 2

In the event leakage is found on the foremost lower trailing arm bush as shown in Figures 1 and 2 the operative should conduct the onward instructions

- Conduct a thorough inspection of the suspension and steering systems including the underfloor to confirm if there is any signs of impact or damage
- Confirm if there is any signs of impact or damage to the lower front control arm and/or bush
- Confirm if there are any complaints of 'clicking' emanating from the foremost lower trailing arm bush

- **The foremost lower trailing arm bush should not be replaced for the symptom described unless the bush is worn / damaged or an acoustic concern is present**
- **The lower front control arm should be cleaned using a suitable cleaning solution if none of the afore mentioned symptoms are not present**
