Technical product information

Topic	Rear Jacking point - Sill damage found during PDI
Market area	Bentley: worldwide (2WBE)
Brand	Bentley
Transaction No.	2065760/2
Level	EH
Status	Approval
Release date

Bentayga Series

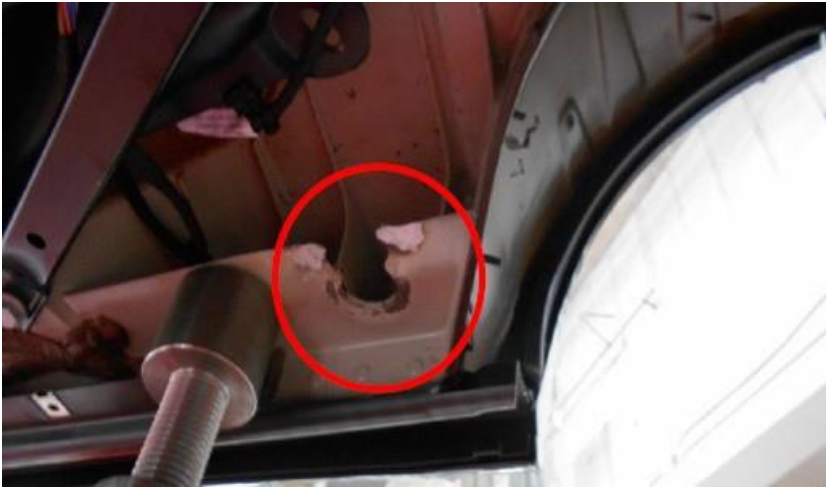
Figure 1

Damage found around the rear sill Jacking point during PDI (Figure 1)

In the event the issue is as described, please raise a technical DISS query ensuring clear photographs are attached

The operative **MUST** await feedback from **Product Support** before conducting any further work
