Technical product information

Topic	Rear lid or boot - Water ingress diagnosis
Market area	Russische Föderation (5RU),Australia E04 Bentley rest Asia and Australia (6E04),China 796 VW Import Comp. Ltd (Vico), Beijing (6796),Germany E02 Bentley rest Europe (6E02),Japan E03 Bentley Japan (6E03),Korea, (South) E08 Bentley South Korea (6E08),United Arab Emirates E06 Bentley Middle East and Africa (6E06),United Kingdom E01 Bentley UK (6E01),United States E05 Bentley USA and rest America (6E05)
Brand	Bentley
Transaction No.	2068829/1
Level	EH
Status	Approval
Release date

Bentayga Series

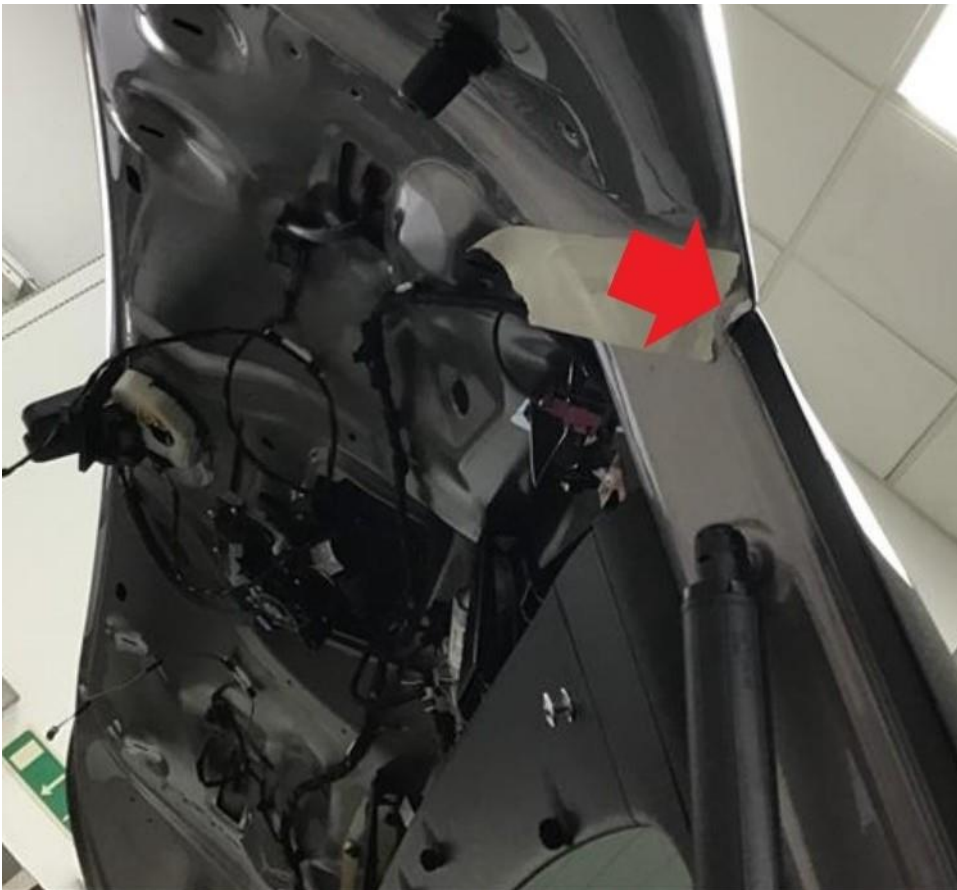
1) Referring to Figures 1 and 2 (below the rear lid strut) check to confirm the sealant is present and in a good condition at the location shown (right hand side)

HINT: Figure 1 shows the rear lid trim removed, however the rear lid trim does not require removal for this operation

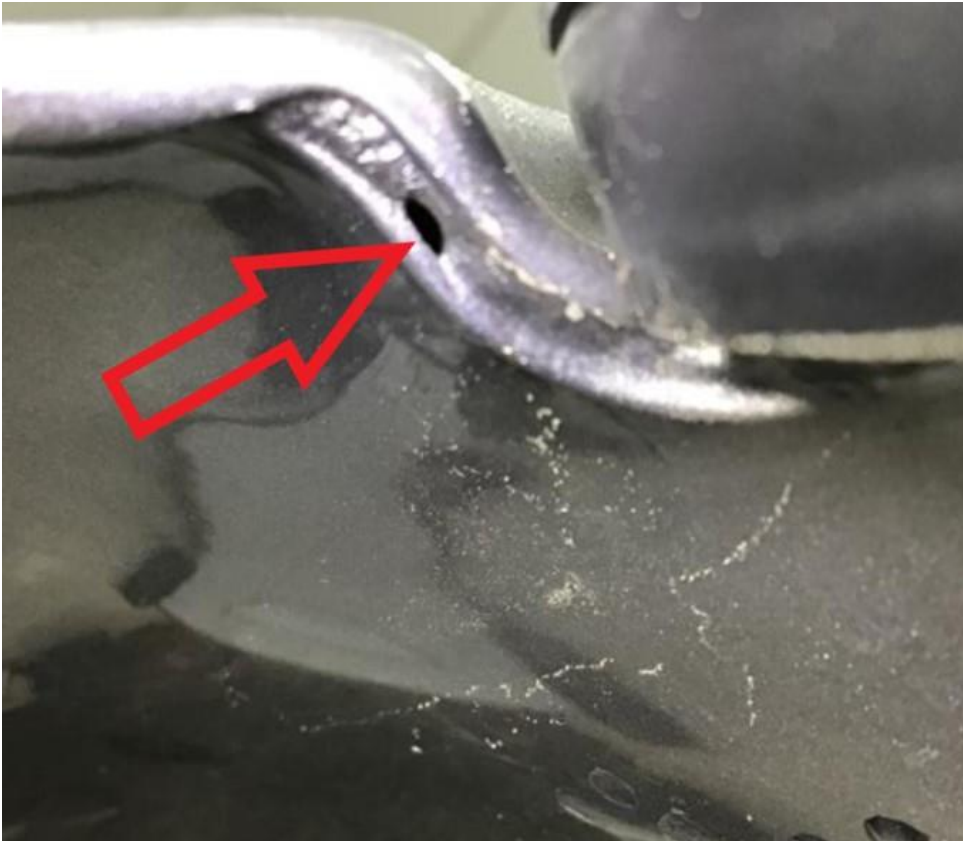
2) In the event that sealant is missing from the locations shown in Figure 2 (left and/or right hand side)

Different locations on the rear lid the operative should clean/prepare the areas concerned and apply sealant (See parts information) to the applicable locations

- Once sealant has been applied conduct a local paint repair in the location in which sealant was missing

3) Once the sealant and paint repair has been completed and the sealant/paint has cured/dried - Check to confirm the leak has been successfully repaired

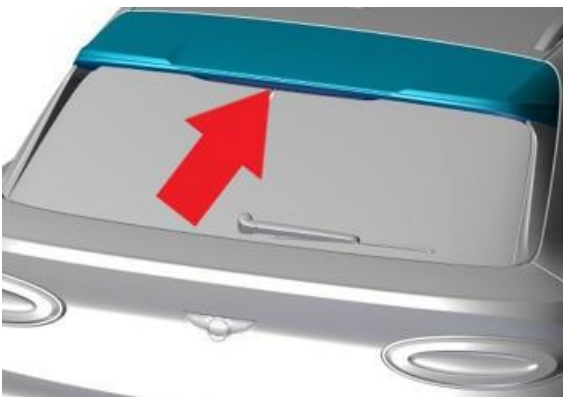
- Figure 3 - Rear spoiler

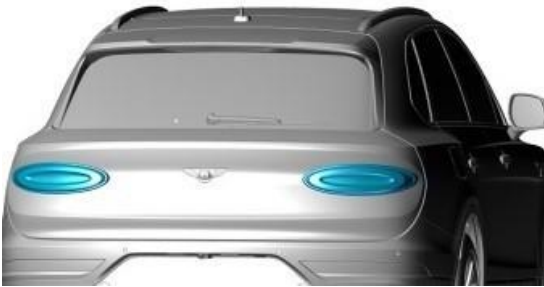
- Figure 4 - Rear lamps

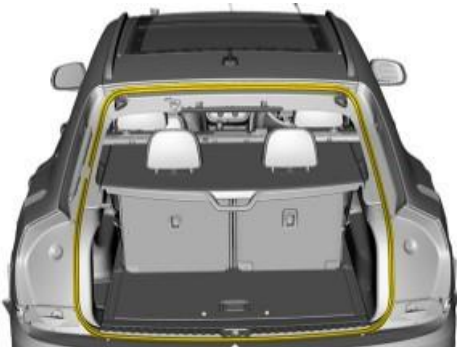
- Figure 6 - Tailgate seal - Refer to Rep.Gr 55 to confirm the seal is fitted correctly and also confirm the seal is not damaged or distorted

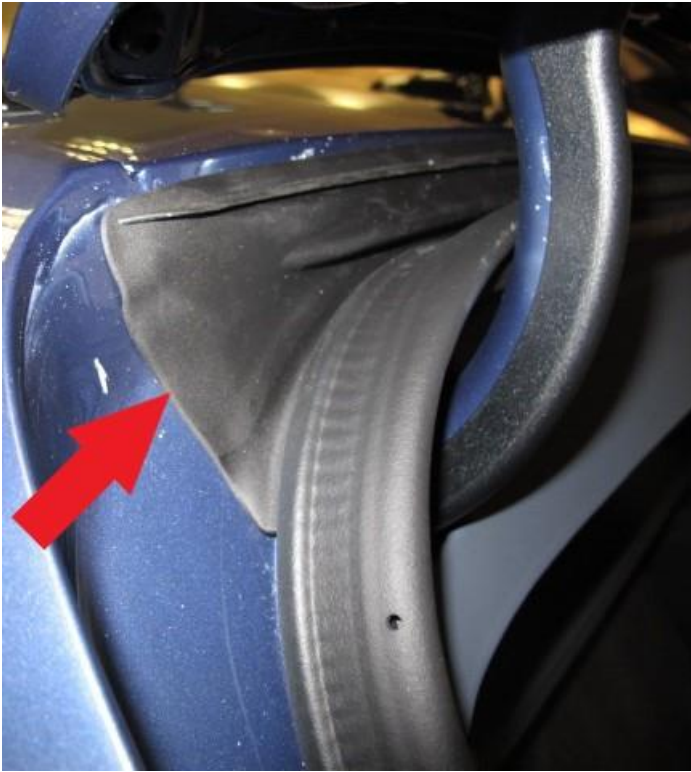
- Figure 7 - Upper water deflector – Check to confirm the upper water deflector is fitted correctly and not damaged/distorted

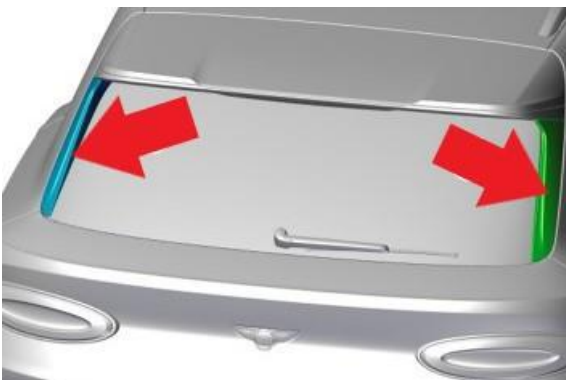
Figure 8

- Rear spoiler side strakes (Figure 8) - Check to confirm the side strakes are secure and water is not leaking past the location tang seals

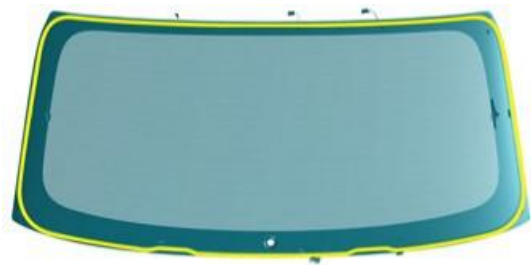
Figure 9

- Rear window glass (Figure 9) - Apply water in the locations shown (yellow line) to confirm the rear window glass is not leaking due to missing sealant
