| Title: | MCC HVAC Upgrades | | | |
| Number: | SB_588.3 | Release Date: | 6/20/2022 | |

## **Subject:**

Addressing fault codes and upgrades to the MCC HVAC system.

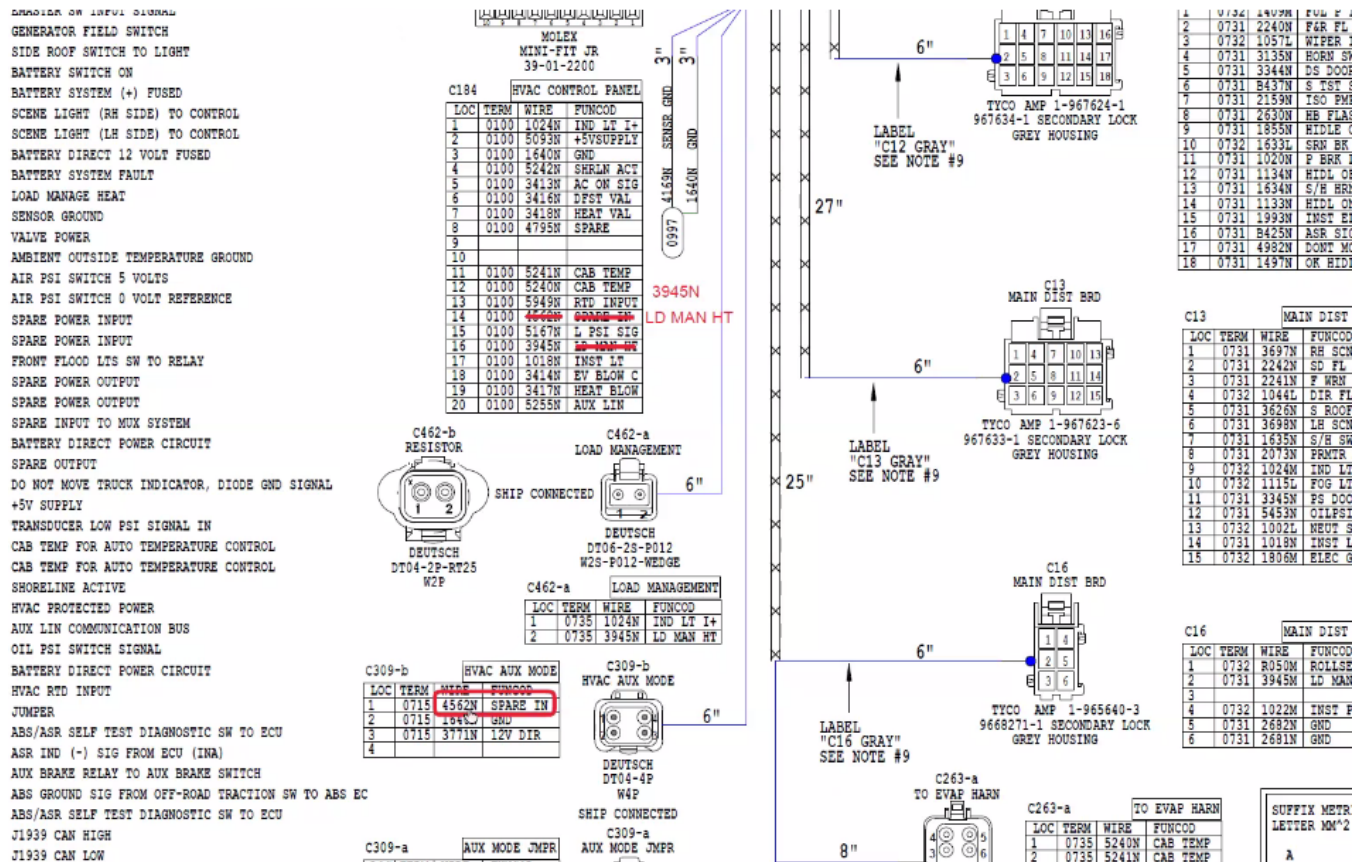
- a. With the correct Mini-Fit Junior pinning tool, re-pin wire 3495 in connector C184 from pin 16 to pin 14.
- b. If the correct Mini-Fit Junior pinning tool is not available:
  - i. Cut wire 3495 at connector C184.
  - ii. Connect wire 3495 to wire 4562 at connector C309.
  - iii. Leave wire 4562 in connector C184 pin 14.
- c. Refer to diagram below.

4. If vehicle is hardwired (not using multiplex networking) re-pin load manager connector to control panel part number # **63-4753-0002**.

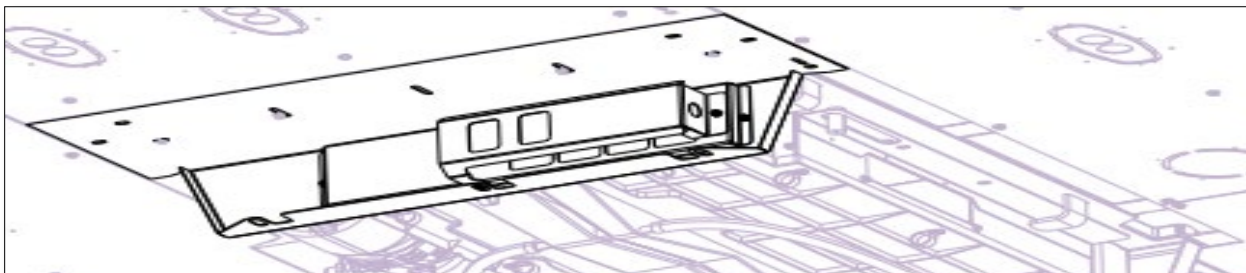
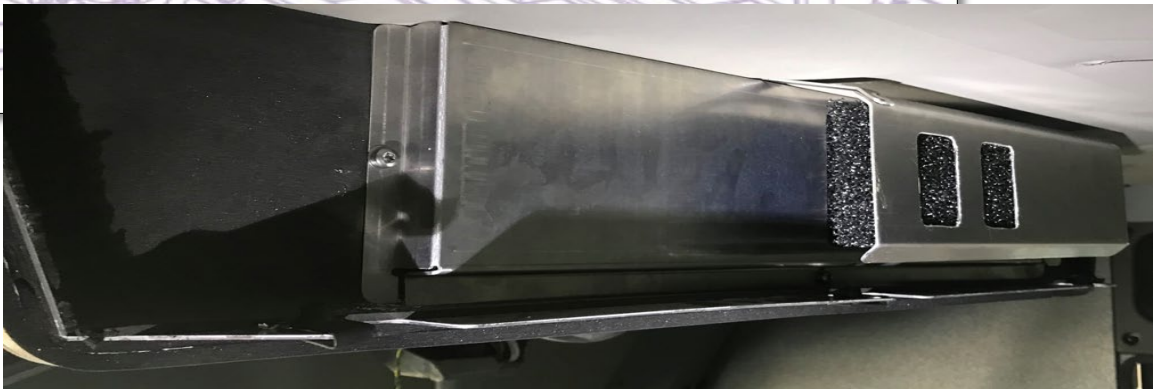
This will eliminate unnecessary messages and only display the faults that are currently active which will save time on troubleshooting and part replacements. The upgrade also allows the temperature to be controlled in defrost mode. To ensure that the AC system operates correctly and doesn't spray condensation through the vents, an internal baffle needs to be added to the diffuser as part of the air balancing package that also increased fan speed.

When the new software is installed, make sure the diffuser kit has been installed in the back of the evaporator. If it is not installed, please order **kit # 4067393** through Pierce's parts team. Please see **reference print 4021455** for installation instructions.

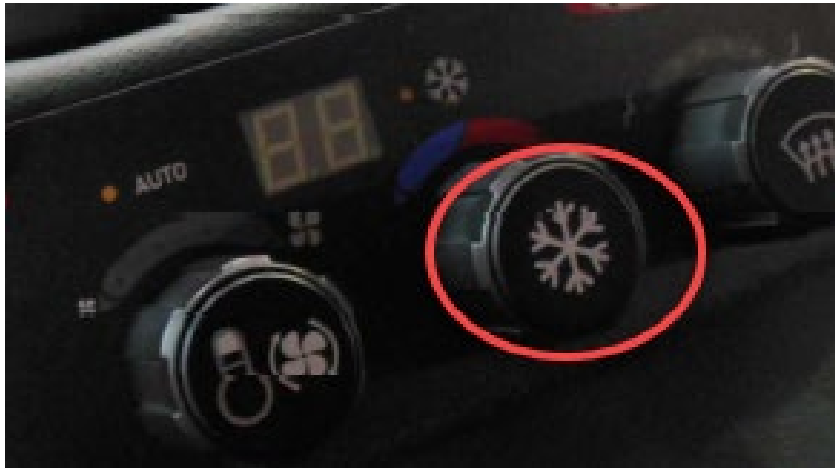
*AC Button*

6. Digital Temperature Displayed in Wrong Format

- a. Temperature can be displayed in Fahrenheit or in Celsius
  - i. To change one from the other, press the center AC button quickly 6 times and wait 10-15 seconds for it to change
  - ii. It might be required to wait and press the AC button one more time for it to change over

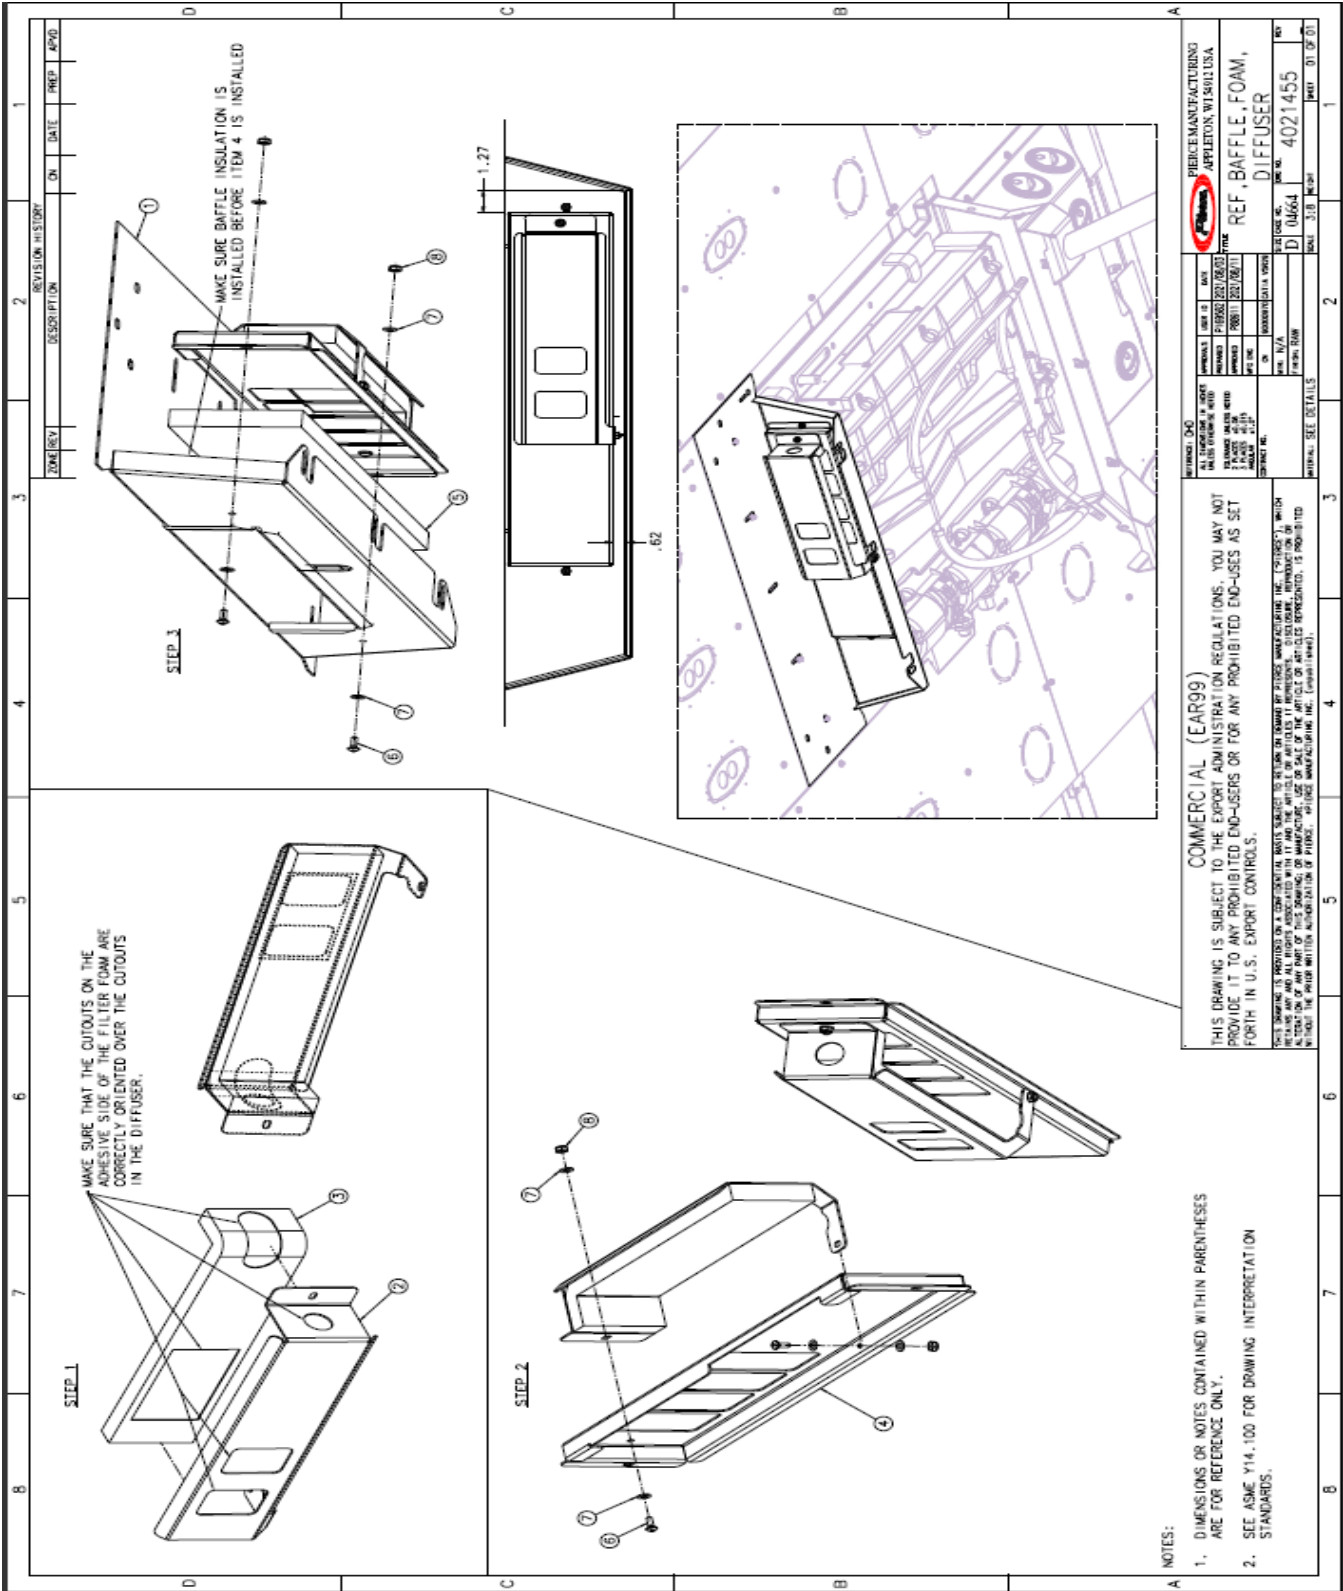
Reference Print 401455

7. Evaporator Fans Slow Down or Will Not Run

- a. Ensure faults are not active and not in a load manage state
- b. Mechanical siren cable needs to be ran back and connected to the battery. It can be connected direct or switched battery. We just need to eliminate it from the passenger side cab distribution as it requires such a high amp draw at start up and operation
- c. If condition continues after siren cable reroute, then wires (ckts 1397 and 1398) for the evaporator need to have the wire size increased to 8 awg. This will be run from the evaporator fan fuses in the cab roof distribution all the way to the evaporator fans.
