# Technical Service Bulletin

**97 MIL on: DTC U064100 or U064000 for fuel tank breather - 2.0 ltr. TFSI EA888**  
97 23 90 2069123/1 January 17, 2023.

Model(s)	Year	VIN Range	Vehicle-Specific Equipment
A4, A4 allroad, A5, A5 Cabriolet, and A5 Sportback	2021 – 2022	All	Not Applicable

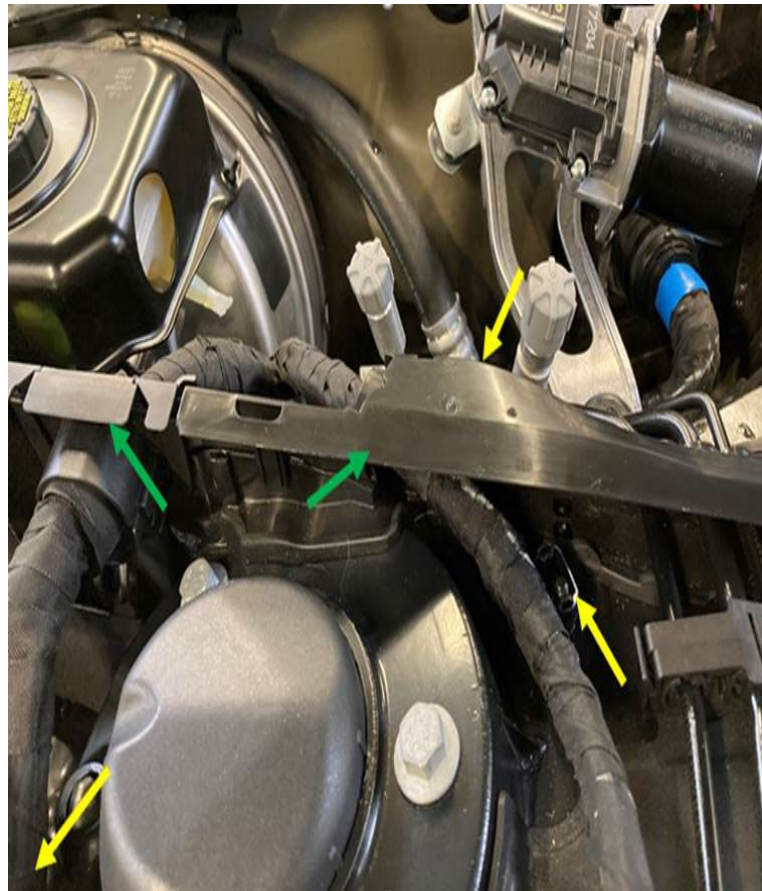
**Figure 1:** Plenum chamber covers (green arrows).

1. Remove plenum chamber covers (green arrows, Figure 1)

Release wiring harness securing clips (yellow arrows, Figure 1).

Using a seam ripper, expose the wiring harness as shown in Figure 2.

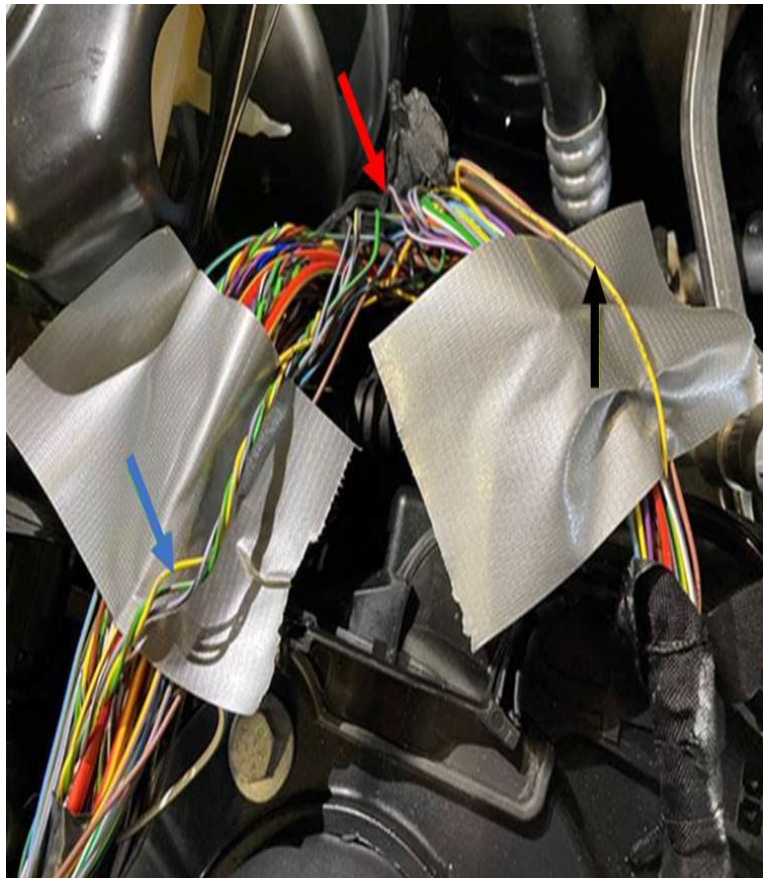
**Figure 2:** Wires isolated for modification.

2. Isolate the yellow/grey wire (triple twisted wire; blue arrow, figure 2) in the left bundle.

Isolate the yellow/purple wire in the right bundle (black arrow, Figure 2).

Cut the yellow/grey wire at the blue arrow and unravel it in the direction of the plenum chamber up to the red arrow.

Cut the yellow/purple wire at the black arrow.

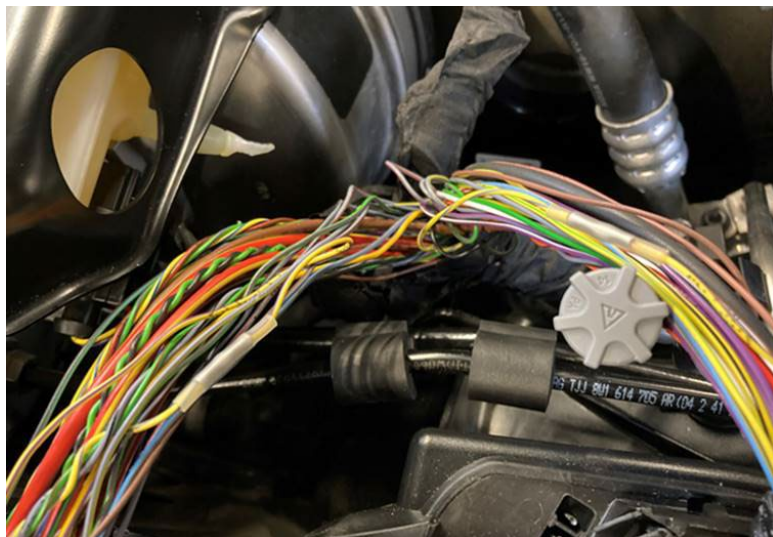
**Figure 3:** wire modification complete.

3. Using wire harness repair set **VAS 1978 B**, perform the following:

Connect the untwisted yellow/grey wire (plenum chamber side) from the left bundle to the yellow/purple wire in the right bundle (engine side).

Connect the remaining yellow/purple wire (plenum side) to the yellow/grey wire (engine side).
