**Subject: Certain New Cascadia Vehicles Equipped
with Cummins Engines—Inspection for Properly
Torqued Engine Mounting Bolts**

**Models Affected: 2023 New Cascadia vehicles built from August
24, 2022, through December 13, 2022.**

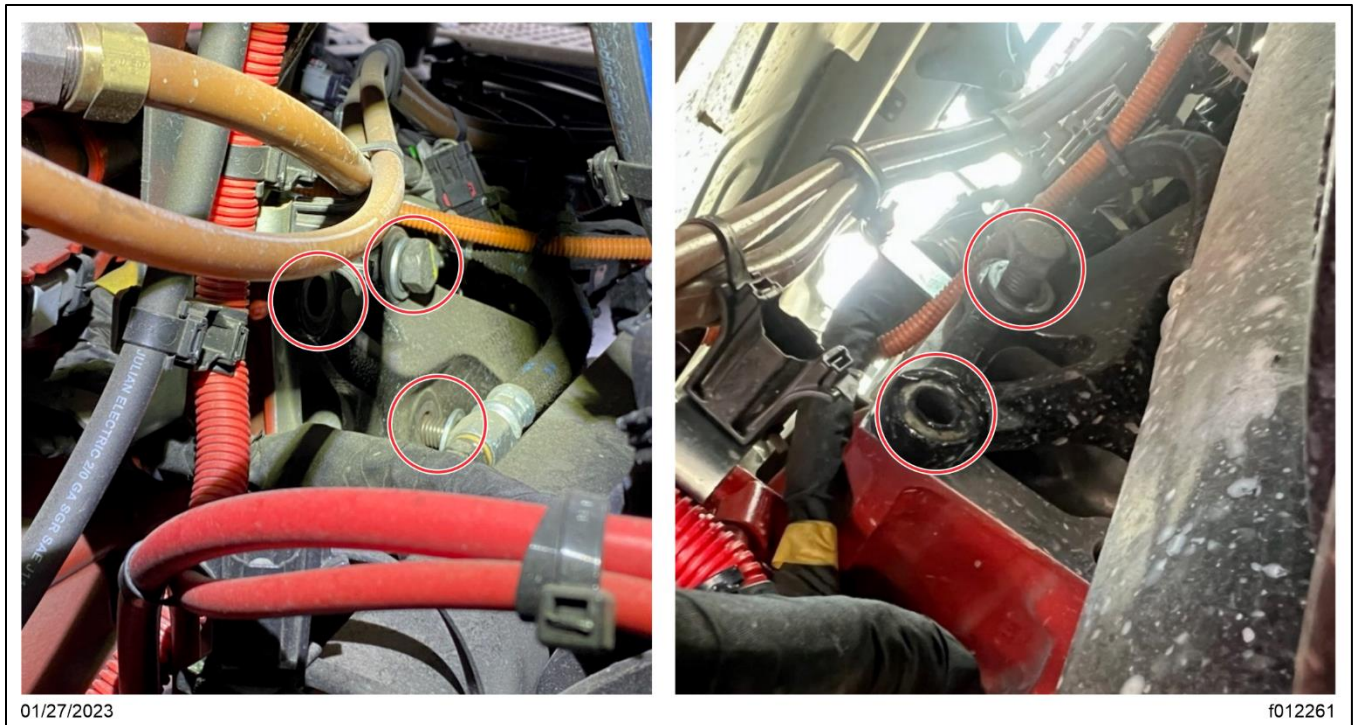
Fig. 1, Loose or Missing Rear Engine Mounting Bolts

1. Park the vehicle on a level surface, shut down the engine, and set the parking brake. Chock the tires.
2. Inspect the rear engine mounting bolts for missing or loose bolts. See [Fig. 1](#).
3. If the bolts are present and do not appear to be loose, confirm that the torque of these engine bolts is 213 to 269 lbf·ft (289 to 365 N·m).
4. If the bolts are loose or missing, replace the bolts. See [Fig. 2](#). Part numbers for the correct bolts are shown in [Table 2](#).
5. Apply red Loctite to the bolts, and tighten 213 to 269 lbf·ft (289 to 365 N·m).
