Service Alert

**Subject:**

CRACKED REAR DIFFERENTIAL (REVISED)

Service Alert No.: SA-007/23

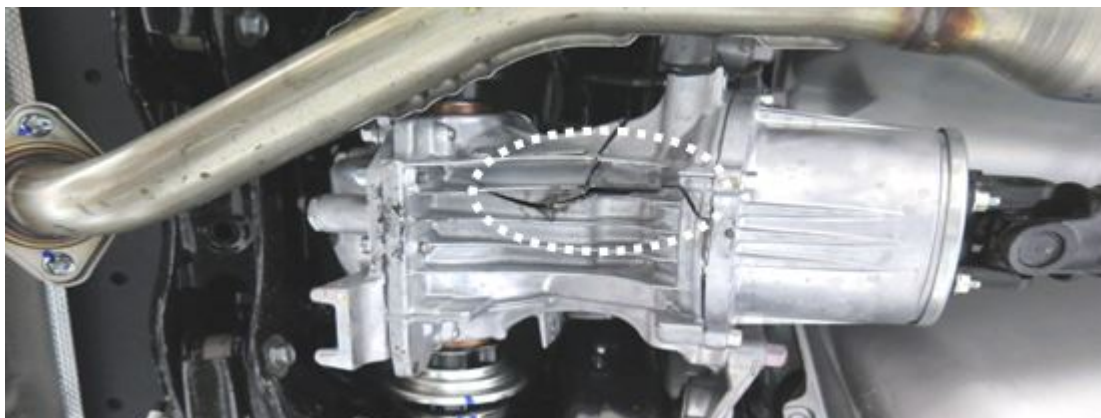
The rear differential case could develop a crack in the case, as shown below.

4. Replace the rear differential assembly according to MGSS.

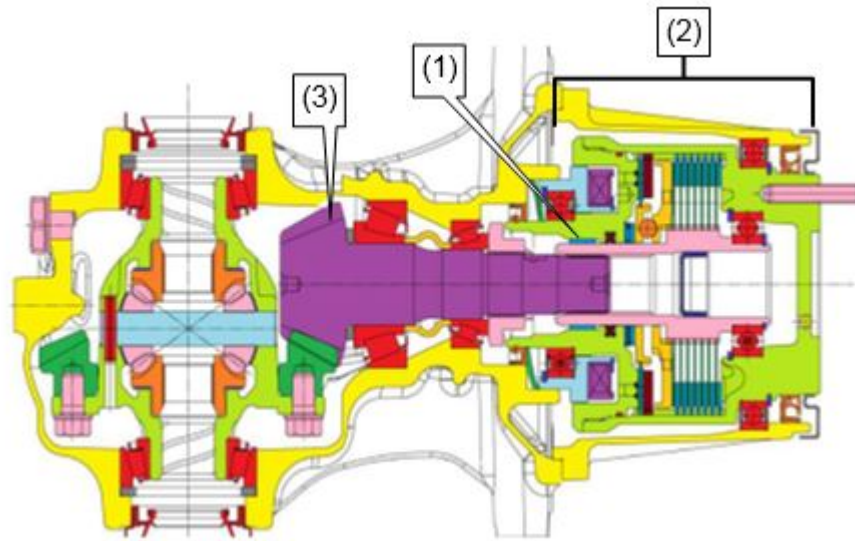
This concern is caused when the sliding bearing (1) in the coupling (2) is seized and causes the coupling component to fit loosely. The pinion shaft head (3) then contacts the differential case and causes a crack.
