# Technical Service Bulletin

**INSUFFICIENT HEATER PERFORMANCE UNDER -4 °F (-20 °C)  
OR COLDER ENVIRONMENT**

**Bulletin No.: 07-001/23**

2022 MX-30

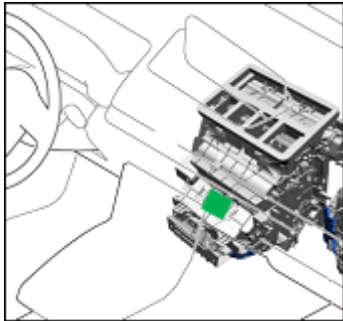
Label on heater unit

\*If concerned VIN is around the one in parentheses in the table, confirm the part number on the label attached to the heater unit.
